Pre-Construction Road Condition Report for WestConnex M5N

Project No: PSS17131

for WestConnex M5N

date June 2017

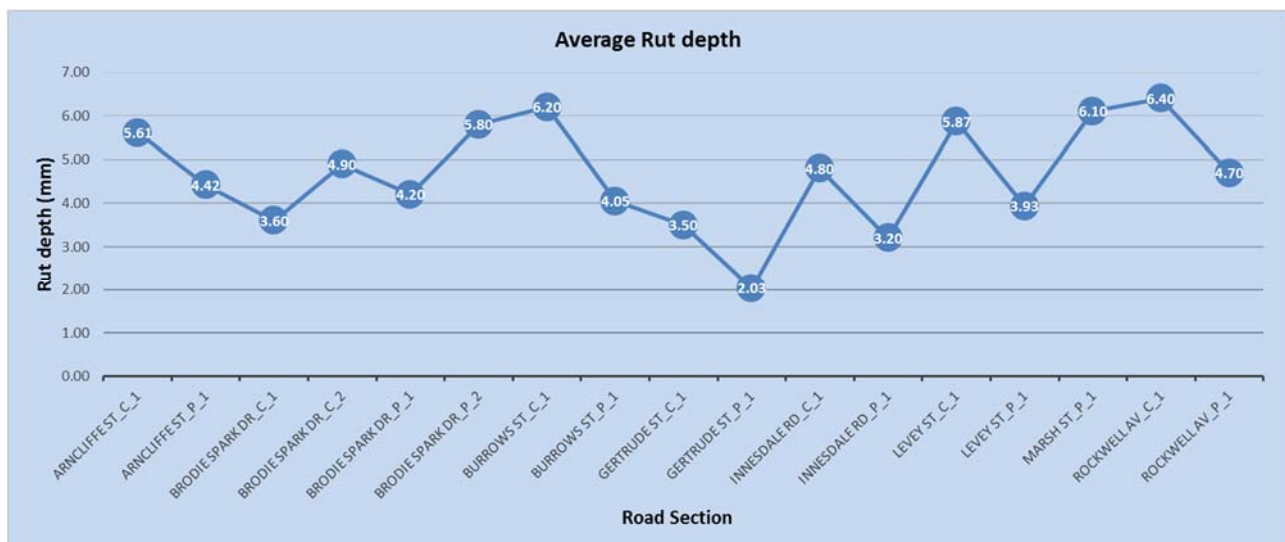
Figure 2.1: Average condition Rut depth Bayside Council

Figure 2.1 presents the average rut depth of each road section and the majority of the sections present rut depth of around 5mm, mostly in ‘good’ condition.

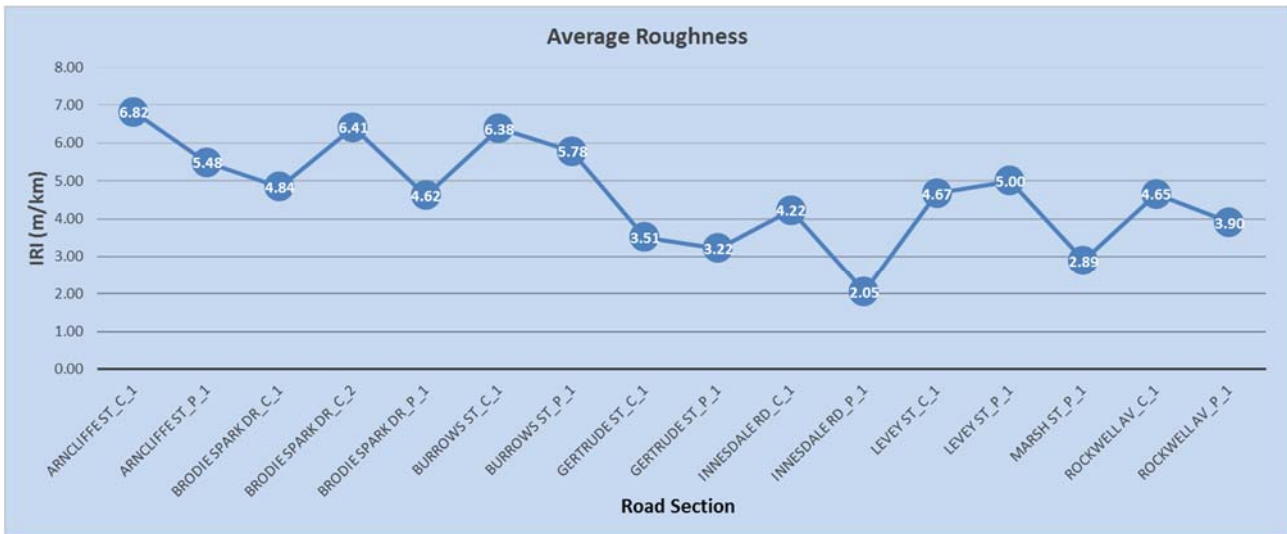
Figure 2.2: Average condition-Roughness-Bayside Council

Figure 2.2 shows the average roughness condition of each surveyed section. Most sections present roughness value of more than 4.2 IRI, which is considered ‘Poor’ according to the assumed level of service definitions (Section 1.3).

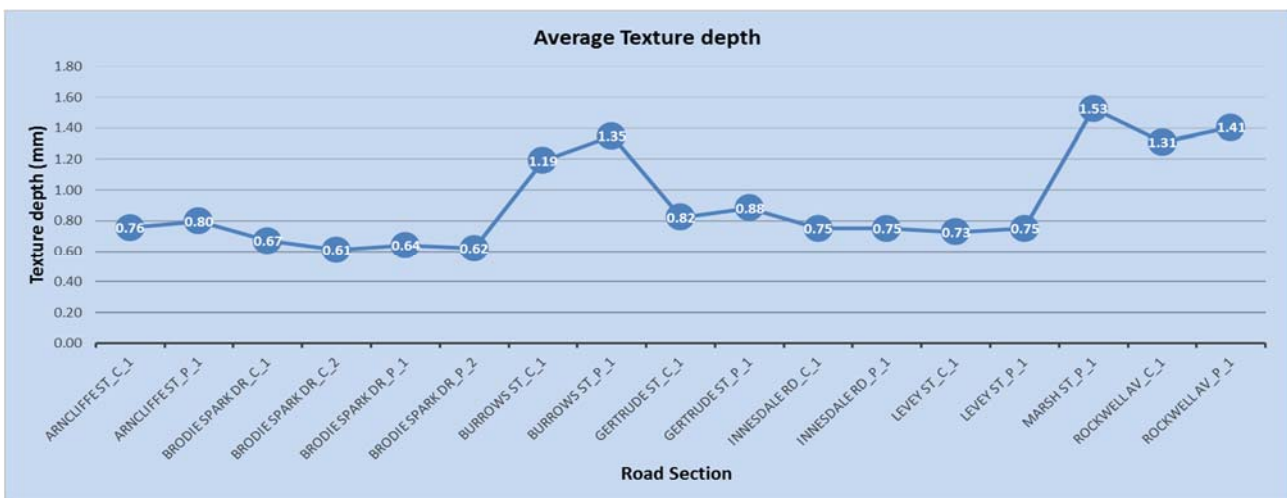
Figure 2.3: Average condition-Texture depth-Bayside Council

As indicated in Figure 2.3 all of the road sections have texture depth of 0.6 mm or more, which is considered 'Fair'/ "Good" condition for texture depth.

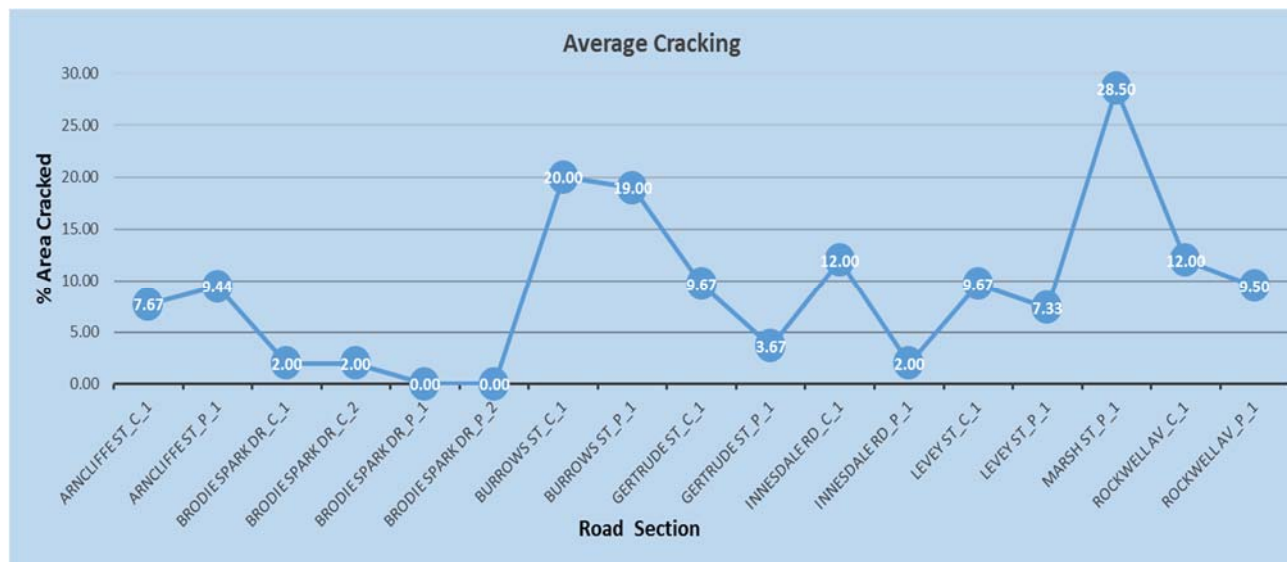
Figure 2.4: Average condition-Cracking-Bayside Council

Majority of the road sections of Bayside Council have less than 10% of area cracked and it is considered as 'Good'.

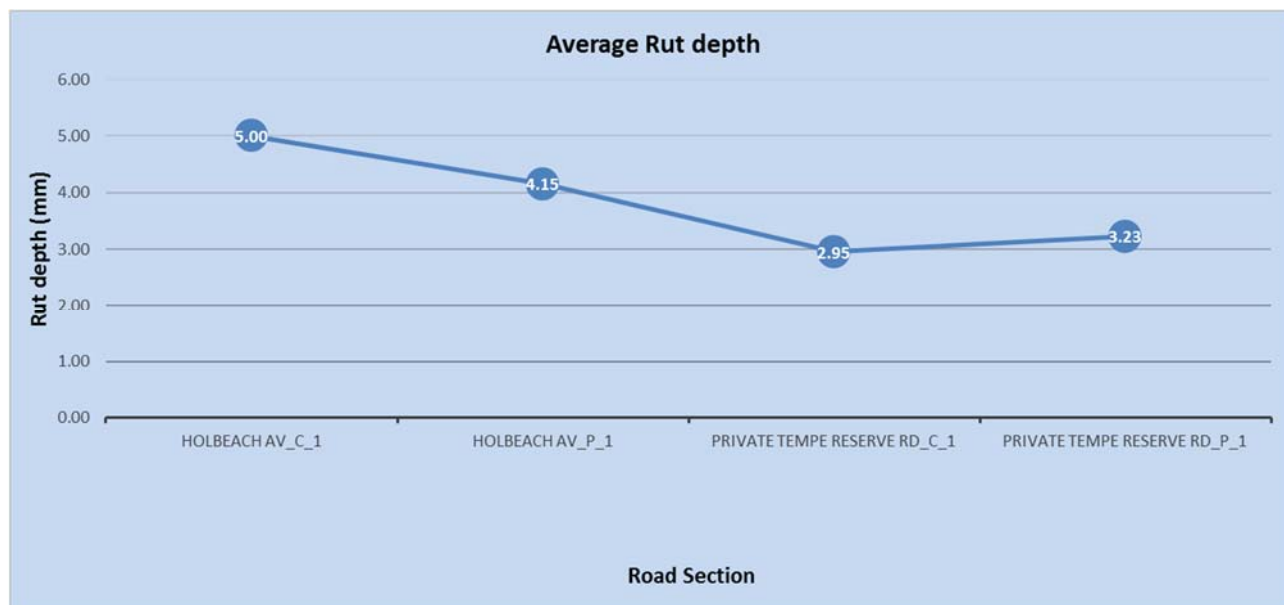
Figure 3.1: Average condition-Rut depth-Inner West Council

Figure 3.1 presents the average rutting of each road section and the 3 out of 4 sections have rut depth of less than 5 mm which is translated as ‘Good’ condition.

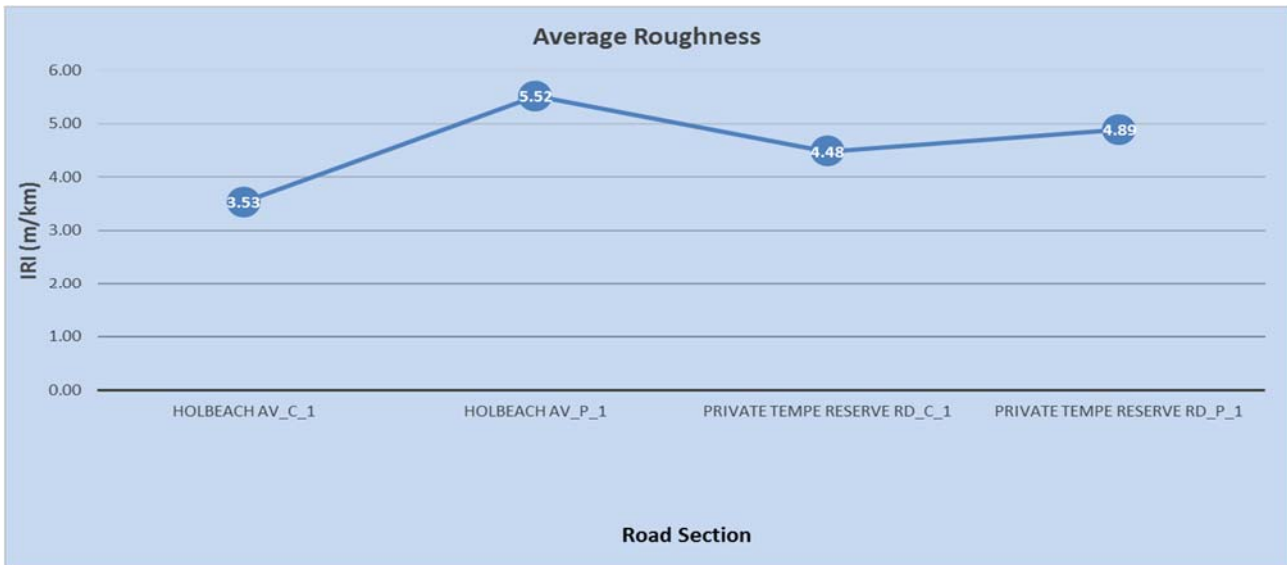
Figure 3.2: Average condition-Roughness-Inner West Council

Figure 3.2 shows the average roughness condition of each surveyed section. Based on current LoS definitions (Section 1.3), Private Tempe Reserve Rd sections sit in “Poor” condition. Holbeach Avenue has prescribed direction in “Very Poor” and counter direction in “Fair” condition.

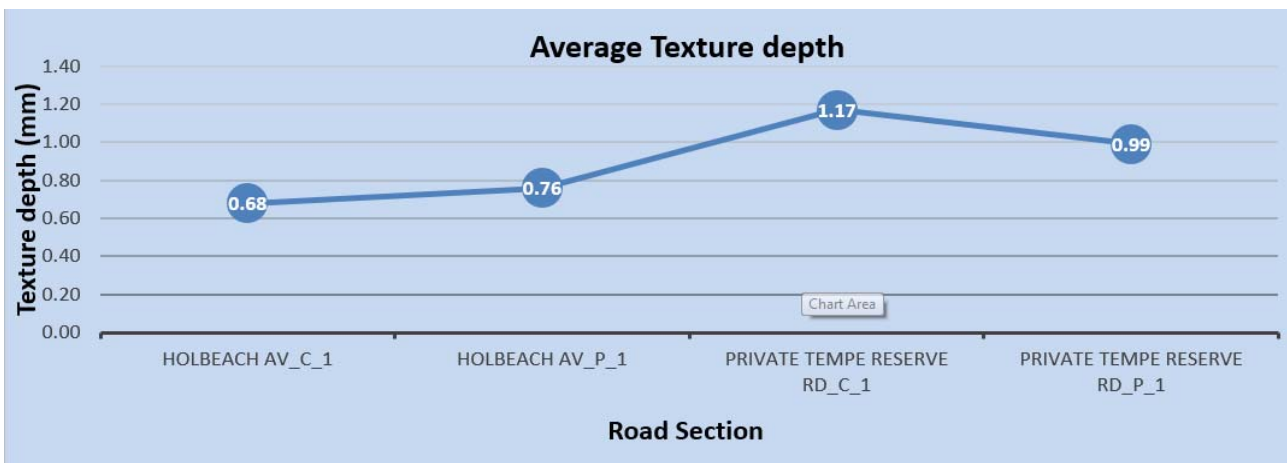
Figure 3.3: Average condition-Texture depth-Inner West Council

As shown in Figure 3.3, all road sections have texture depth of more than 0.6 mm. Based on current LoS definitions (Section 1.3) for texture depth, Private Tempe Reserve Rd sections sit in “Good” condition while Holbeach Avenue sections are in “Fair” condition.

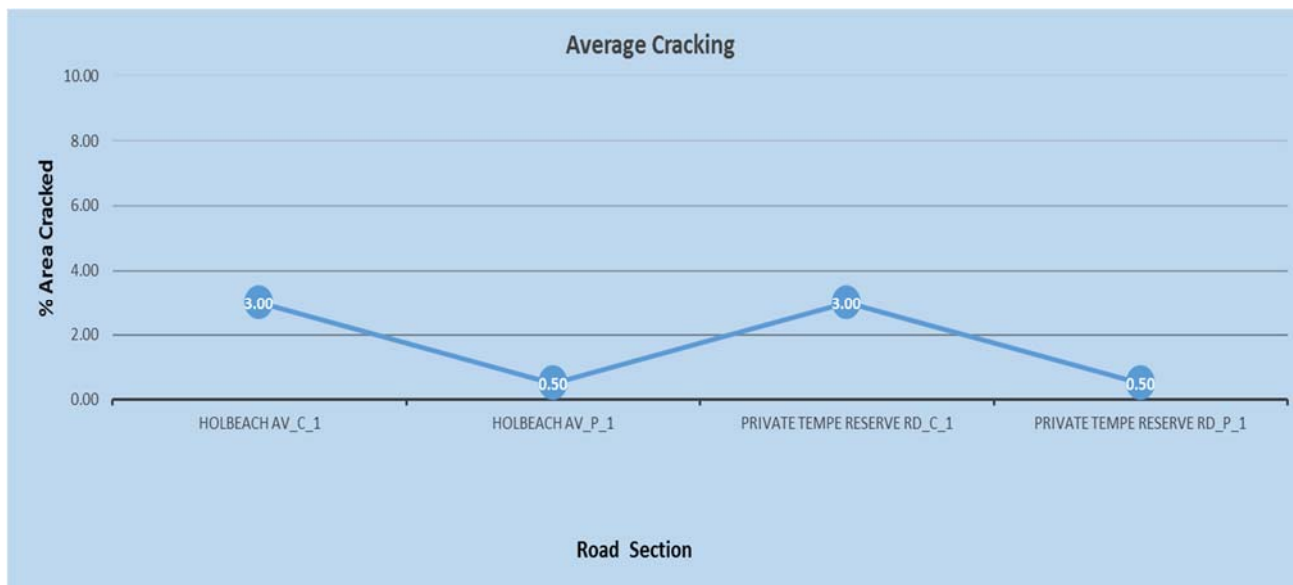
Figure 3.4: Average condition-Cracking-Inner West Council

All surveyed road sections of Inner West council are in “Very Good” condition in terms of Cracking (<5% of the area cracked, Figure 3.4).
