# Local Road Dilapidation Report Sydney City Council

Project Name: WestConnex New M5

Project number:	15.7020.2597
Document number:	M5N-CN-RPT-PWD-0005
Revision date:	09/05/2016
Revision:	00

Pre-Construction Road Condition  
Report for WestConnex New M5 Main  
Works Project – Sydney City Council

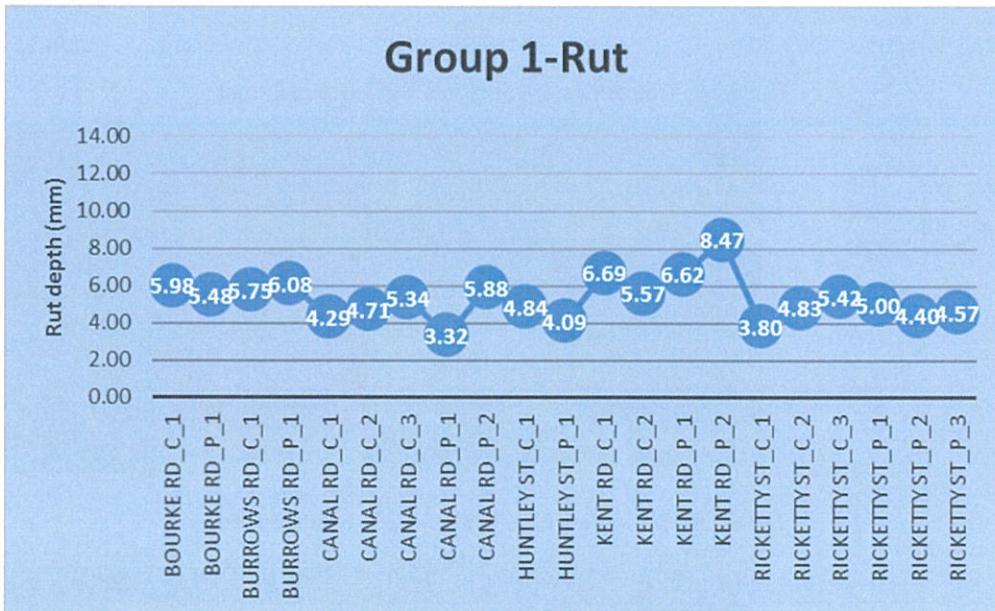
Figure 2.1: Rutting condition- SCC- Group 1 road

Figure 2.1, Figure 2.2 and Figure 2.3 present the average rutting of each lane and the majority of the road sections fall in the category of 'good' or 'fair' according to the condition definition (Section 1.3). Some sections are presenting over 10mm localised rutting, such as HUNTLEY ST\_C\_1, KENT RD\_P\_1 and KENT RD\_P\_2.

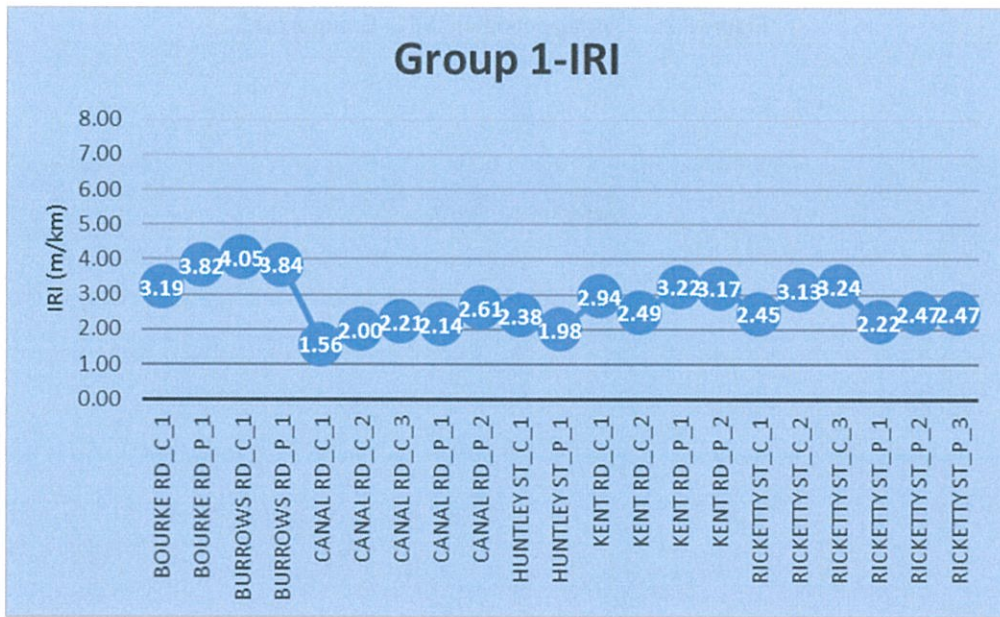
Figure 2.4: Roughness condition- SCC- Group 1 road

Figure 2.4, Figure 2.5 and Figure 2.6 show the average roughness condition of each survey road. Most road sections can be considered 'good or 'fair', except HARBER ST\_P\_1, CHURCH AV\_P\_1, MADDOX ST\_C\_1, and MADDOX ST\_P\_1.

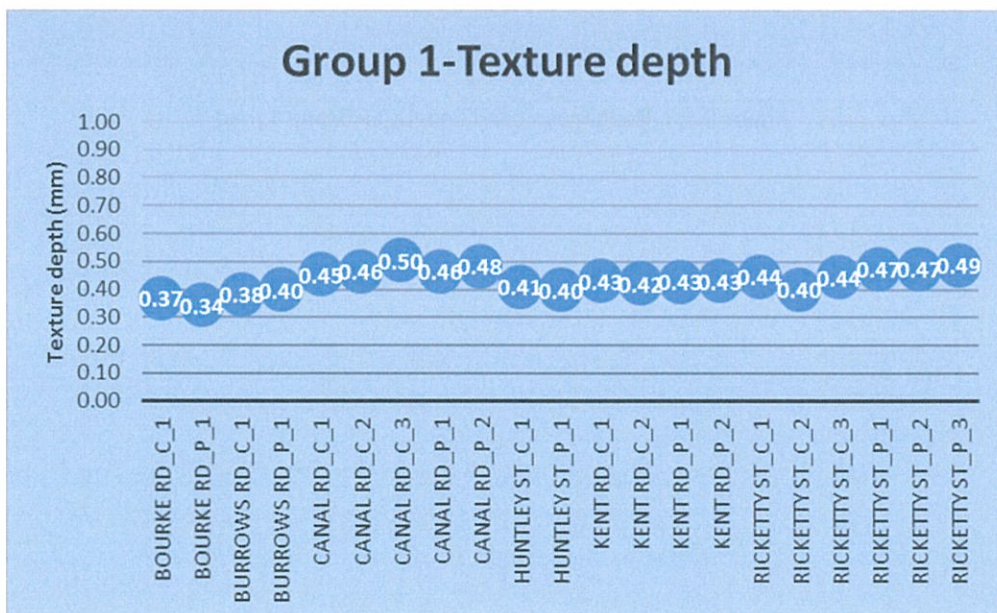
Figure 2.7: Texture depth- SCC- Group 1 road

Average texture depth for Group 1, Group 2 and Group 3 are presented in Figure 2.7, Figure 2.8 and Figure 2.9. Approximately half of the road sections are considered 'poor' and the rest categorised as 'fair'.

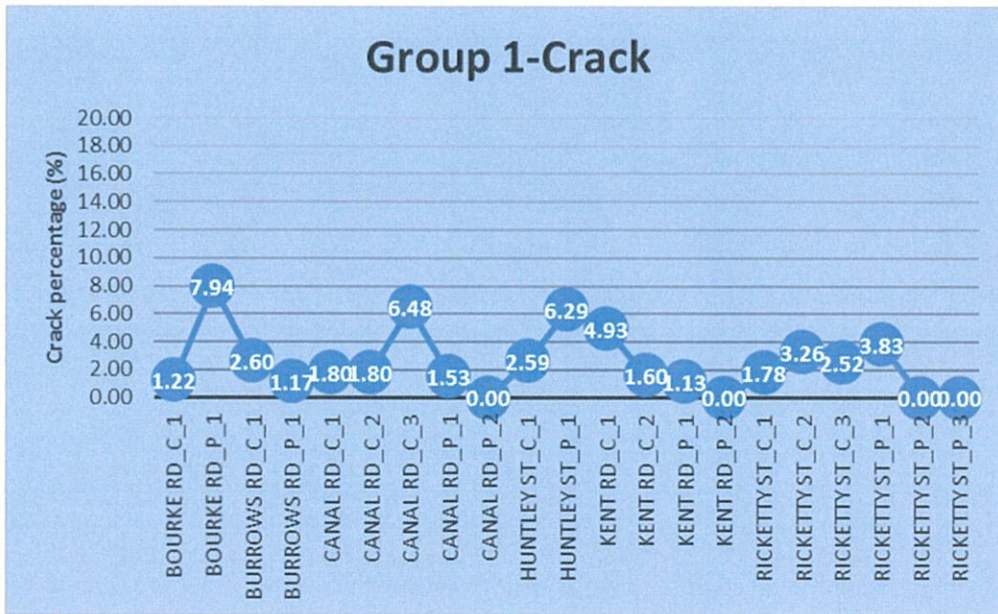
Figure 2.10: Cracking condition- SCC- Group 1 road

Figure 2.10, Figure 2.11 and Figure 2.12 present average cracking of Group 1, Group 2 and Group 3 road. The majority of road sections can be considered 'very good' in terms of cracking. Severe local cracking is found on BOURKE RD\_P\_1 (31% cracked area) and CHURCH AV\_P\_1 (19% cracked area).
