Local Road Dilapidation Report Hurstville Council

Project Name: WestConnex New M5

Project number:	15.7020.2597
Document number:	M5N-CN-RPT-PWD-0002
Revision date:	09/05/2016
Revision:	00

Pre-Construction Road Condition
Report for WestConnex New M5 Main
Works Project- Hurstville Council

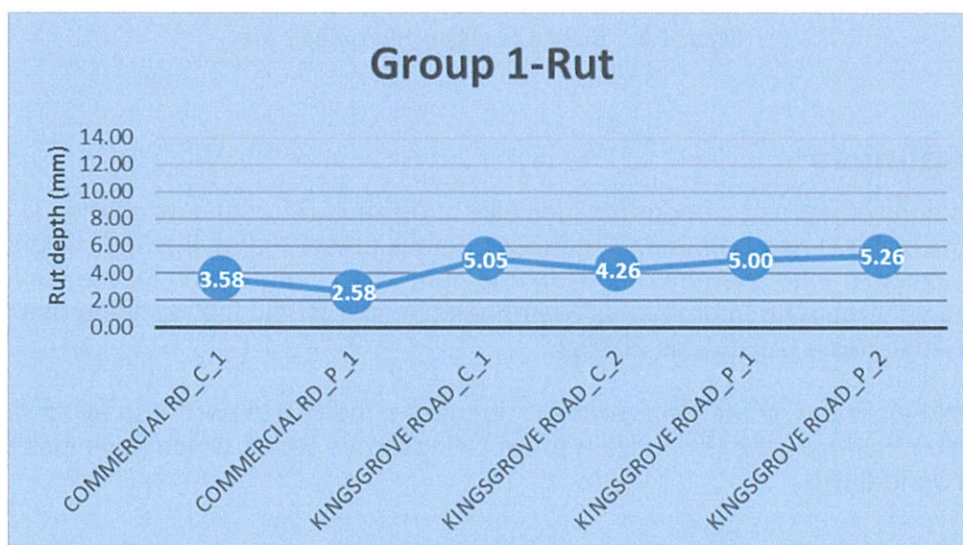
Figure 2.1: Rutting condition- HC- Group 1 road

Figure 2.1 and Figure 2.2 present the average rutting of each road direction. Majority of the roads present less than 5mm rut depth and they are considered mostly ‘good’. Kingsgrove Road both lane and directions have over 8mm rut depth. Kirrang Street counter direction lane 1 also shows over 9mm of rut depth.

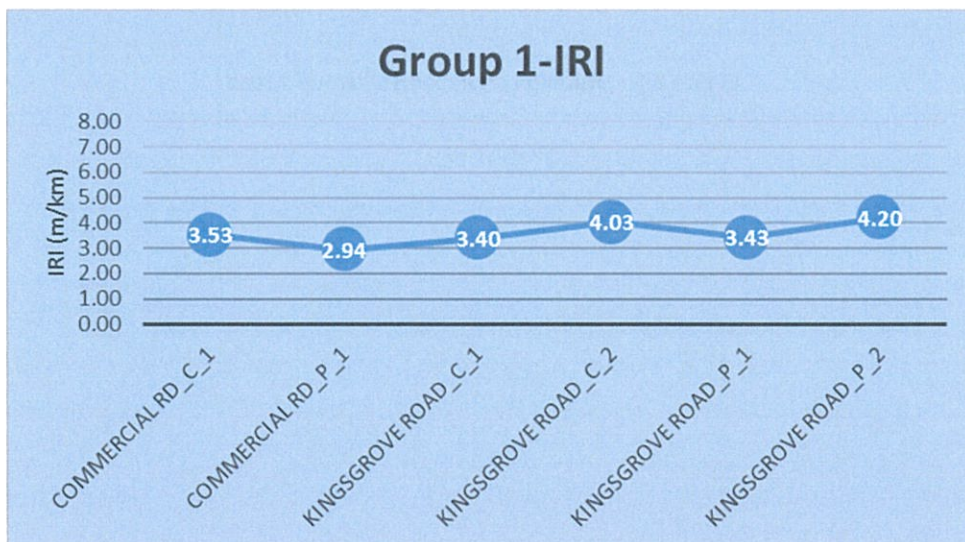
Figure 2.3: Roughness condition- HC- Group 1 road

Figure 2.3 and Figure 2.4 show the average roughness condition of each survey road. Most roads present 'good' or 'fair' roughness condition except Kingsgrove Road, which have localised roughness of up to 8 IRI.

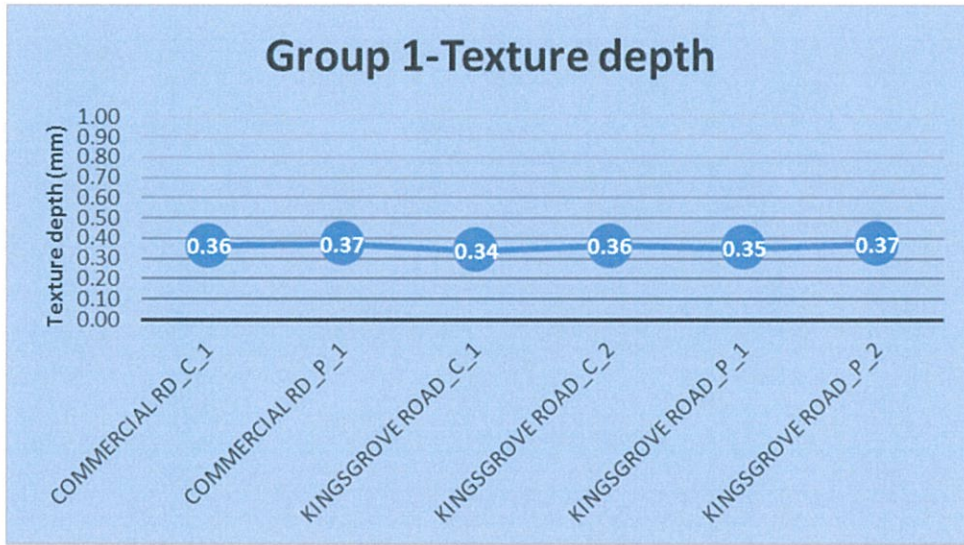
Figure 2.5: Texture depth- HC- Group 1 road

As indicated in Figure 2.5 and Figure 2.6, most Group 1 roads present texture depth of less than 0.4mm, which fall in a 'poor' category. Most road in Group 2 have better texture condition ('fair').

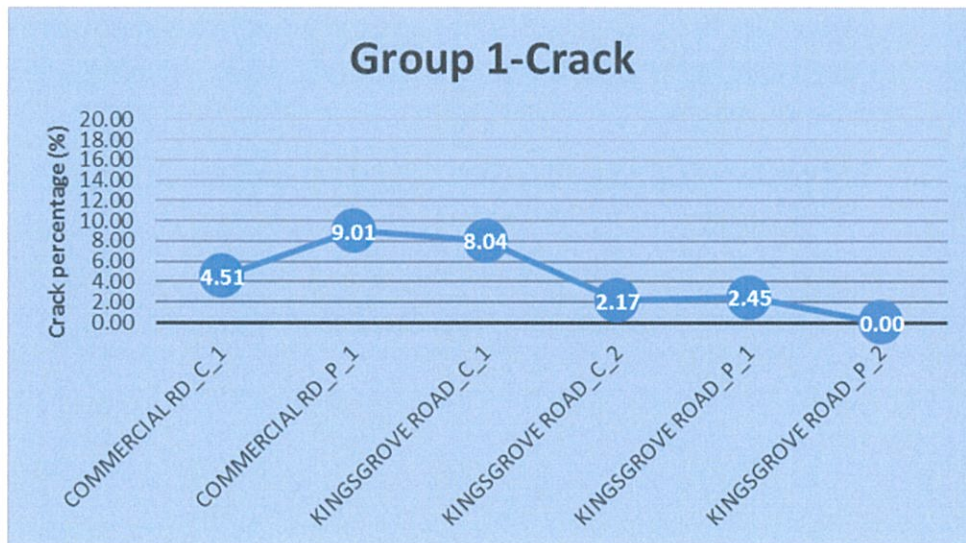
Figure 2.7: Cracking condition- HC- Group 1 road

Figure 2.7 and Figure 2.8 present the average cracking of the road lane in each Group. Commercial Road prescribed direction lane 1 is heavily cracked with 11.9% cracked area. Severe cracking also appears on Kingsgrove Road especially in counter direction lane 1 (up to 23% localised cracking).
