Local Road Dilapidation Report Marrickville Council

Project Name: WestConnex New M5

Project number:	15.7020.2597
Document number:	M5N-CN-RPT-PWD-0004
Revision date:	09/05/2016
Revision:	00

Pre-Construction Road Condition
Report for WestConnex New M5 Main
Works Project – Marrickville Council

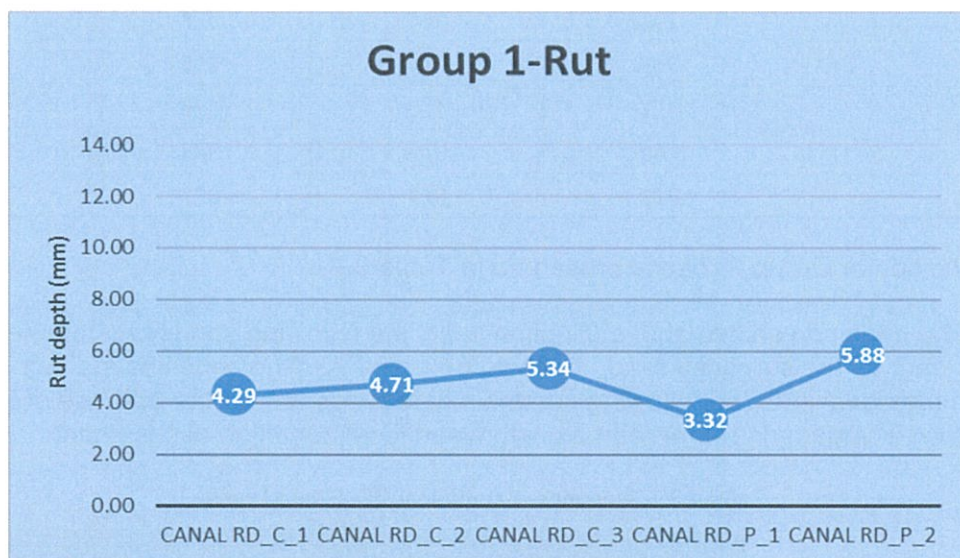
Figure 2.1: Rutting condition- MC- Group 1 road

Figure 2.1 and Figure 2.2 present the average rutting of each road lane for Group 1 and Group 2 respectively. Some sections in Group 2 show rut depth of up to 12mm, such as BELMORE LANE_P_1 and MILNE LANE_P_1 and are considered ‘poor’.

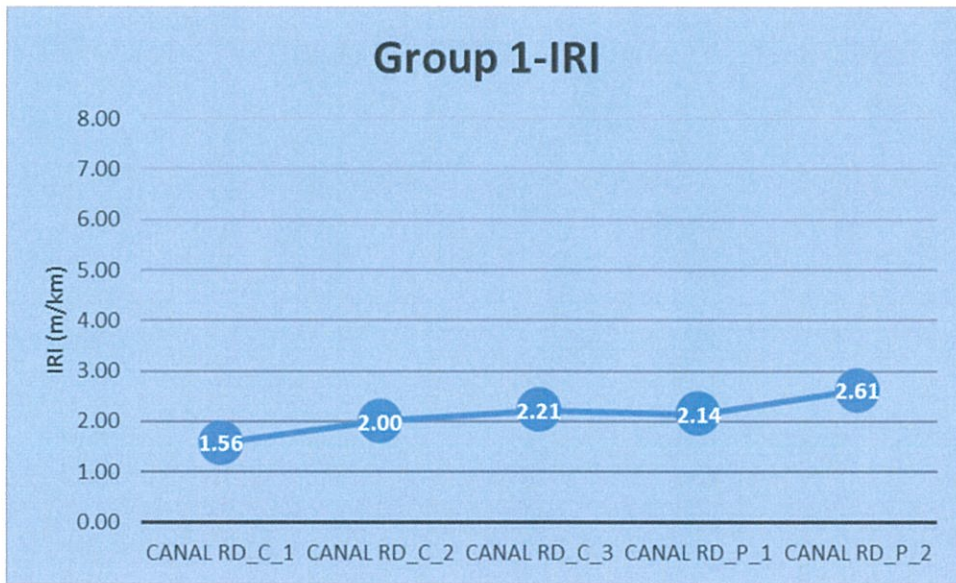
Figure 2.3: Roughness condition- MC- Group 1 road

Figure 2.3 and Figure 2.4 shows the average roughness condition of each surveyed lane for Group 1 and Group 2. Most Group 1 roads present roughness value of around 2 IRI and are considered 'fair', except KINGSGROVE ROAD_P_2. Group 2 contains some section with roughness up to 8 IRI, such as ALFRED ST_P_1, BAKERS LANE_P_1, BISHOP ST_P_1, and STEWART LANE_P_1; VICTORIA ST (SOUTH OF PRINCES HIGHWAY)_P_1 even go up to 10 IRI.

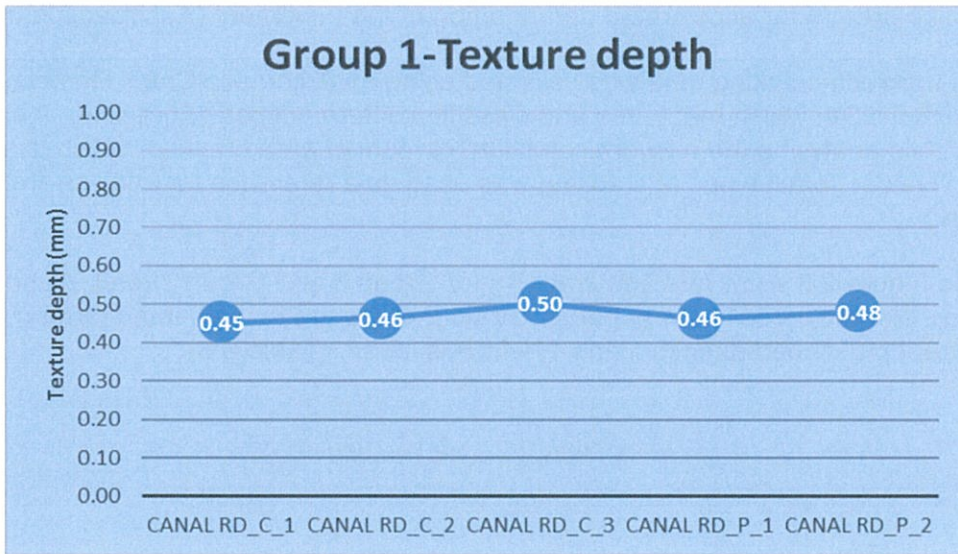
Figure 2.5: Texture depth- MC- Group 1 road

As indicated in Figure 2.5 and Figure 2.6, most roads in Group 1 are considered 'poor' in texture depth condition. Group 2 roads are found to be in 'fair' or 'poor' condition for texture depth.

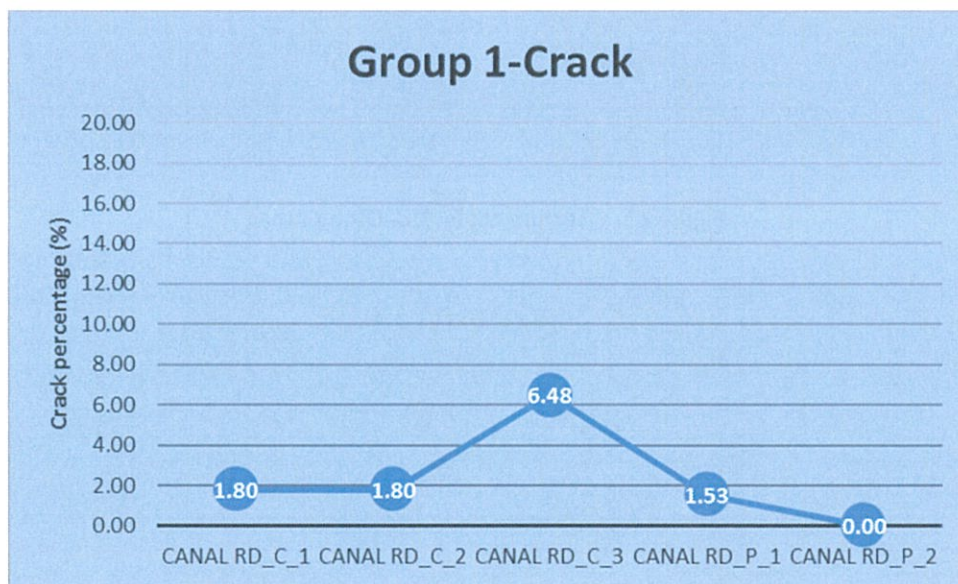
Figure 2.7: Cracking condition- MC- Group 1 road

Figure 2.7 and Figure 2.8 show average cracking for Group 1 and Group 2 road. All sections in Group 1 are considered 'good' or 'very good'. Group 2 roads are in the same cracking state except Wentworth Street prescribed direction lane 1, which is 'poor'. (Table 0.3)
