CONTRACT REPORT

Pre-Construction Road Condition Report for WestConnex M5N

Project No: PSS17131

date June 2017

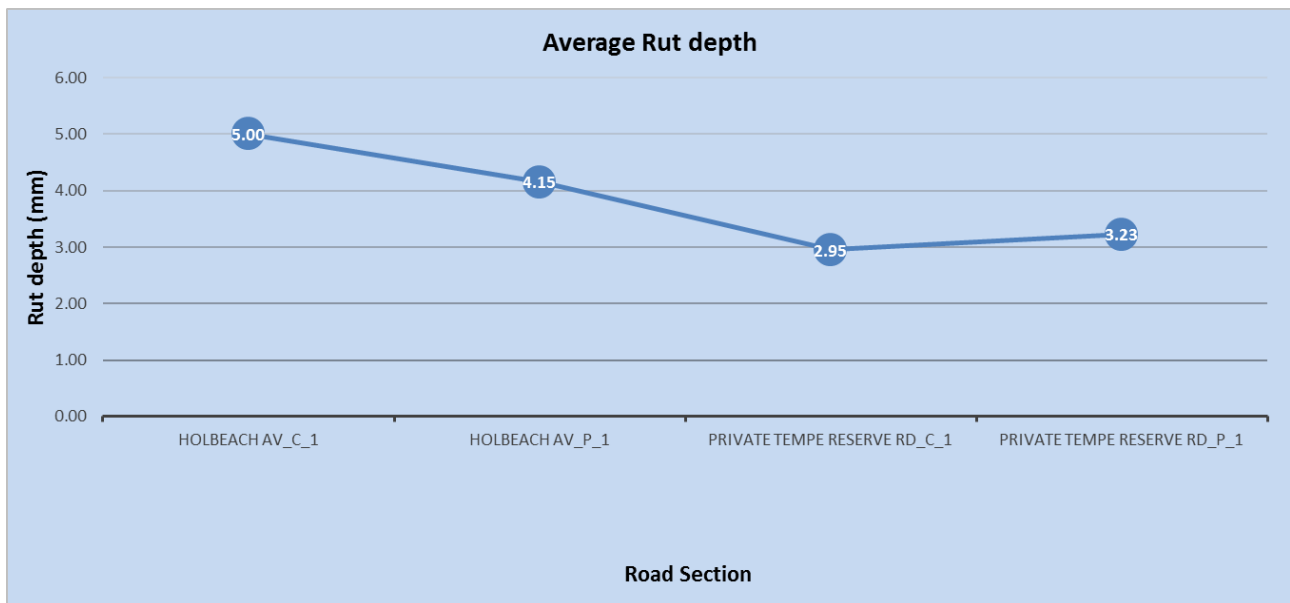
Figure 2.1: Average condition-Rut depth-Inner West Council

Figure 2.1 presents the average rutting of each road section and the 3 out of 4 sections have rut depth of less than 5 mm which is translated as ‘Good’ condition.

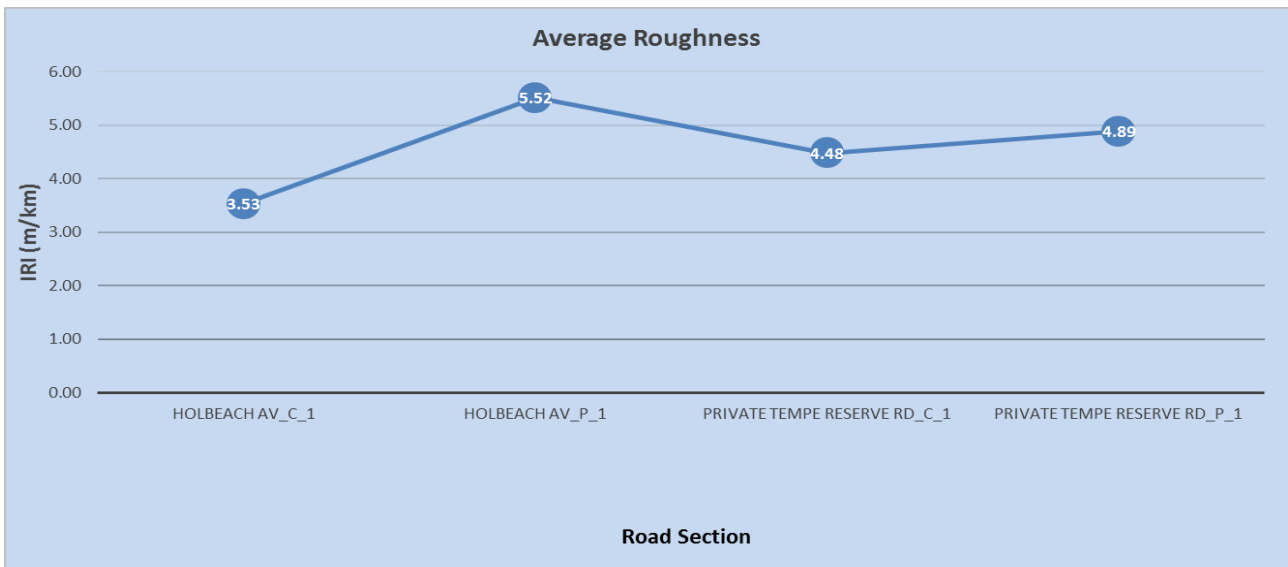
Figure 2.2: Average condition-Roughness-Inner West Council

Figure 2.2 shows the average roughness condition of each surveyed section. Based on current LoS definitions (Section 1.3), Private Tempe Reserve Rd sections sit in “Poor” condition. Holbeach Avenue has prescribed direction in “Very Poor” and counter direction in “Fair” condition.

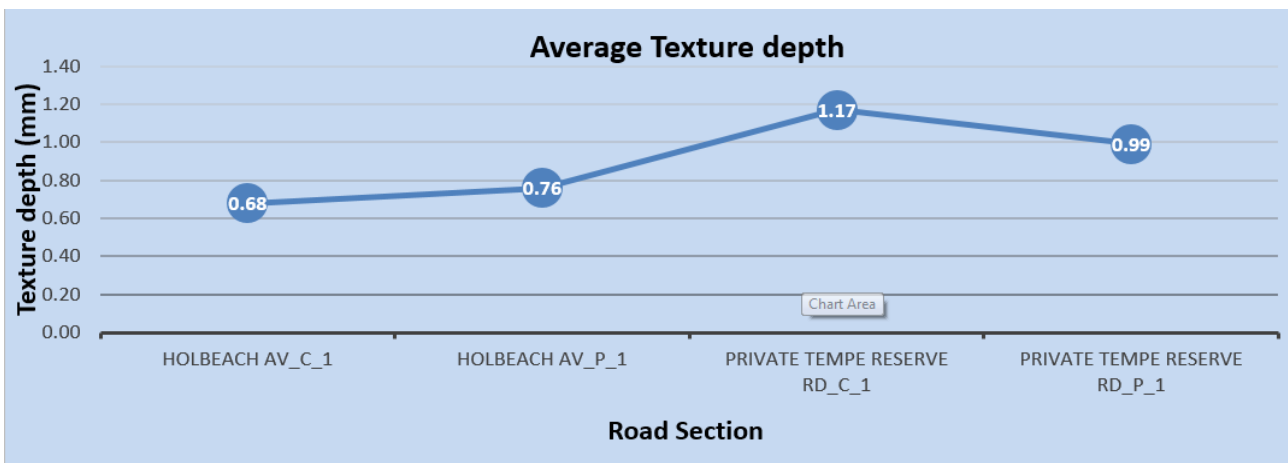
Figure 2.3: Average condition-Texture depth-Inner West Council

As shown in Figure 2.3, all road sections have texture depth of more than 0.6 mm. Based on current LoS definitions (Section 1.3) for texture depth, Private Tempe Reserve Rd sections sit in “Good” condition while Holbeach Avenue sections are in “Fair” condition.

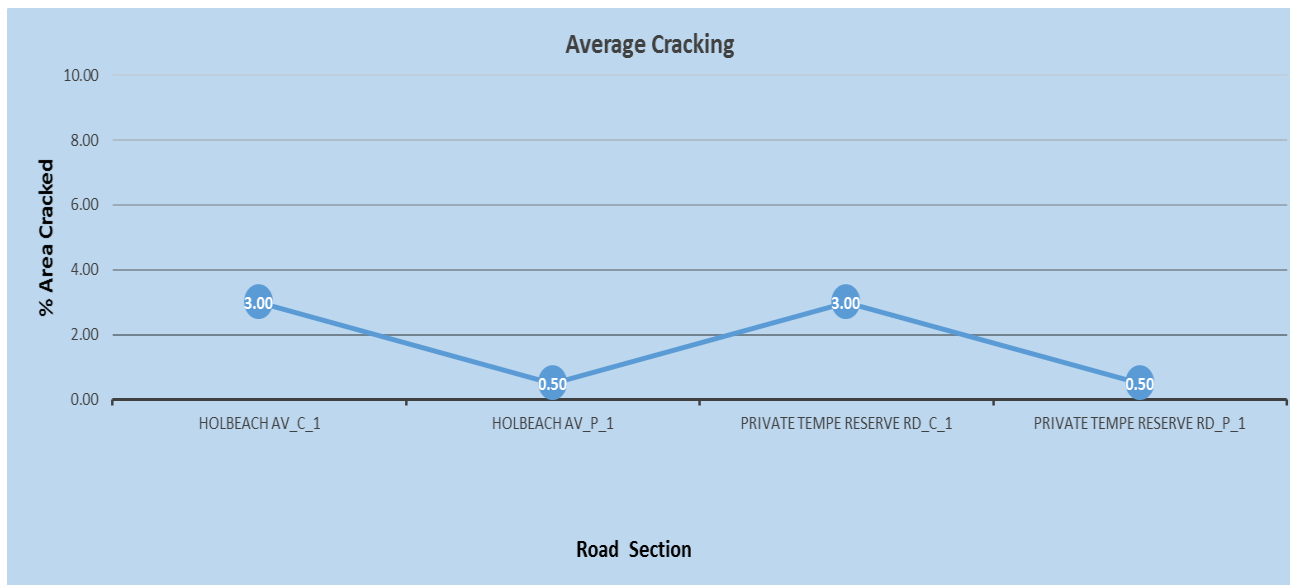
Figure 2.4: Average condition-Cracking-Inner West Council

All surveyed road sections of Inner West council are in “Very Good” condition in terms of Cracking (<5% of the area cracked, Figure 2.4).
