Pre-Construction Road Condition Report for WestConnex M5N

Project No: PSS17265

for WestConnex M5N

date July 2017

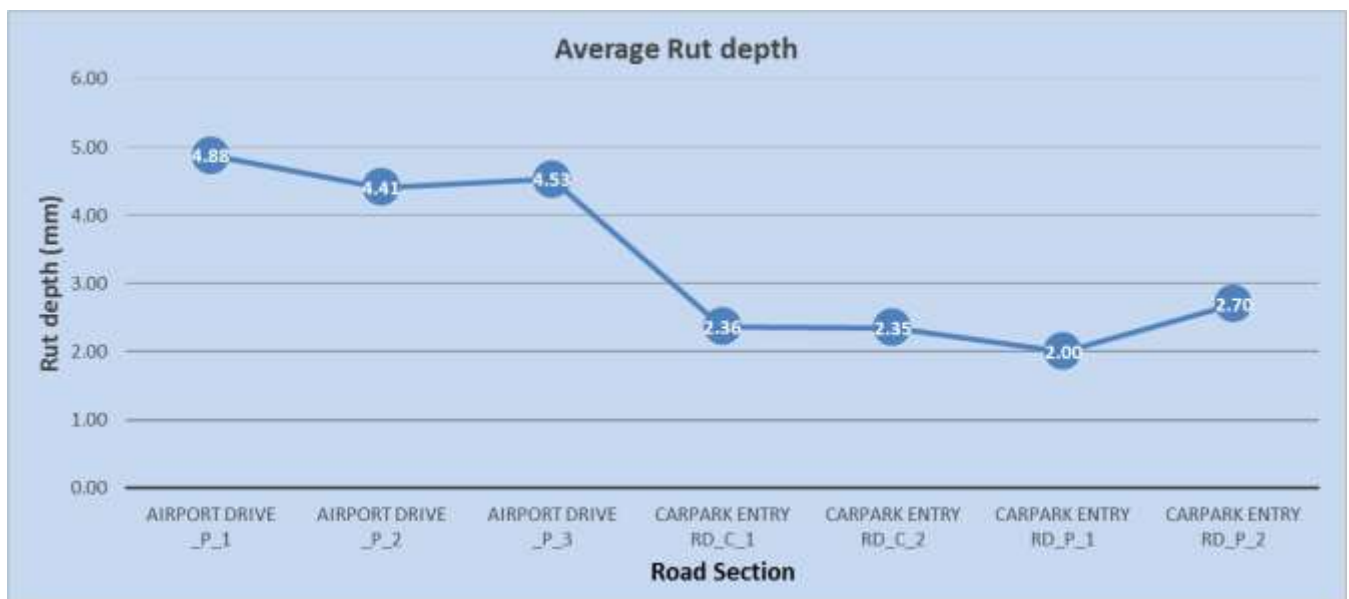
Figure 2.1: Average condition Rut depth Bayside Council

Figure 2.1 presents the average rut depth of each road section and all of the sections are in ‘good’ condition with average rut depth of less than 5 mm.

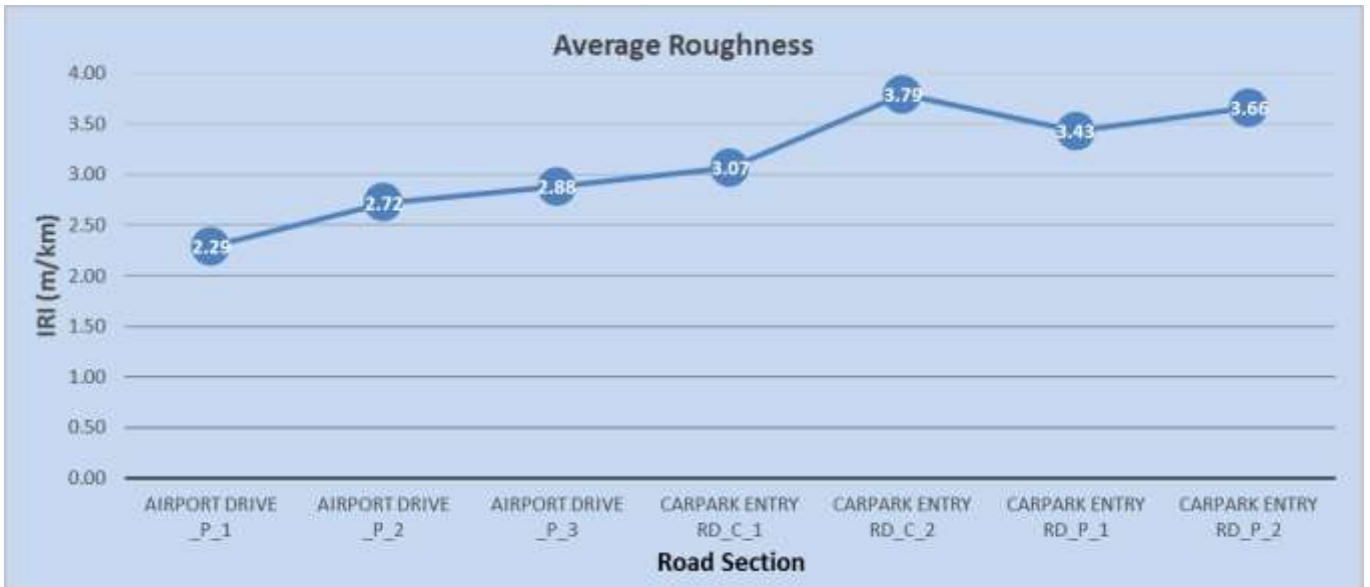
Figure 2.2: Average condition-Roughness-Bayside Council

Figure 2.2 shows the average roughness condition of each surveyed section. Majority of the sections present roughness value in between 3-4 IRI, which is considered 'Fair' according to the assumed level of service definitions (Section 1.3).

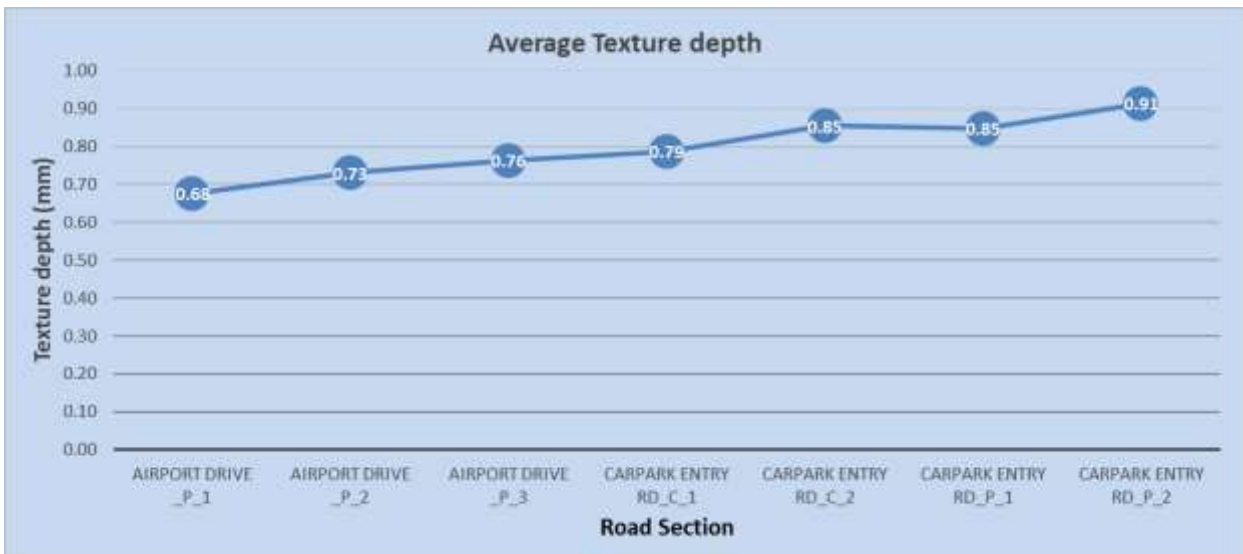
Figure 2.3: Average condition-Texture depth-Bayside Council

As indicated in Figure 2.3 all of the road sections have texture depth of 0.6 mm or more, which is considered 'Fair'/'Good' condition for texture depth.

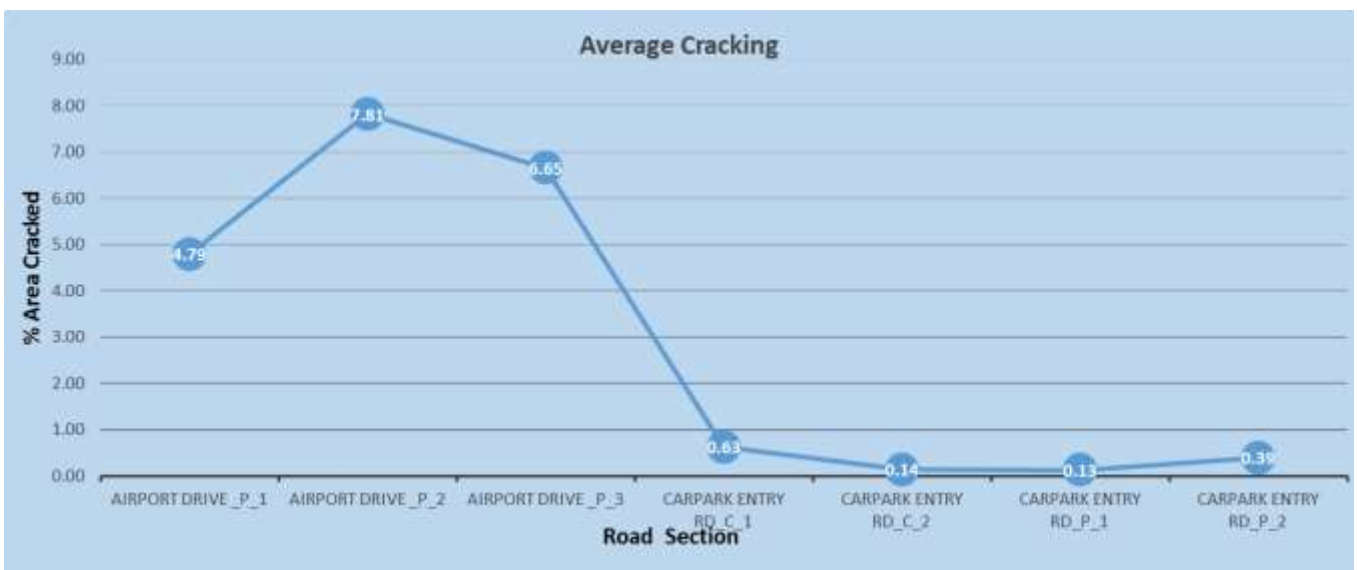
Figure 2.4: Average condition-Cracking-Bayside Council

All road sections of Bayside Council have less than 10% of area cracked and it is considered as 'Good' (Figure 2.4) according to the LoS definitions used.
