Local Road Dilapidation Report

Botany Bay Council

Project Name: WestConnex New M5

Pre-Construction Road Condition
Report for WestConnex New M5 Main
Works Project – City of Botany Bay

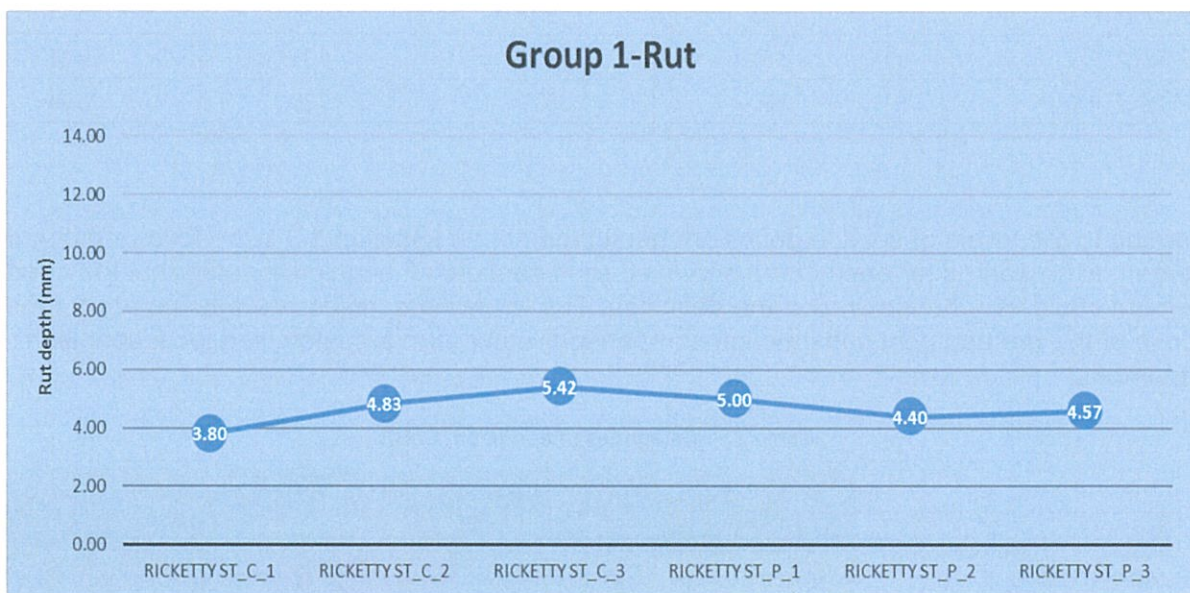
Figure 2.1: Rutting condition- CoBB

Figure 2.1 presents the average rutting of each road direction per lane and the majority of the sections present rut depth of around 5mm, mostly in 'good' condition.

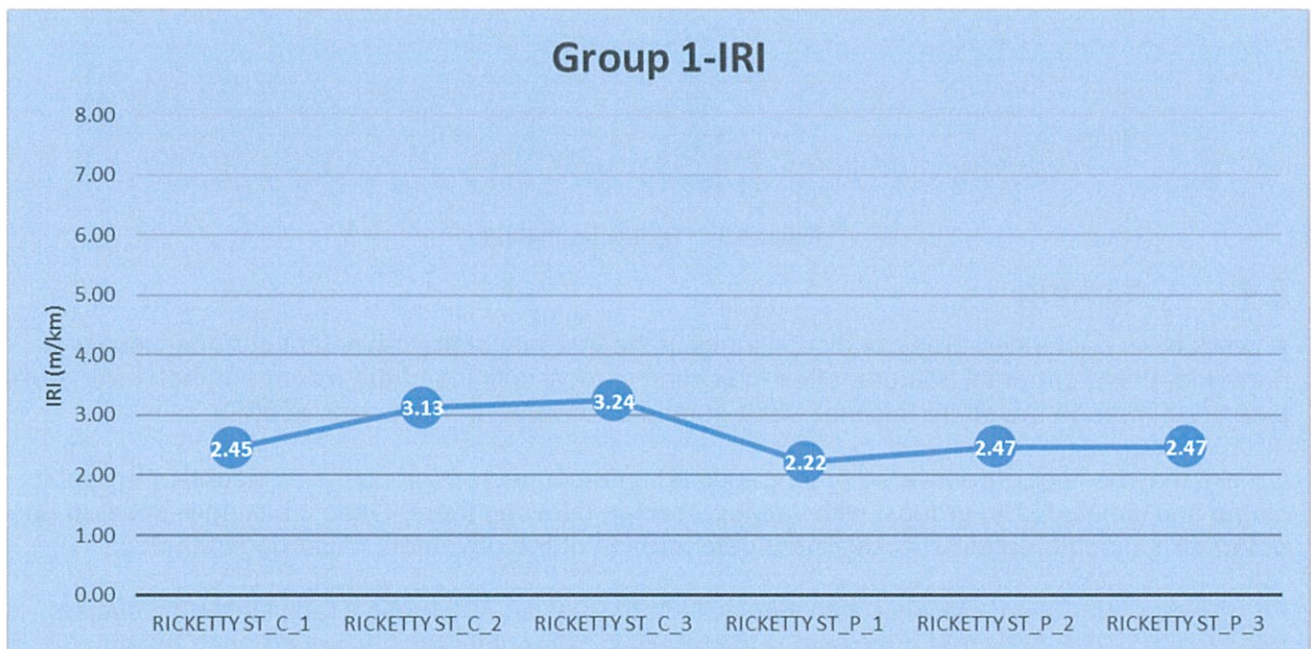
Figure 2.2: Roughness condition-CoBB

Figure 2.2 shows the average roughness condition of each surveyed section. Most sections present roughness value of less than 3 IRI, which are considered to be 'good' according to the assumptions made for this project (Section 1.3).

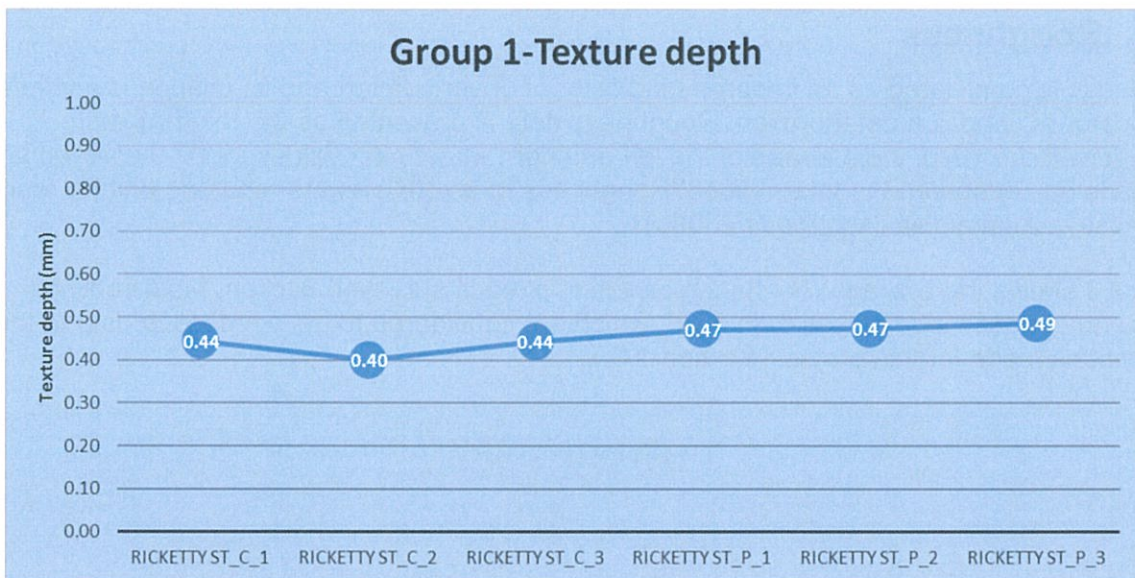
Figure 2.3: Texture depth-CoBB

As indicated in Figure 2.3, most roads present texture depth of less than 0.5mm, which is considered 'fair' condition for texture depth.

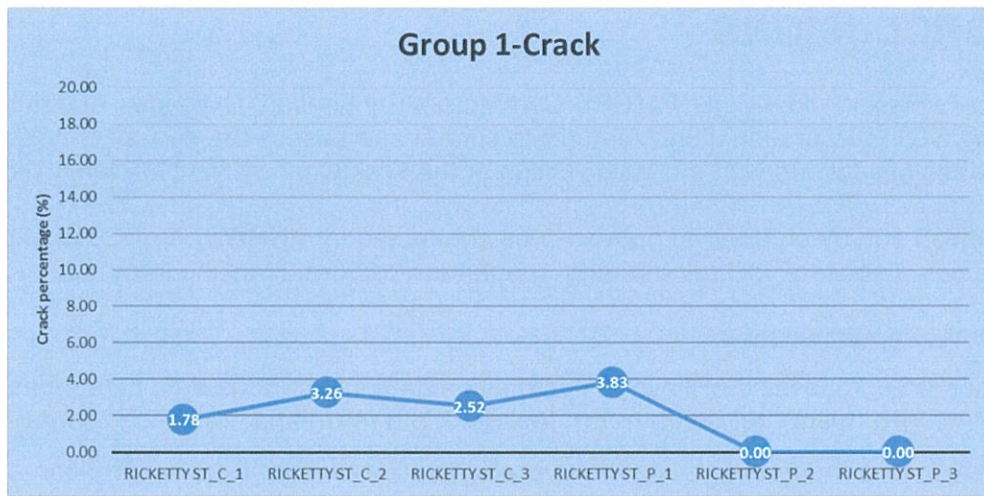
Figure 2.4: Cracking condition-CoBB

Most sections of Ricketty Street present cracking percent of less than 4% and it is considered as 'very good'.
