## **ARBORICULTURAL REPORT**

WestConnex New M5 Prepared for CDS-JV Initial Report Date 14<sup>th</sup> March 2018

VMS Signage Installation at Tempe and St Peters

CDS-JV Document Number: M5N-ES-RPT-LRW-0032 Rev 4. Date 3 May 2018

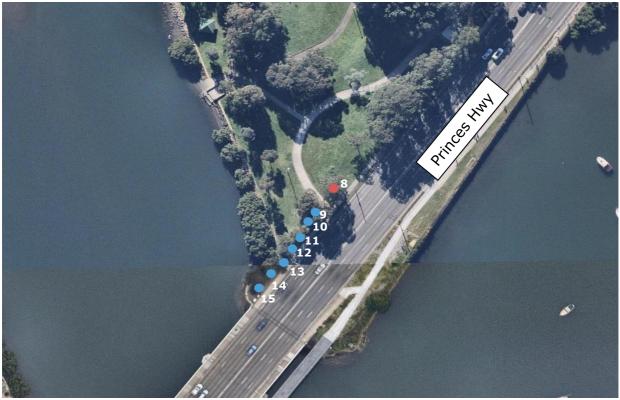
Map 3. Tree numbers (TN) – VMS4, Tempe. Red dot for remove, blue dot for prune

- Remove Eucalyptus botryoides tree TN#8.
- Undertake lateral pruning on seven (7) TN#9, 10, 11, 12,13,14,15 trees to allow for line of sight to VMS4.
- Replacement planting of Eucalyptus botryoides to be undertaken within Kendrick Park Tempe.

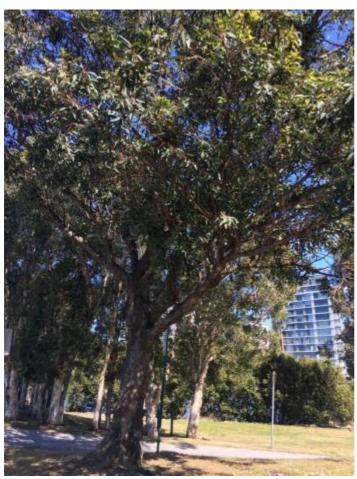
- Removal of a mature Eucalyptus botryoides (Southern Mahogany) TN#8.
   Tree is located at the site for the proposed base of the sign.
- Select branch removal for line of sight clearance on five (5) TN# 9, 10,11,12,13 Melaleuca quinquenervia (Broad Leaved Paperbark). Minor pruning works required.
- Select branch removal for line of sight clearance on two (2) Casuarina glauca (Swamp She-oak) trees TN#14, 15. Minor pruning works required.

Photo 1. Eucalyptus botryoides to be removed.

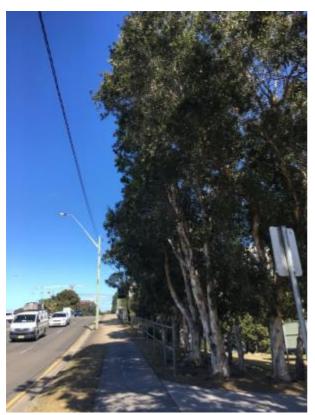
The seven (7) trees that are required to have minor lateral pruning works undertaken for line of sight clearances are within the park land area of Kendrick Park Tempe.

Photo 2. Line of sight clearance required on seven (7) trees.

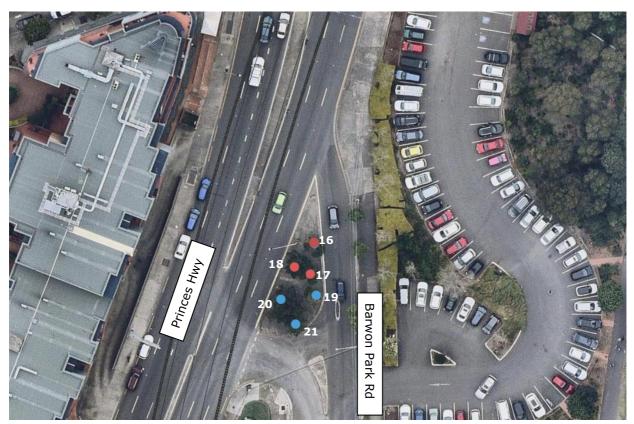
Map 5. Tree Numbers (TN) - VMS5, St Peters. Red dot for remove, blue dot for prune

- Remove three (3) Ficus trees TN#16, TN#17 and TN#18
- Additional Ficus tree in photo 7 may need to have underground services located close to the tree, TN#20. This can be installed with vacuum truck with the supervision of a Consulting Arborist.
- If required undertake lateral branch pruning works.
- Replacement planting of the Ficus to be undertaken at alternative site.

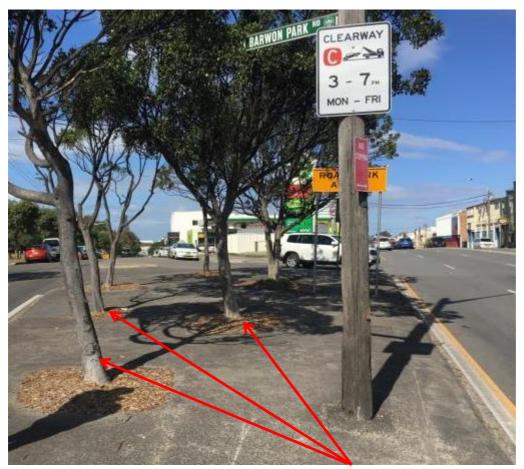
• Removal of thee (3) semi-mature *Ficus spp.* (Fig trees) TN#16, TN#17 and TN#18. Trees are located at the site for the installation of the sign.

The three (3) Fig trees that are required to be removed will be in the way of the sign, supporting infrastructure and the drilling rig to install the sign. Trees are in fair to poor condition due to the site constraints at the location of the trees.

Photo 3. Three (3) Ficus trees to be removed. TN#16, TN#17 and TN#18

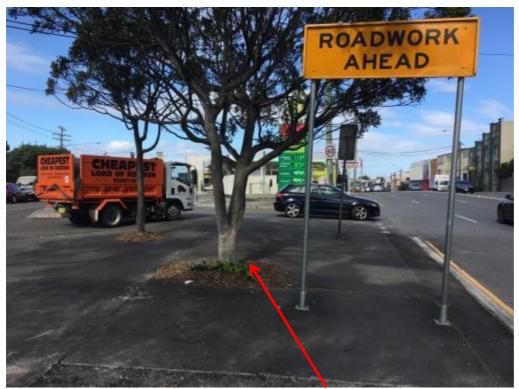
Photo 4. NDD this tree for services. TN#20
