Arboricultural Impact Assessment

CPB Dragados Samsung Joint Venture (CDS-JV)
25-29 Burrows Rd,
St Peters NSW 2044

McEvoy Street & Euston Road ALEXANDRIA NSW 2015

Revision 3

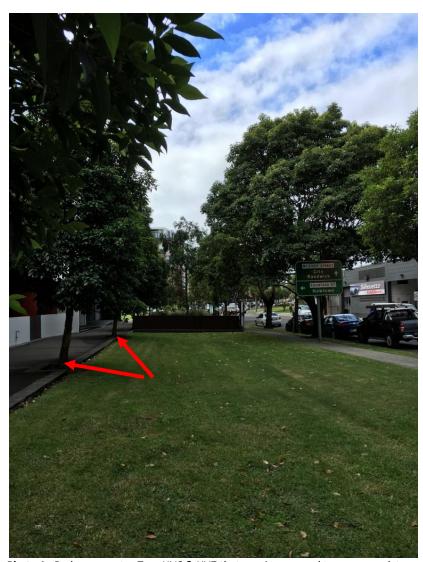
Photo 1 –Red arrow notes Tree HV6 & HV7 that require removal to accommodate works.

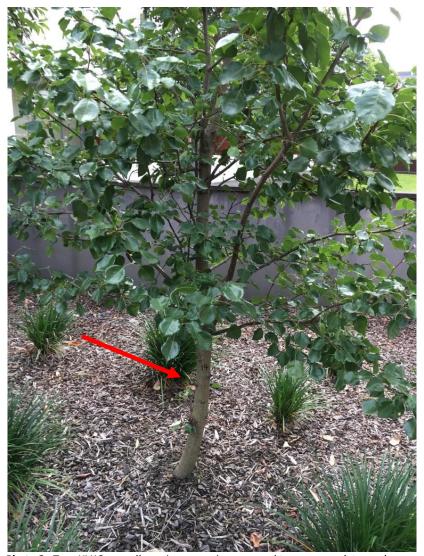
Photo 2 –Tree HV12 – small specimen requires removal to accommodate works.

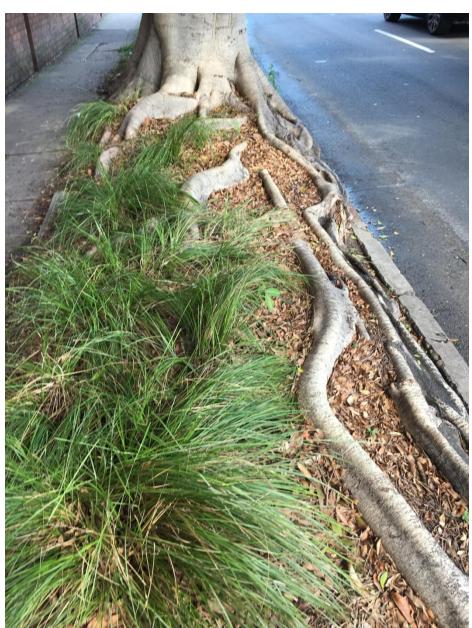
Photo 3 –Tree HV97, note large diameter roots running along kerb line, it is likely roots will be limited in roadway.

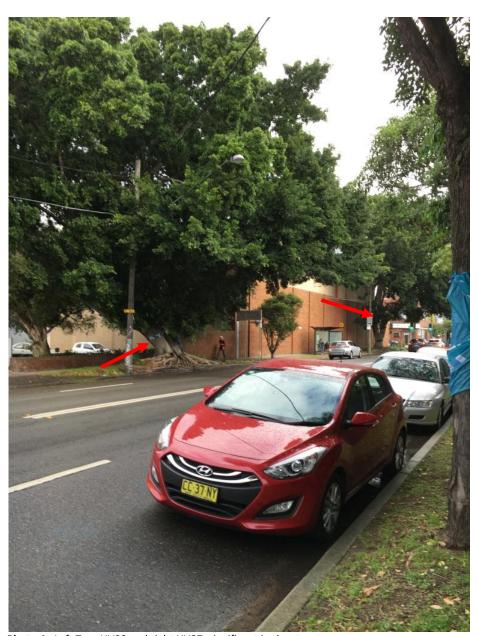
Photo 4 –Left Tree HV99 and right HV97, significant in the streetscape.

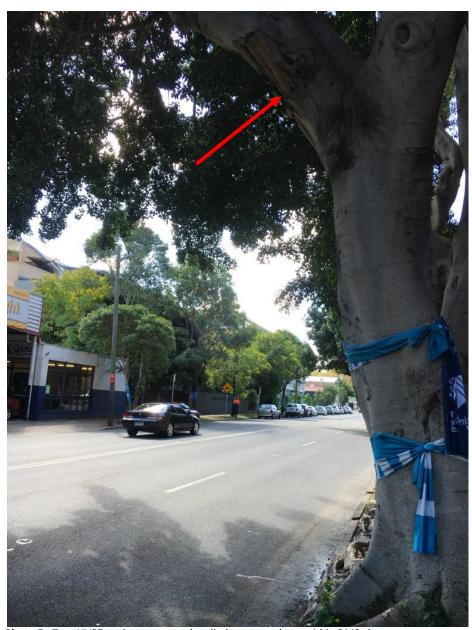
Photo 5 – Tree HV97, red arrow notes low limb over roadway within RMS clearances.

Re-direction of traffic into the kerbside laneway will be required to carry out works, only small diameter branches overhang the roadway within the RMS defined clearances, the required pruning will be less than 5% total live canopy will not negatively impact this tree.

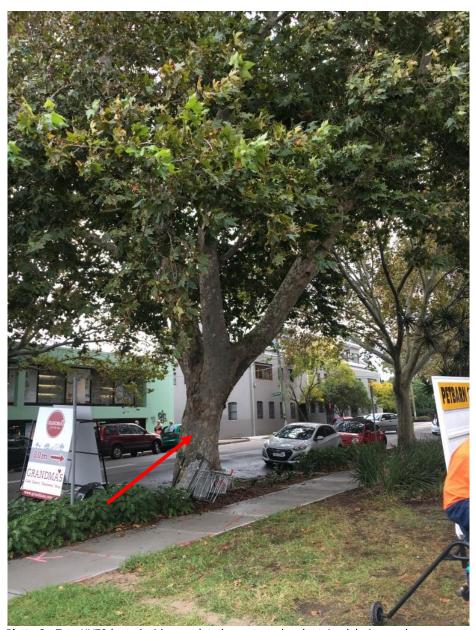
Photo 6 – Tree HV79 (noted with arrow), to be protected and retained during works.

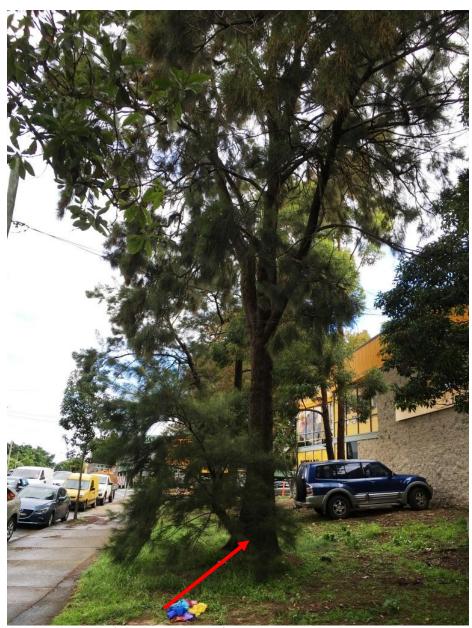
Photo 7 – Tree HV72 (noted with red arrow). Tree requires removal to accomodate proposed works.

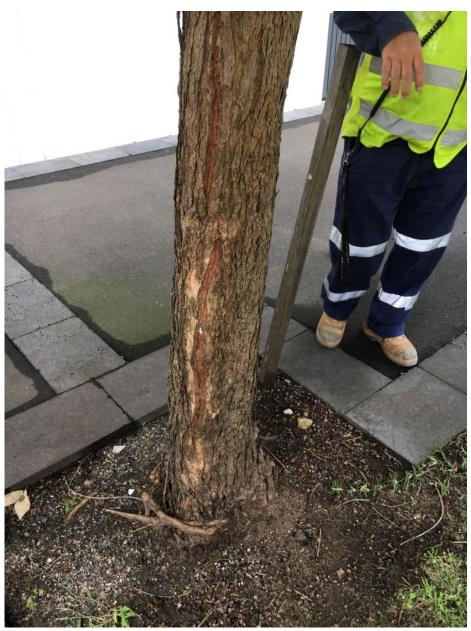
Photo 8 – Tree HV3, this Brushbox is located close to new townhouses and will need to be removed to accomodate proposed works. The street avenue will not be affected.
