28, 32 and 42-44 Campbell Street St Peters

Catalogue of Historic Building Fabric

Prepared for CPB Dragados Samsung Joint Venture

December 2016

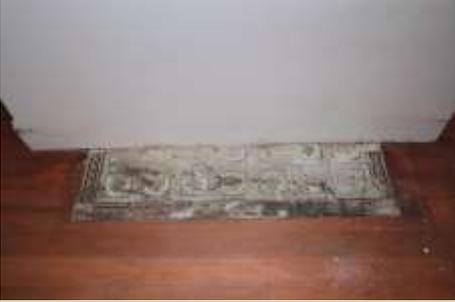
29	Chimney surrounds	0			
30	Tessellated tiles	3	Poor condition

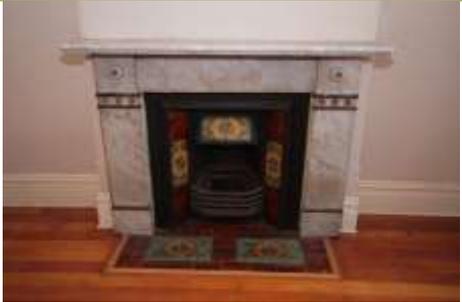
29	Chimney surrounds / fireplace	3	Extreme care must be taken for the removal of these items

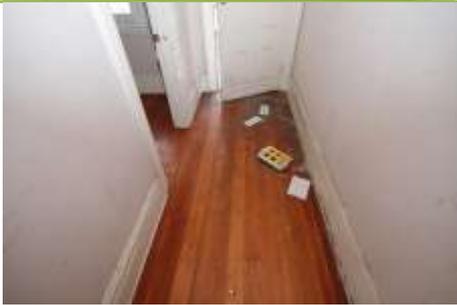
35	Skirting boards	7		Lead (pb) paint

- Any salvage material found to contain hazardous material, i.e. lead paint, should be managed in accordance with current hazardous materials legislation.
