Arboricultural Impact Assessment

Westconnex New M5
Conduit Installation
200 Bourke Road
MASCOT NSW 2020

CDS reference: M5N-ES-RPT-LRW-0053-00

April 2019

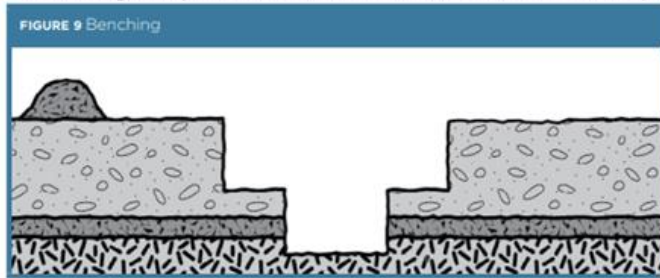
1. In order to dig a deeper trench, CDSJV would need to bench further out (horizontally) so that personnel could work safely within the trench. Benching out would cut directly into paper bark tree.

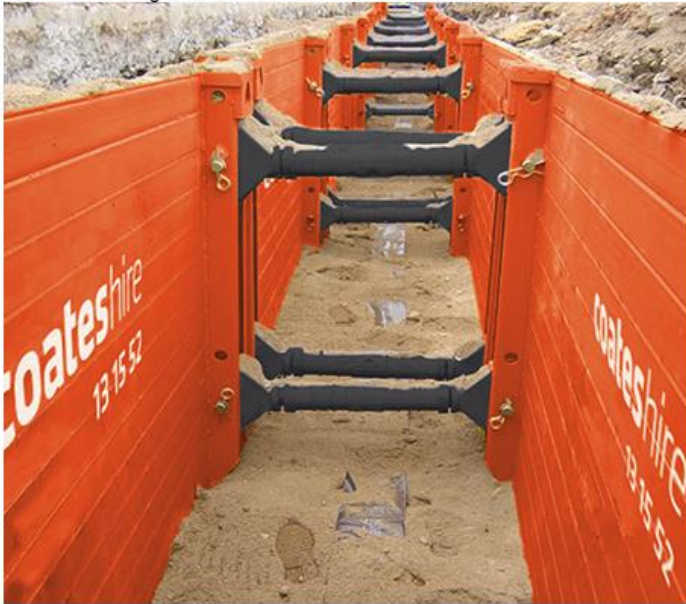
2. An alternative to benching is installing a shoring box which stabilises the walls of the trench (see below). However, to install the shoring box, CDSJV would need to cut through roots located within the Critical Root Zone and existing services would need to be relocated.

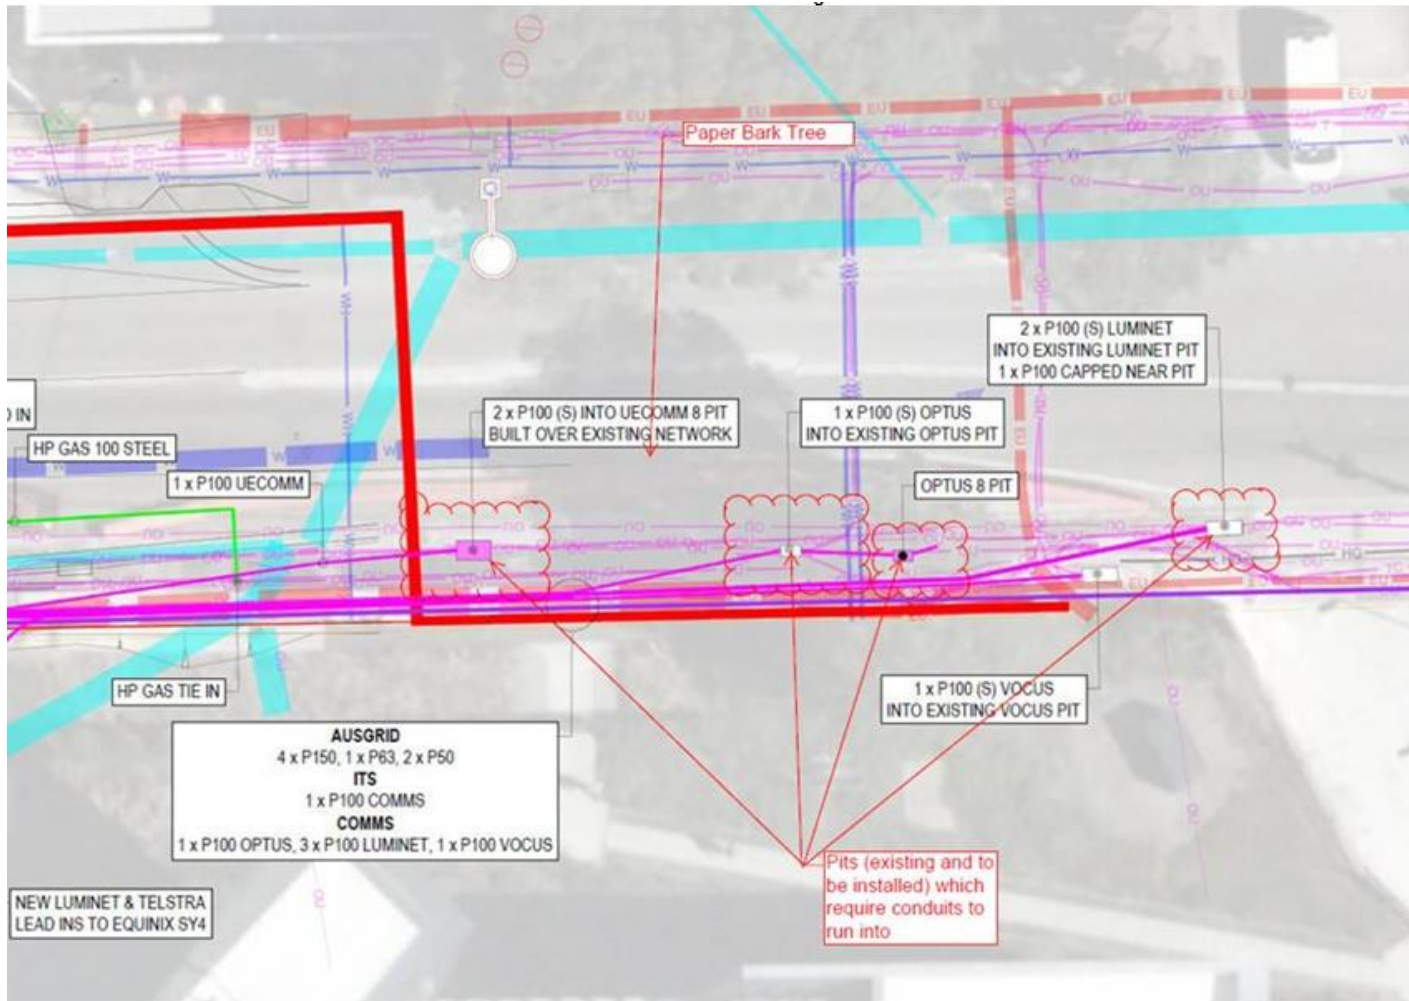
3. Under-boring would enable the conduits to be installed beneath the root system safely however, the new conduits would need to feed into existing and proposed pits at sharp angles. This would not be compliant with specifications dictated by the asset owners and CDSJV does not have approval to change the depth of the existing pits. Changing the depths of the designed pits would have flow on effects to other services which have been installed across the Bourke Street/Gardeners Road/Kent Road alignment.

The only option left with CDSJV is to remove the Paper Bark Tree and install the seven new conduits where the tree is currently located.

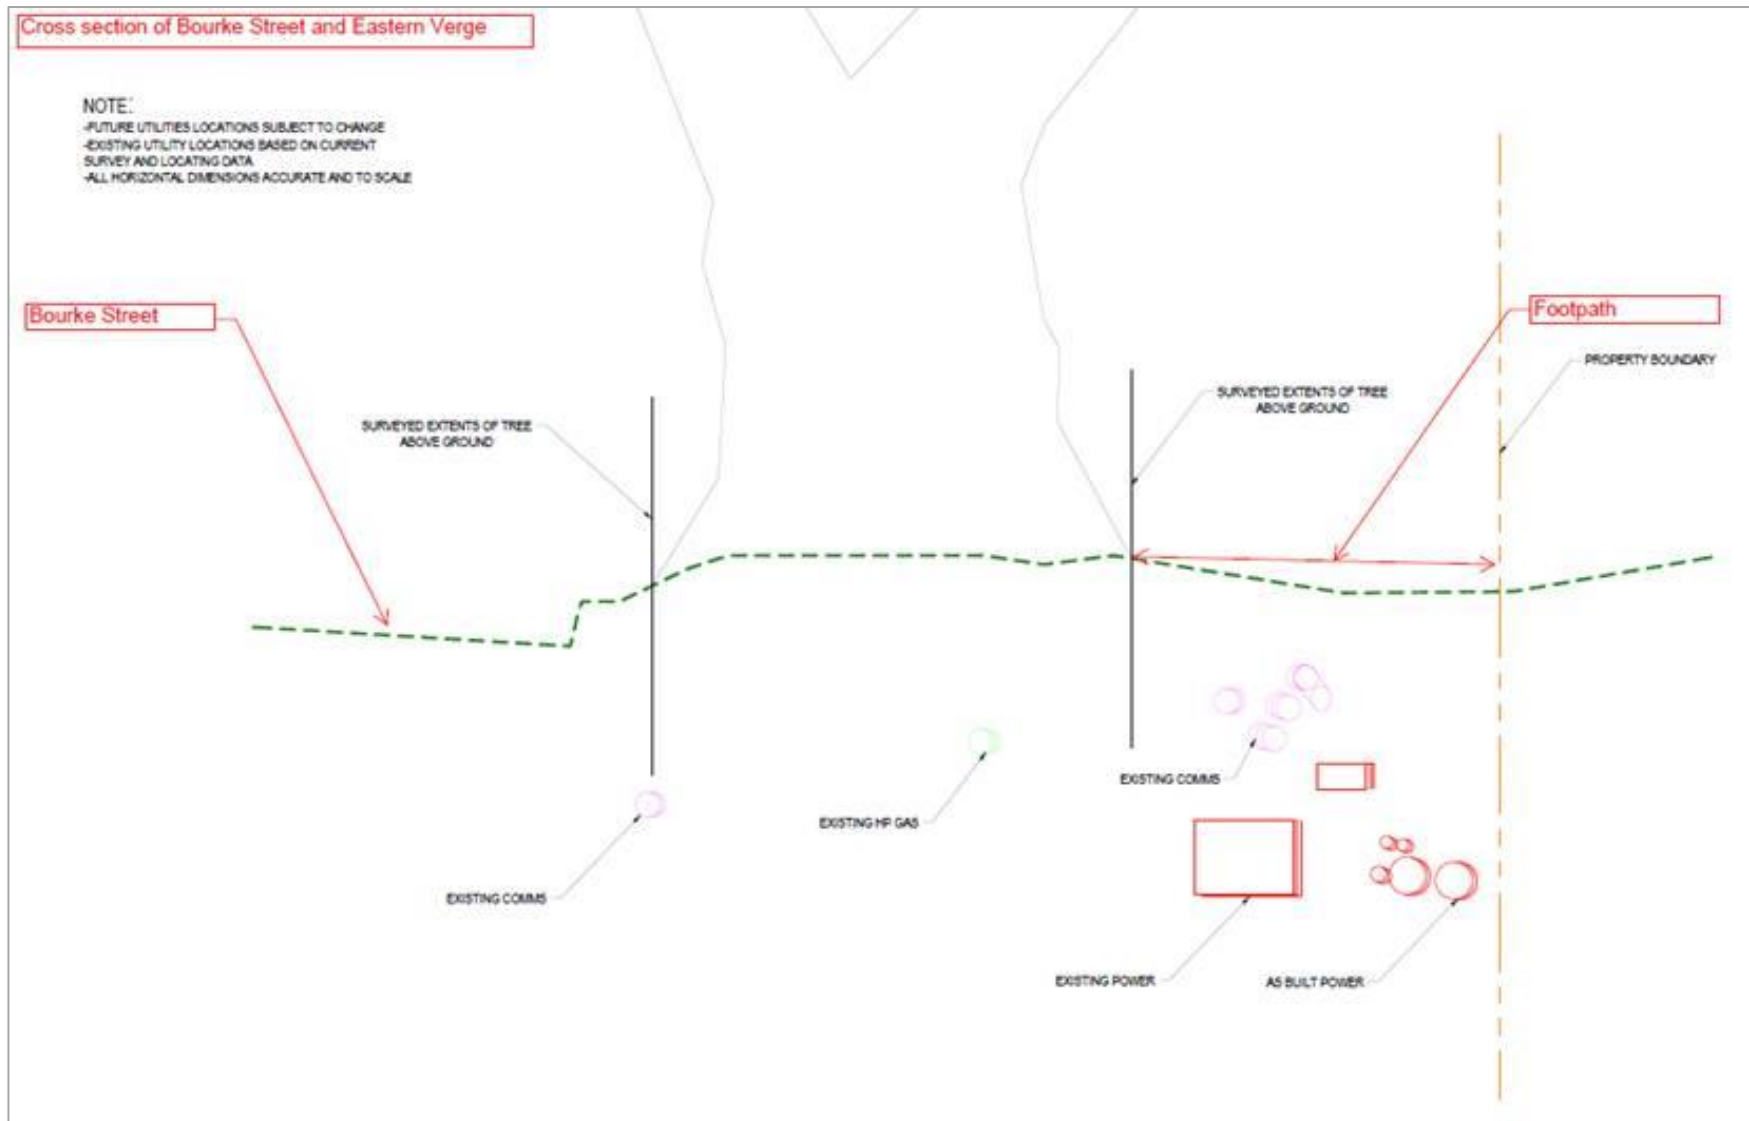
Appendix E – Cross Section of existing utilities surrounding Tree 1

Seven (7) new conduits are required to be placed between the roadway and the private boundary line. I have been informed that the Equinix SY4 data centre, located at 200 Bourke Road, is the most interconnected data centre in Australia. As such, every asset provider has their lead-in pit located within the eastern verge of Bourke Street, this does not allow any room for the required seven (7) conduits (see Appendix E).

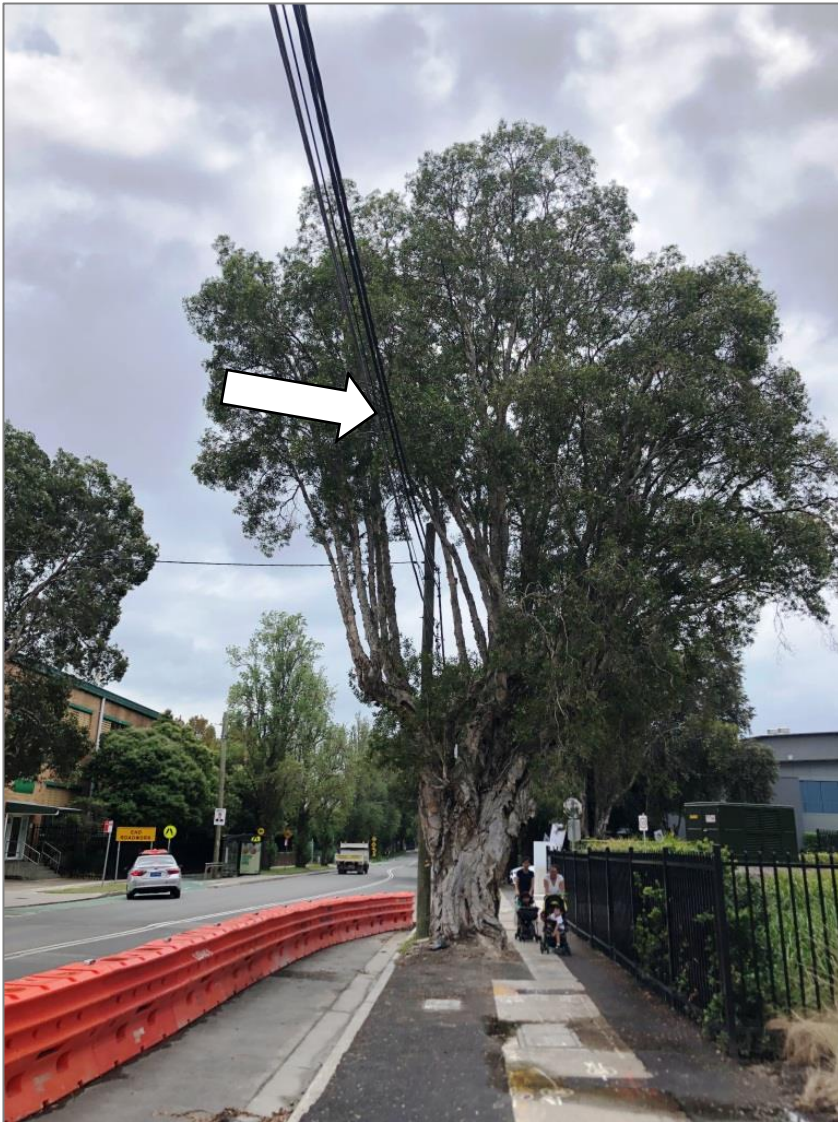
Plate 1 – Tree 1 -Arrow notes bundled cable through canopy. Unsure if this is in response of multiple outages caused by tree branches or (the more likely response) of trying to retain tree canopy and power line clearances.

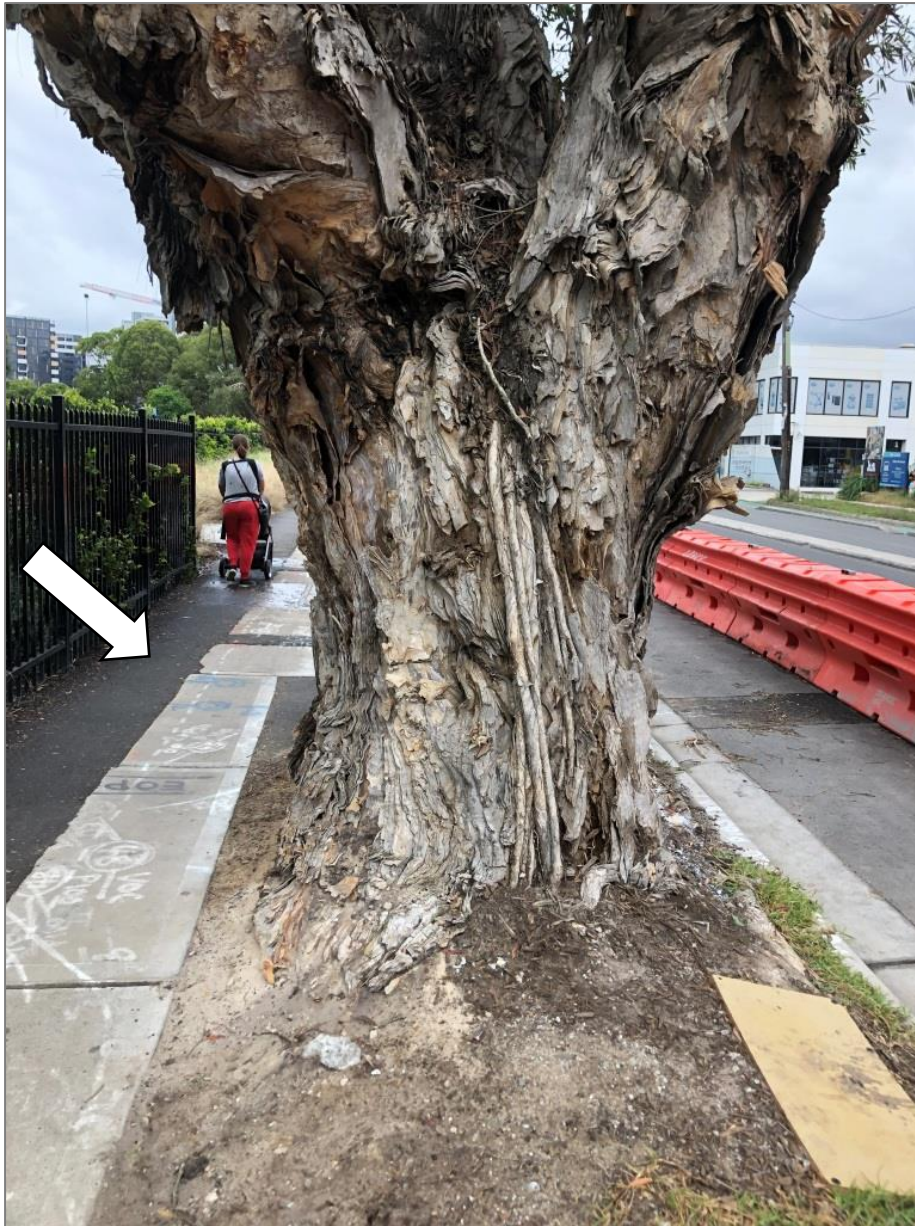
Plate 2 – Arrows notes bitumen of where existing footpath has been recently raised for service inspection or placement. Tree has been subject to multiple root disturbances.
