ARBORICULTURAL REPORT

WestConnex Stage 2 33kV supply 71A Bourke Rd Alexandria

> WestConnex New M5 Prepared for CDS-JV Date 13th October 2017

CDS-JV Document Number: M5N-ES-RPT-MNE-0001_01

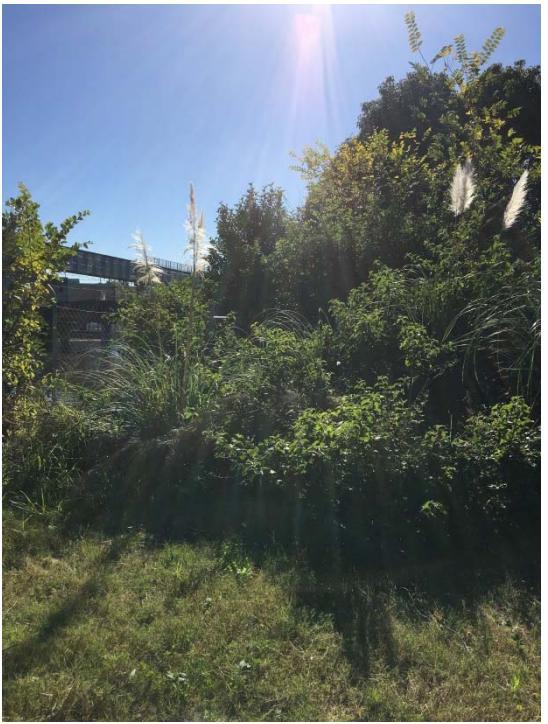
Photo 1. Front of site with weed species.

- Remove all vegetation in Part 1 2.5m either side of the cable alignment, which consists of: weeds and **1** over-mature Acacia tree.
- Property owner, Sydney Water, is to provide approval prior to any weed and tree clearing.
- At the completion of the works replant with 3 trees that will have a mature canopy that will replace the lost canopy from the Acacia trees. In addition to the trees some understory planting will also help with native birds and restore the area back to a native garden area. Replanting shall be done in consultation with Sydney Water.

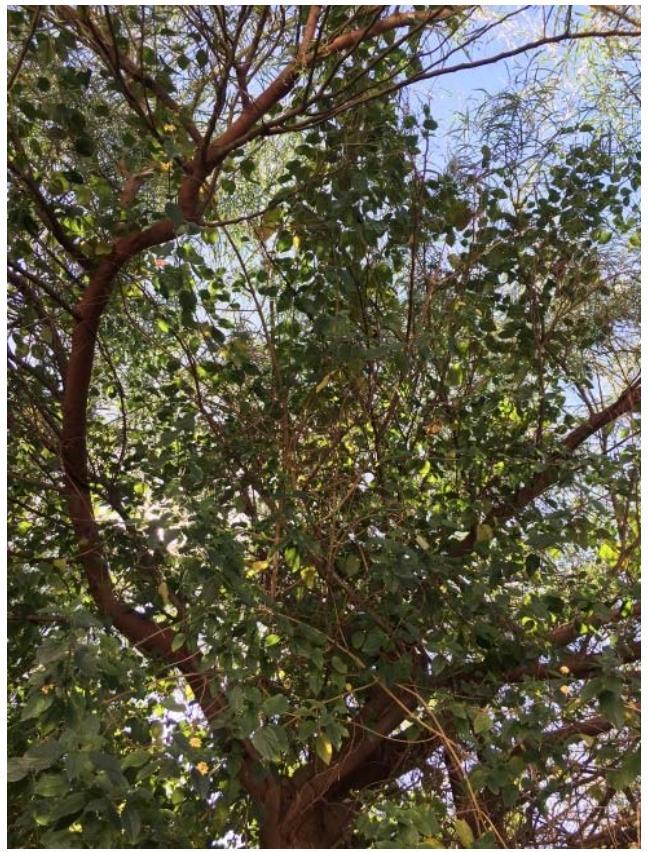
The only trees of note within this area are over - mature *Acacia spp.* (wattle), most likely being *Acacia longifolia* (Sallow Wattle) but due to the over grown weeds in the area close inspection was not possible for further identification. The three (3) wattles appear to be all in poor health and one of the trees has split in the lower trunk area. The three (3) Acacia have a diameter at breast height between 120mm and 200mm and a height up to 5m. Acacia trees are considered to be pioneer plants that are one of the first to establish in disturbed sites. They are fast growing but also are short lived trees. These three (3) trees are at the end of their useful life.

Photo 2. Acacia spp. with weeds and vines.

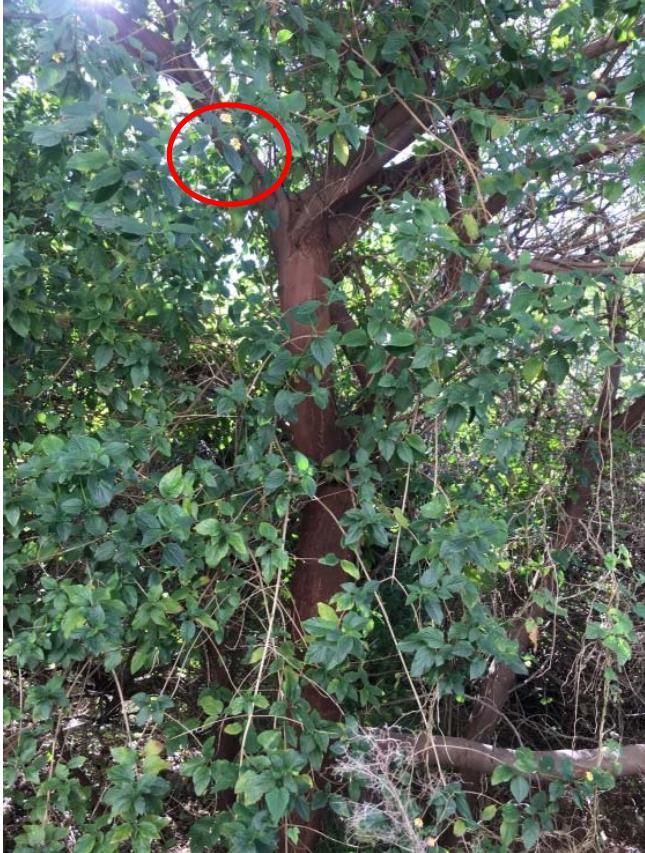
Photo 3. Second *Acacia spp*. with advanced borer damage which is a likely point of failure.

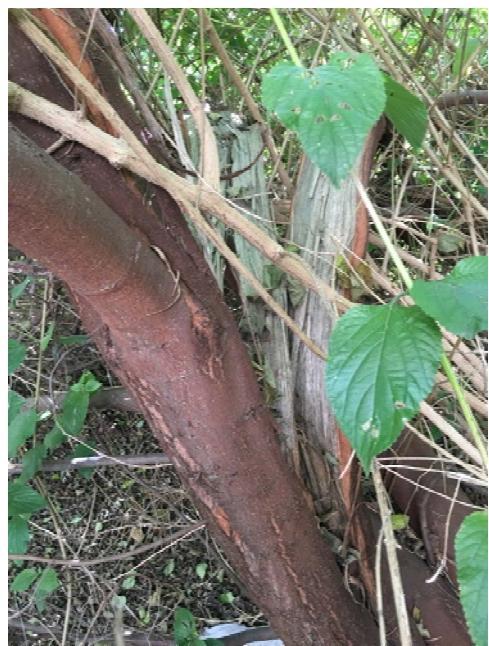
Photo 4. The third Acacia tree with split trunk at the base.

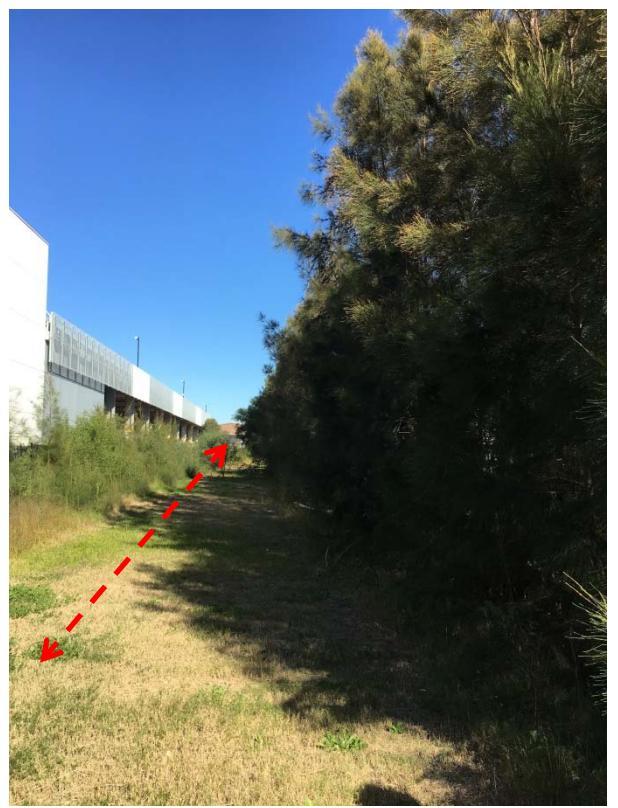
Photo 5. Proposed route for the 33kV parallel to Alexandra Canal.

The alignment where the 33kV line is to be installed by trenching is outside any of the *Casuarina glauca* Tree protection Zone the open trenching will not affect any trees or the heritage channel.

Tree protection zone fencing is to be installed along the drip line of the *Casuarina glauca* in accordance with AS 4970-2009: *Protection of Trees on Development Sites.*
