# Arboricultural Impact Assessment

Westconnex New M5  
Variable Message Sign Installation  
118 Euston Road  
ALEXANDRIA NSW 2015

*CDS reference: M5N-ES-RPT-LRW-0052-00*

**April 2019**

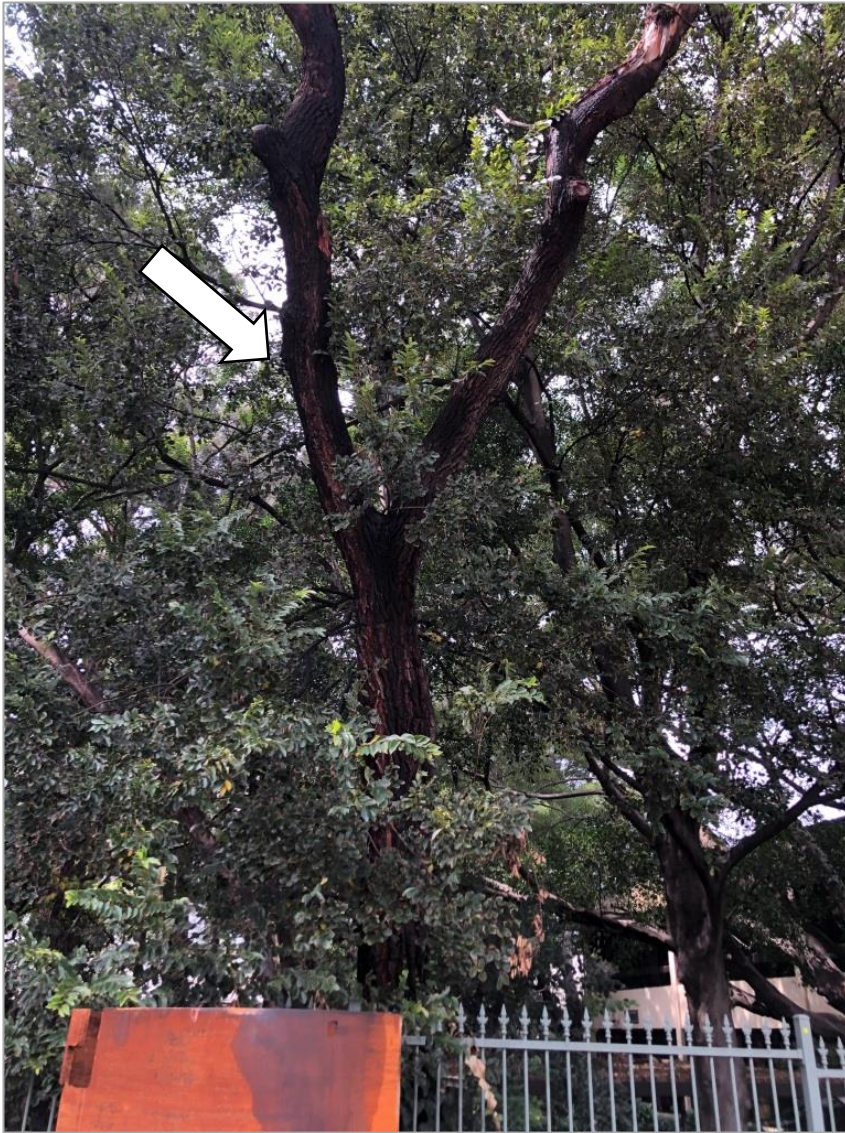
The tree bifurcates at five (5) metres above ground level into almost equal diameter stems, one of the stems (the northern stem) overhangs the location of the VMS and requires removal to allow installation and clear vision from CCTV located at Euston Road/Sydney Park Road intersection.

Whilst in some cases, removal of co-dominant stems can be carried out without detriment to the tree, it is my opinion, given the subject tree form and weight distribution along these two stems, removal of one stem will significantly affect the stability of this tree.

This is due to the fact that the majority of the weight is distributed to the upper canopy of the subject tree, and the tree's natural form. Previous lower lateral branch removal (not known to be related to New M5 works) also contributes to the higher risk of failure.

Plate 1 – Tree A1 65 -Arrow notes the co-dominant stem that overhangs the VMS (VMS footing can be noted as orange structure at base of tree).

As such, whilst the whole tree is not affecting the placement of the VMS or the visibility issue of the CCTV, tree removal is the safest option, in my opinion.

Tree removal shall be carried out to comply with Workcover Code of Practice *Amenity Tree Industry* 1998.

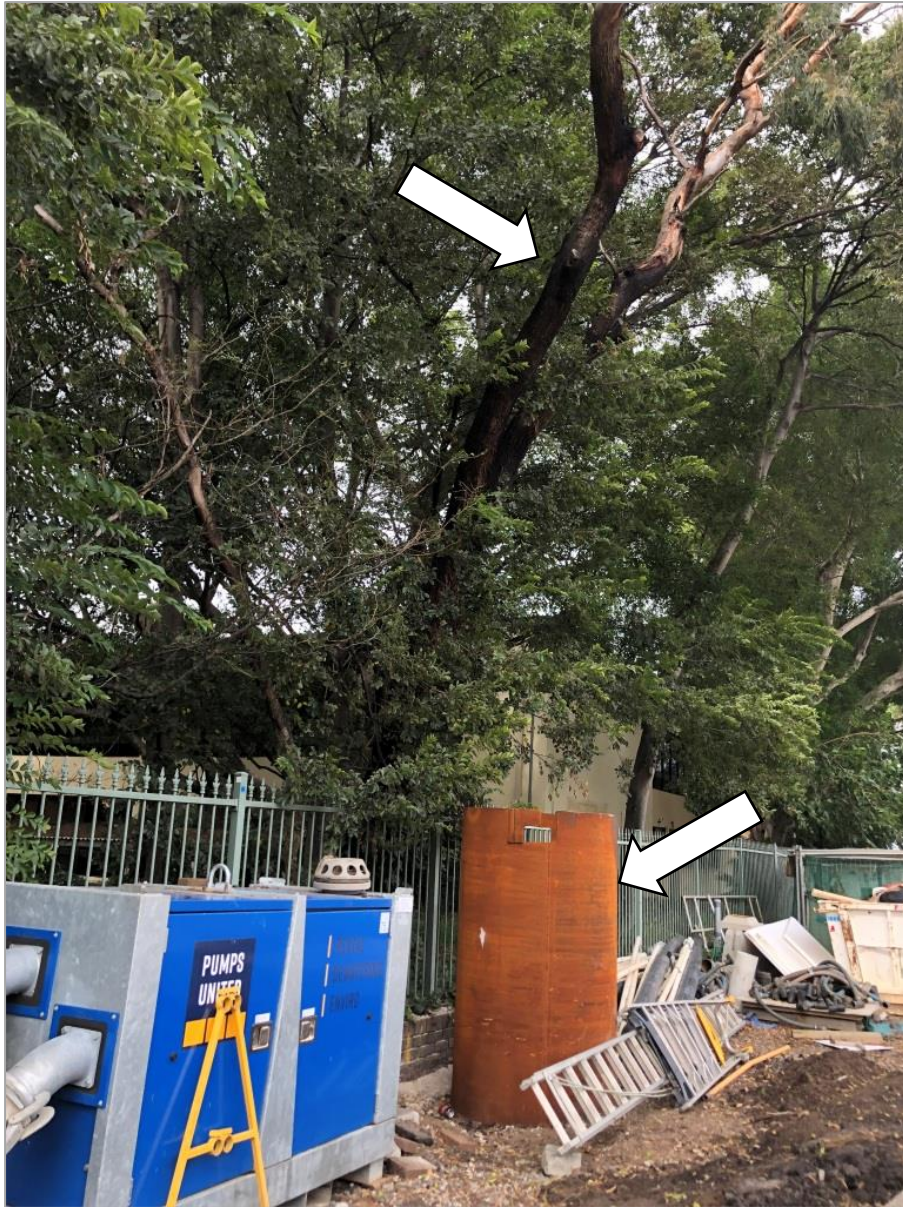
Plate 2 – Arrows note subject tree and VMS footing.
