### 1.0 Introduction

### 1.1 Background

- 1.1.1 This Arboricultural Impact Assessment report has been prepared for Westconnex-New M5. It relates to the establishment of new street lights along Campbell Street and the pruning requirements of trees located within Simpson Park. The street light poles have been established in accordance with the engineering justification provided by Westconnex-New M5 (**Appendix 4**).

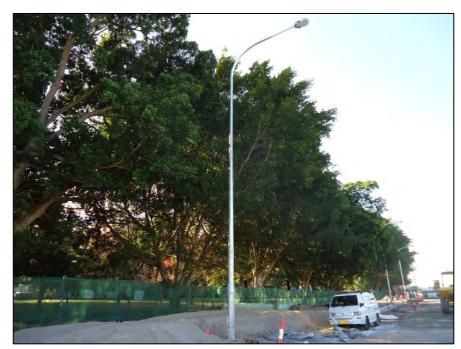
**Photo 1:** Light pole 76 adjacent tree 151.

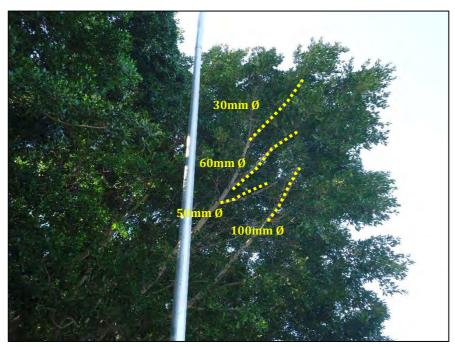
**Photo 2:** Branches from tree 151 identified for removal.

- **Tree 151:** Selective removal and/or reduction of second and third order branches growing around and below new street light. Pruning is restricted to approximately four second order branches 30mm, 60mm, 50 and 100mm in diameter as shown in photo 2, **Appendix 2**.

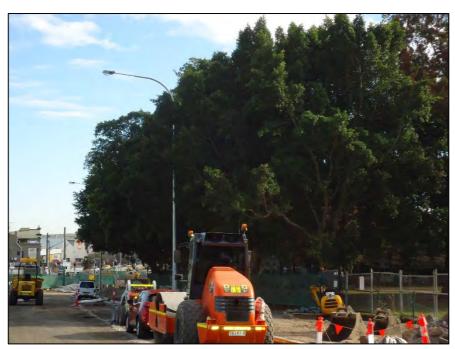
Photo 3: Light pole 80 adjacent tree 148.

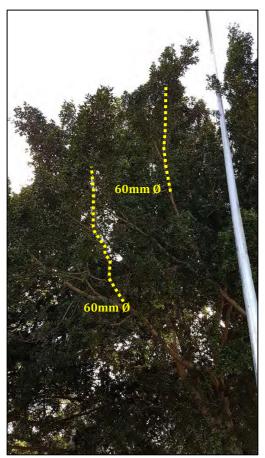
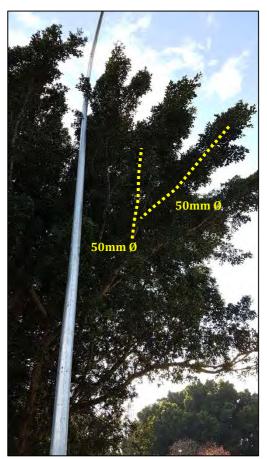
**Photo 4:** Branches from tree 148 **Photo 5:** Branches from tree 148 identified for removal.

identified for removal.

- 4.5 Specific pruning works for each of the trees are identified as:
  - **Tree 148:** Selective removal and/or reduction of second and third order branches growing around and below new street light. Pruning is restricted to approximately four second order branches 60mm, 3x40mm and 20mm in diameter as shown in photo 2, **Appendix 2**.
