WestConnex Stage 2 New M5

Conditions of Approval B39, D37 and D38

Heritage, Contributory Item and Heritage
Conservation Area Archival Recording and
Research Reports

Prepared for CPB Dragados Samsung Joint Venture

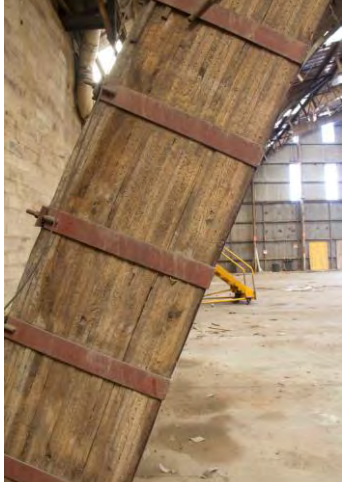
Image N	Direction	Details	Thumbnail
056_RUDDERSBOND_MARCH2016.jpg	E	Facing east in locus 1, view of underside of arch and foundation in profile against east wall.

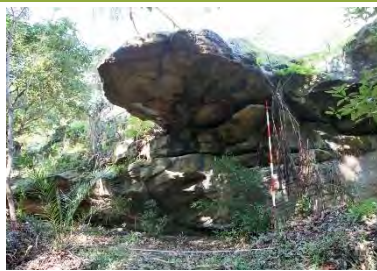
002_STOTTS_RESERVE_ROCK_OVERHANG_2017	W	Rock overhang showing depth and proximity to 47 Barnsbury Grove.

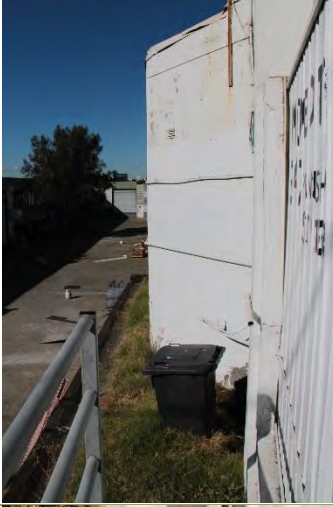
039_DYNAMO_GARAGE_2016	NW	Facing east, condition of north-east side of north-eastern façade.

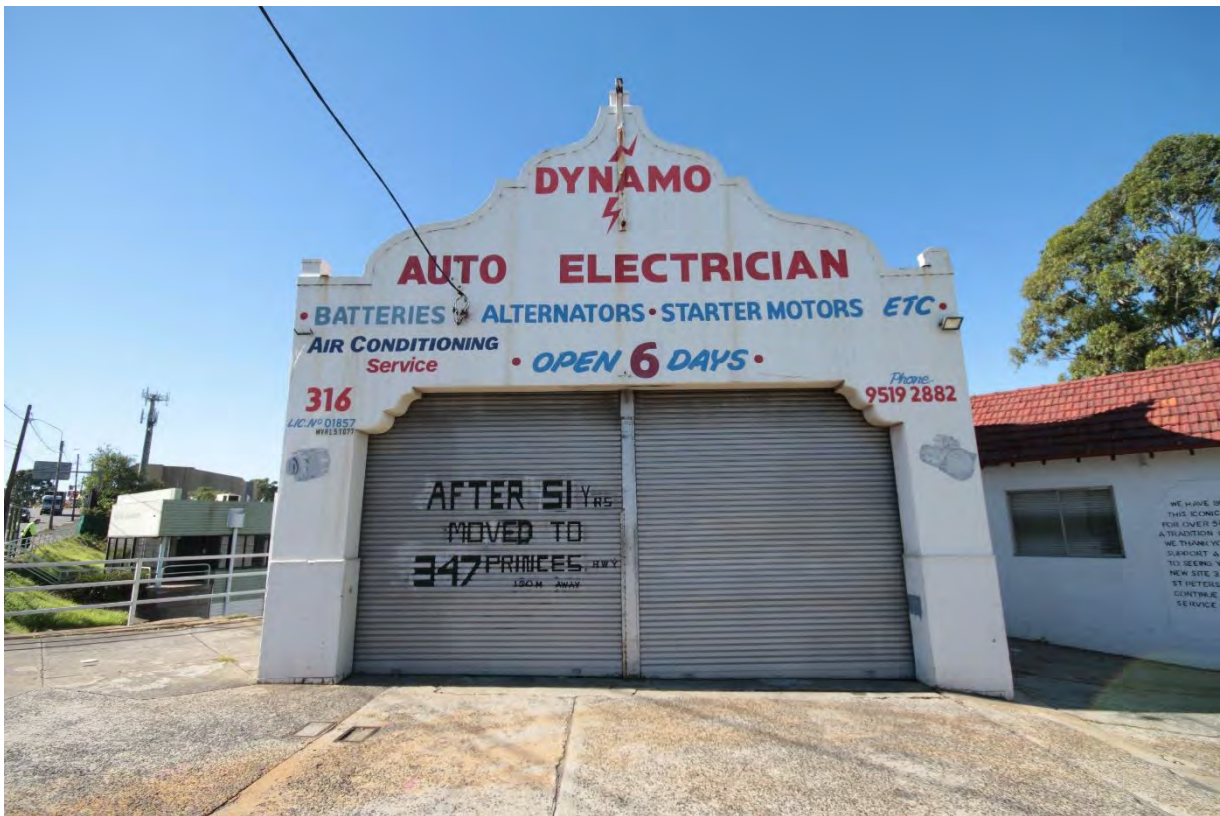
Figure 4. Condition of the Building façade in 2016.

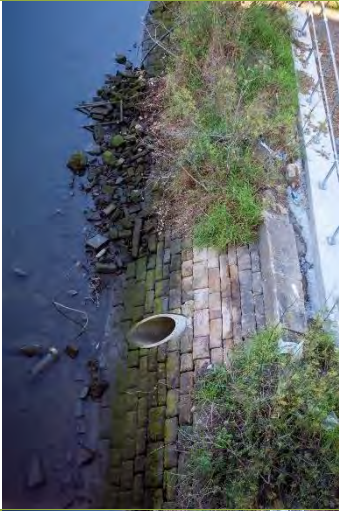
005_ALEXANDRA_CANAL_PW_2020	SW	Detail of replaced sandstone around the newly inserted stormwater canal. Western side of the canal, south of bridge 10.

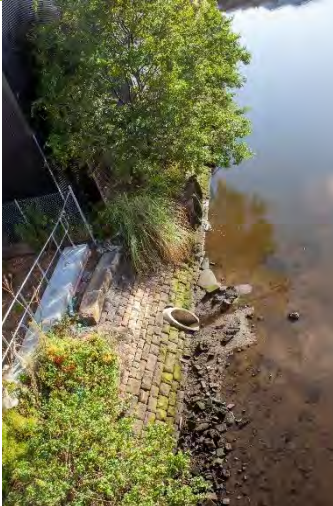
<p>015_ALEXANDRA_CANAL_PW_2020</p>	<p>NE</p>	<p>General view of the canal wall around the newly inserted stormwater outlet, including vegetation. Western side of the canal, north of bridge 10.</p>

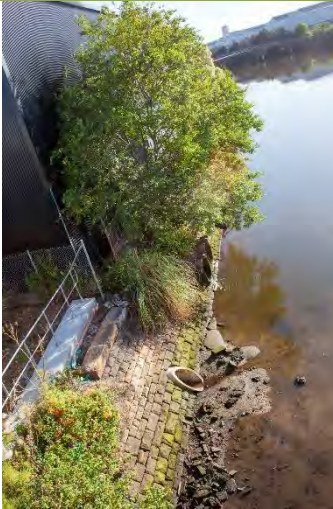
<p>016_ALEXANDRA_CANAL_PW_2020</p>	<p>NE</p>	<p>Detail of replaced sandstone around the newly inserted stormwater canal. Western side of the canal, north of bridge 10.</p>
