Arboricultural Impact Assessment

Wolli Creek – near Beverly Grove Park
KINGSGROVE NSW 2205

Revision 4

July 2017

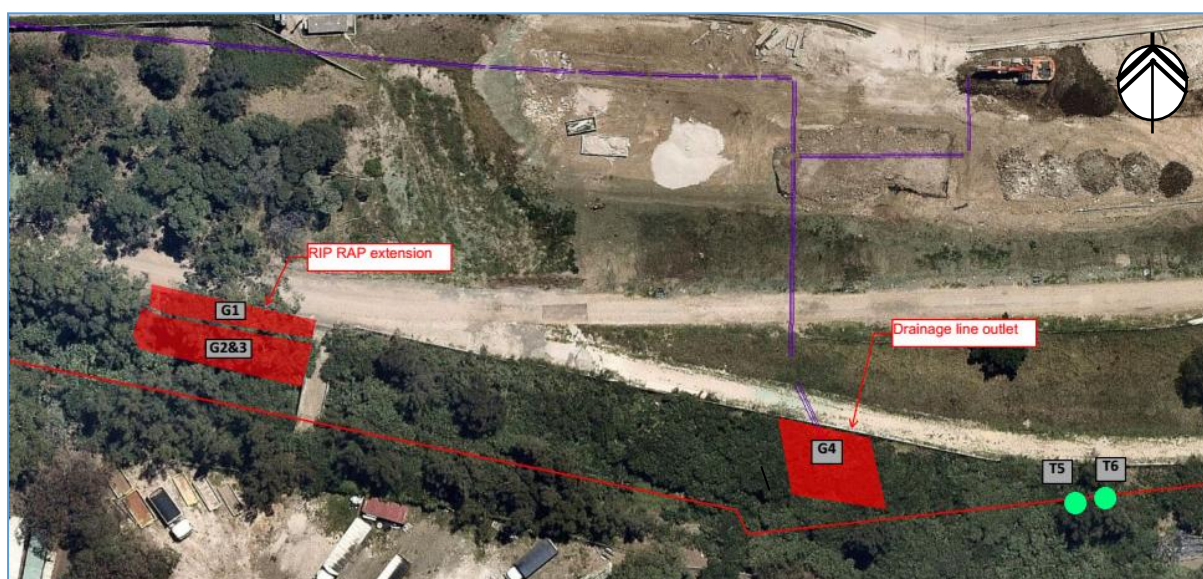
Figure 2 – Marked up Aerial. Red blocked areas indicate trees/groups proposed for removal. Green dots indicate trees to be retained. Red line indicates permanent boundary.

Four (4) tree groups (G1, G2, G3 & G4) and two (2) individual trees (T5 & T6) were assessed and included in this report (see Figure 2 below). Details of these are included in the Schedule of Assessed Trees – Appendix E, the tree location plan is as below. Of these trees:

- four (4) trees/tree groups are prescribed (i.e. considered a 'tree' under the planning approval) trees—Group 1, Group 2, Trees 5 & 6; and
- two (2) are non-prescribed trees (i.e. exempt from authority approval to remove or prune due to being noxious weed species), - Group 3 and Group 4

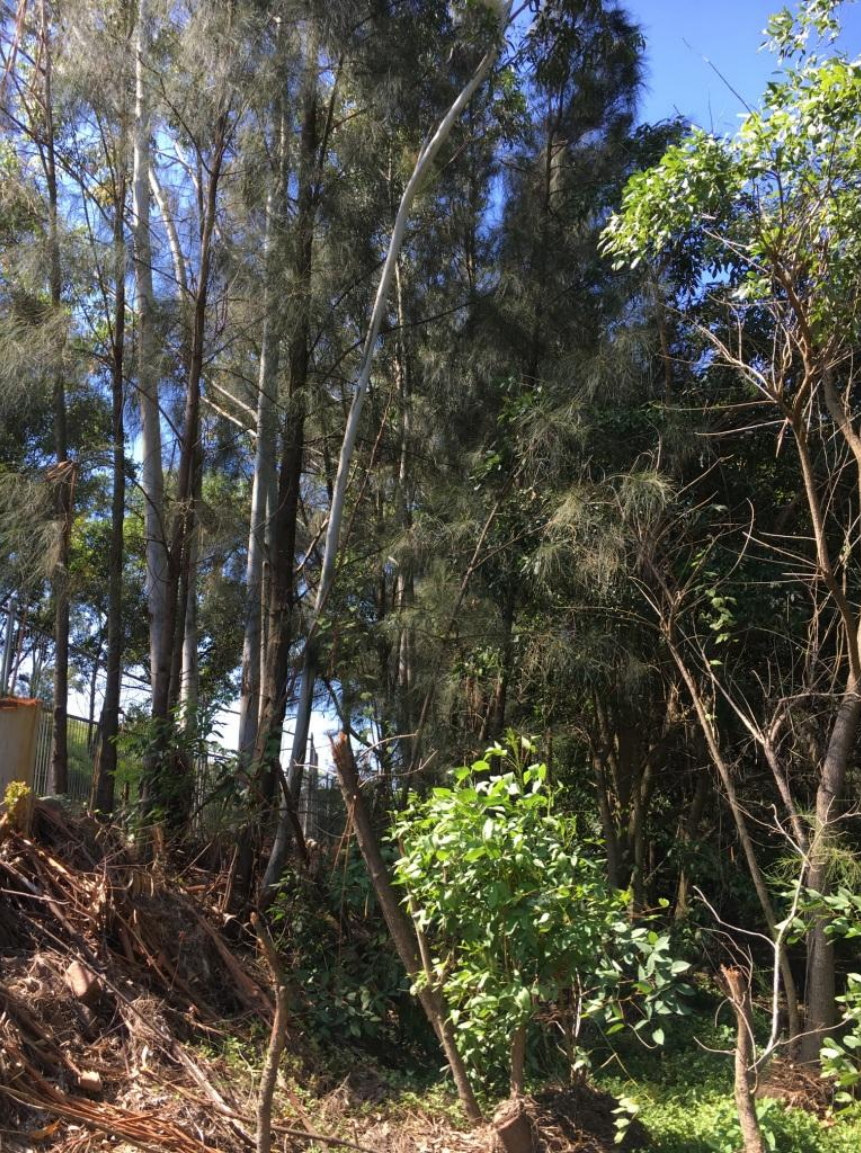
Photo 1 – Group 1, *Eucalyptus tereticornis* mainly located on upper area of creek bank.

Group 1 (*Eucalyptus tereticornis* Forest Red Gum) are required to be removed to allow rip rap installation. Difficult access (slope and existing creek) will require heavy vehicle movement well within the defined Structural Root Zones (SRZ), this cannot be supported under Australian Standard 4970-2009 Protection of trees on development sites (“AS4970”).

Although this group has been attributed a *Medium* Retention Value (RV – see Appendix C) they are early mature specimens, most likely having grown quickly in the abundant water and nutrient supply from the existing creek and drainage area and readily replaceable in the future.

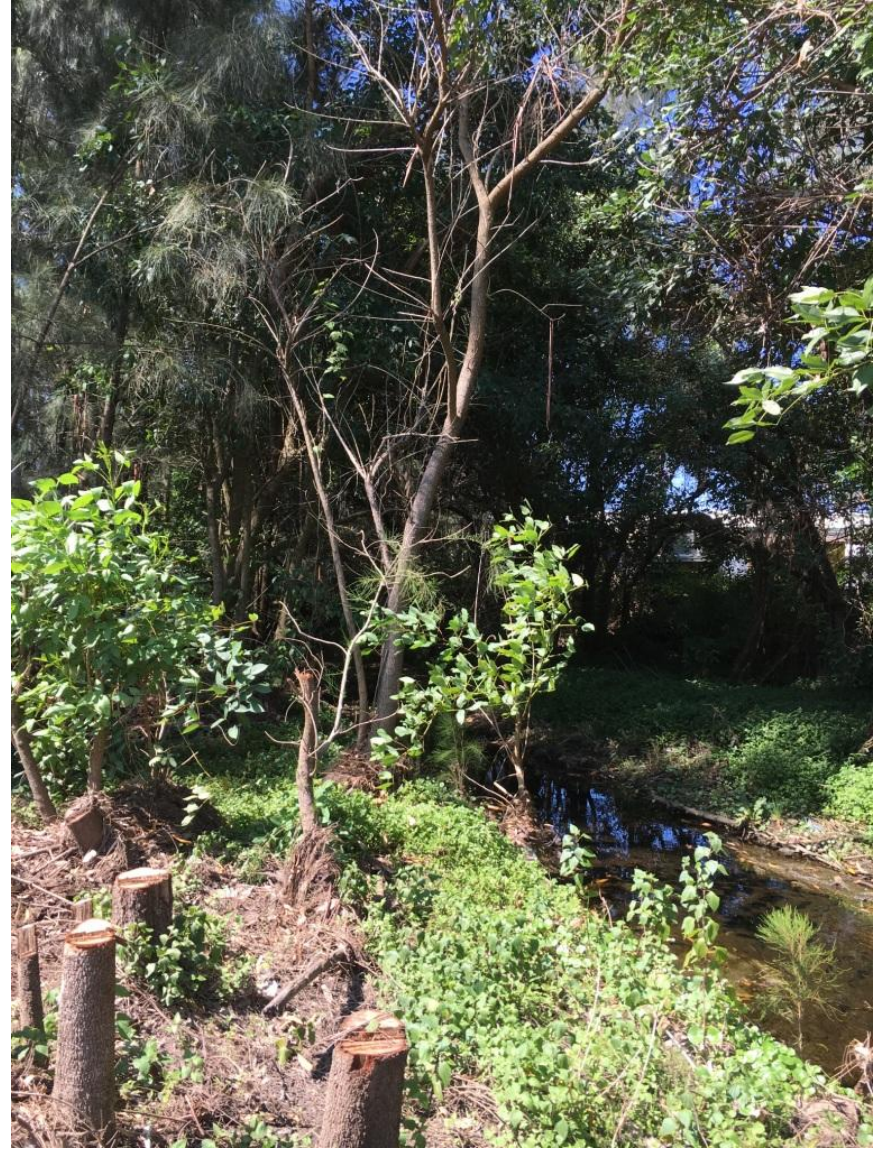
Photo 2 – Group 2 & 3 – stumps in foreground as the subject of previously approved report.

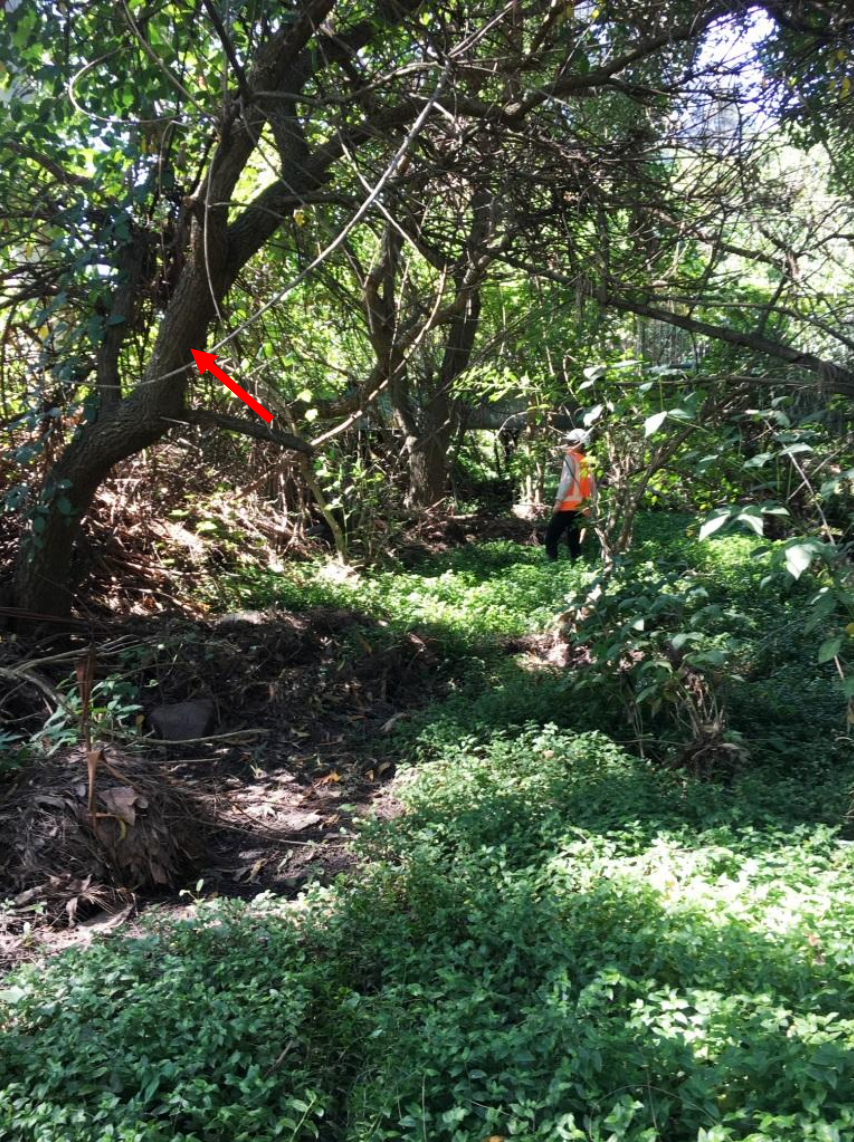
Photo 3 – Group 3 Area heavily infested with weed species such as Cockcombe Coral (red arrow).

Group 3 and 4 (*Erythrina crista-galli* Cockscombe Coral Tree) are healthy but they are a declared noxious weed species and have been attributed a *Low* Retention Value (RV – see Appendix C).

Group 3 requires removal for the installation of rip rap (rock or other material used to armour the stream bed to protect against scour and erosion).

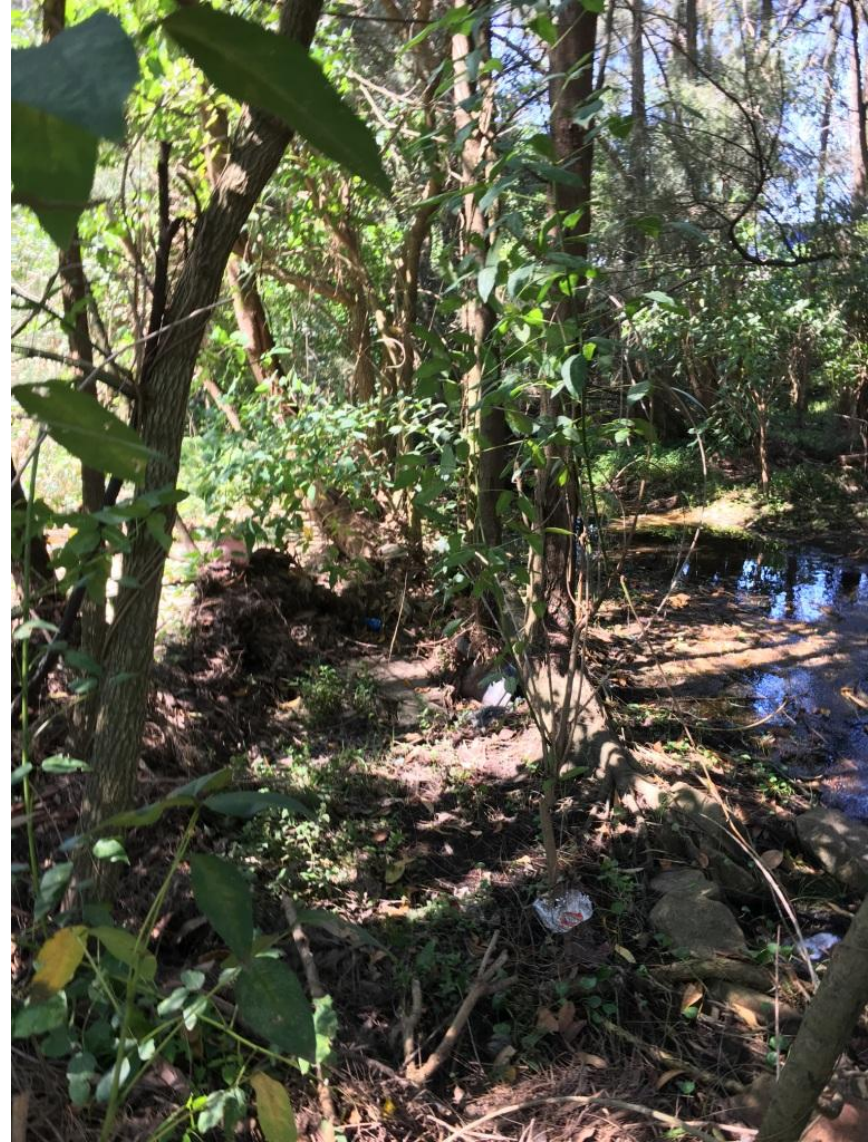
Photo 4 – Group 2 & 3 – Area subject to flooding and currently dense with debris/rubbish.

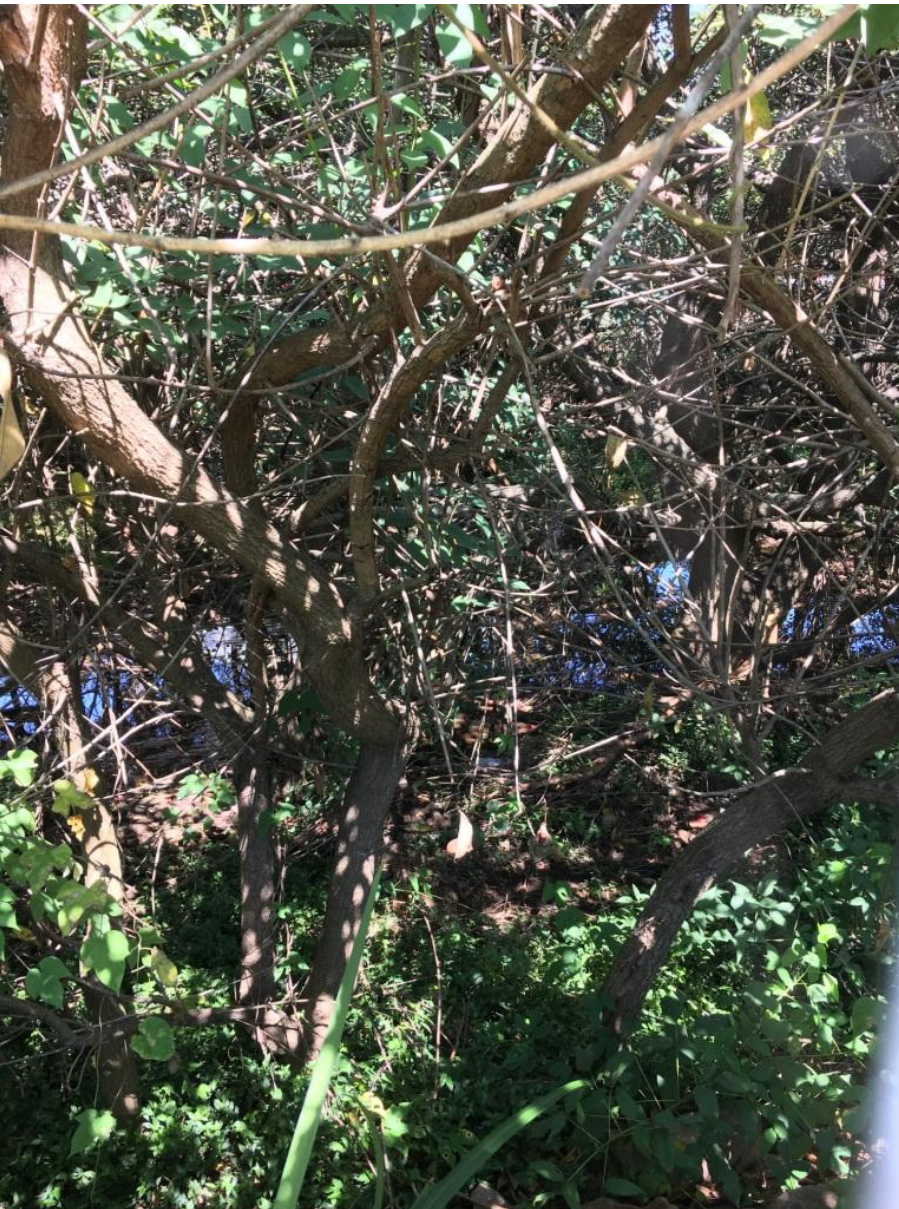
Photo 5 – Group 4 Area dense/impenetrable currently with noxious Cockscombe Coral.

Group 4 is required to be removed to allow the construction of the Headwall within the current design proposal.

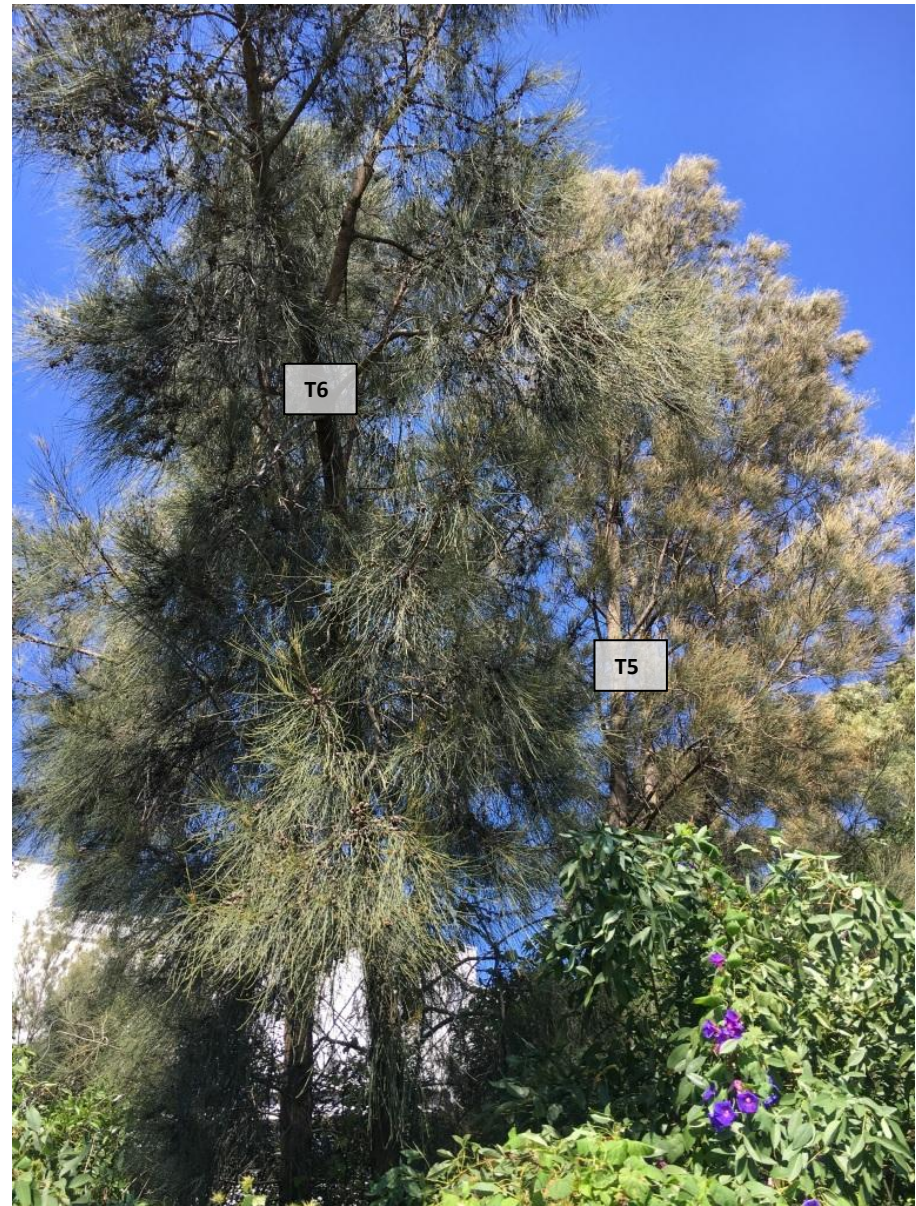
Photo 6 – Trees 5 & 6 being retained.

Under the current proposal these trees will be well clear of works. However given machinery accessing this area, extra care has been taken to ensure these trees are protected.

Tree 5 has a radial notional Tree Protection Zone of 4.8m, Tree 6 has a radial distance of 5.4m, and branch spread does not extend out of the radial TPZ distance so no pruning will be required.

These two (2) trees should remain unaffected from the proposed works.

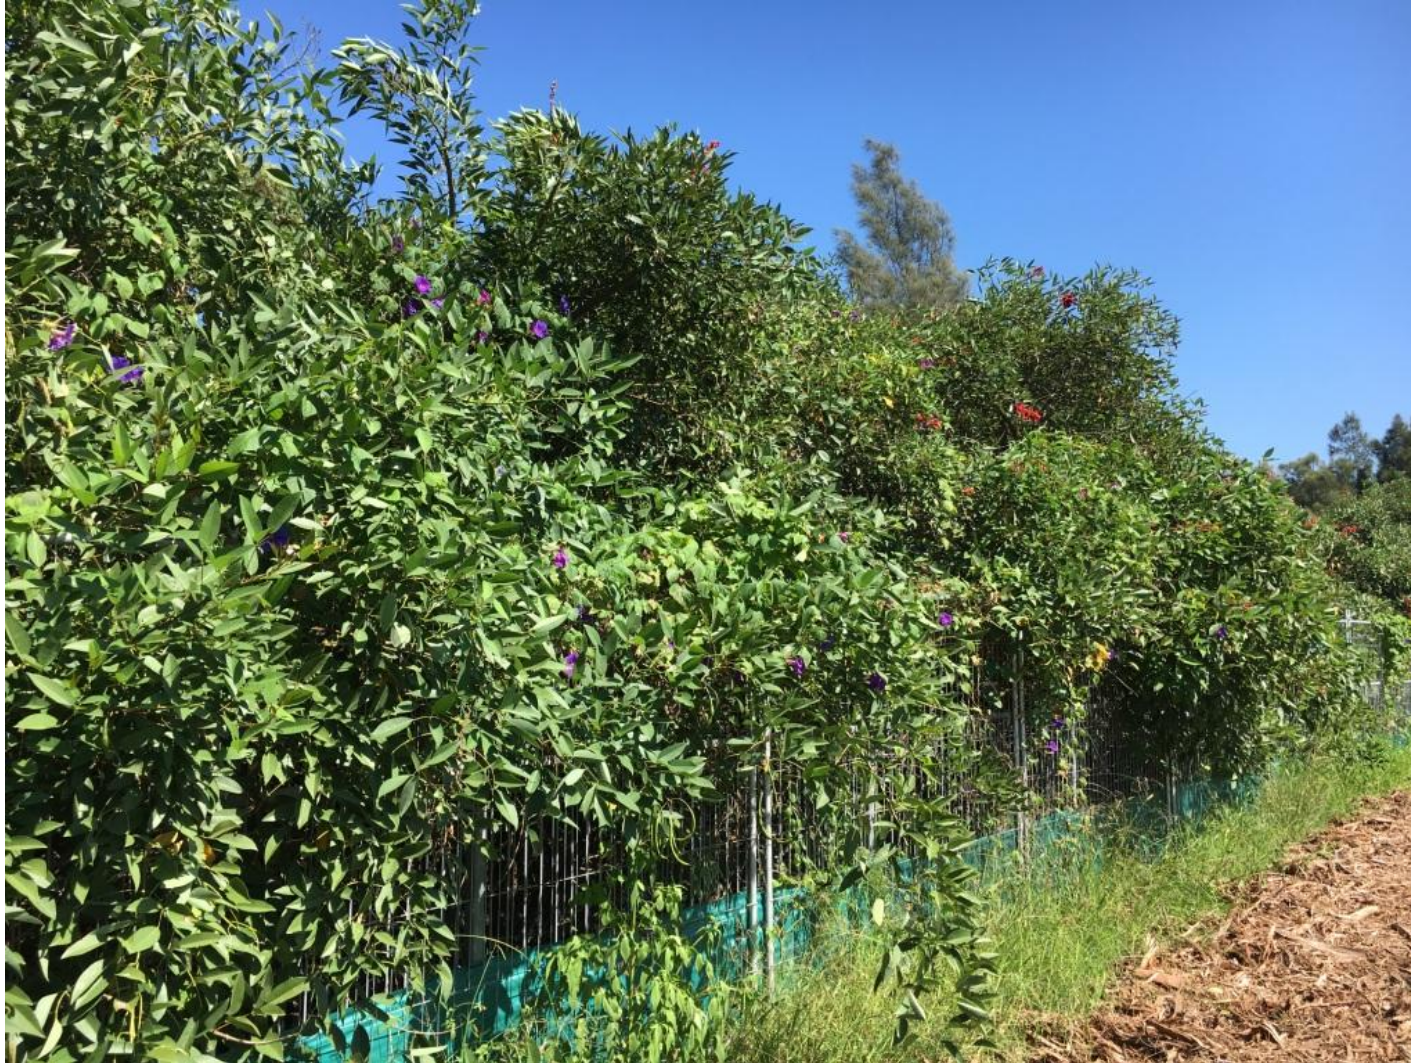
Photo 7 – Group 4 Area dense/impenetrable with noxious weed - Cockscombe Coral Tree.
