Tree Removals and Plantings

- Pool Flatrock Kingsgrove HVC
- St Peters Tempe No. 1 & No. 2 HVC
- Marsh Ave / Wolli Creek HVC

Project Name: WestConnex New M5

Project number:	15.7020.2597
Document number:	M5N-ES-RPT-PWD-0004
Revision date:	24/06/2016
Revision:	01

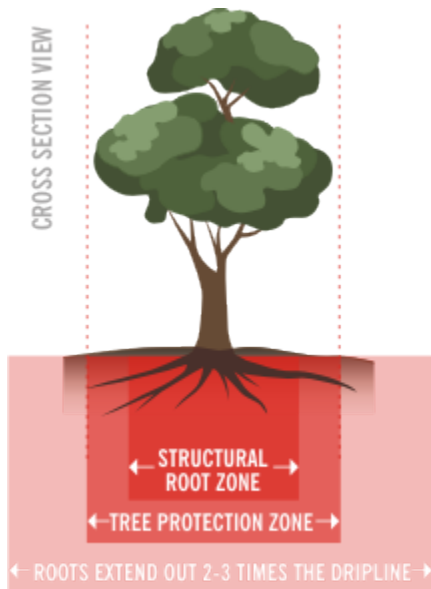
Fig 1. TPZ and SRZ protection zones.

The second data collected for tree protection is the Structural Root Zone (SRZ) which is an area considered essential for tree stability: loss of roots in this area is likely to cause the tree to become unstable in the ground.

The dimensions of the SRZ are determined from the Diameter of the Tree taken above the root flare.

Any excavation within the TPZ or the SRZ must be approved by the Project's consulting arborist prior to any works within this area. See Appendix 1. Tree Protection on Construction Sites.

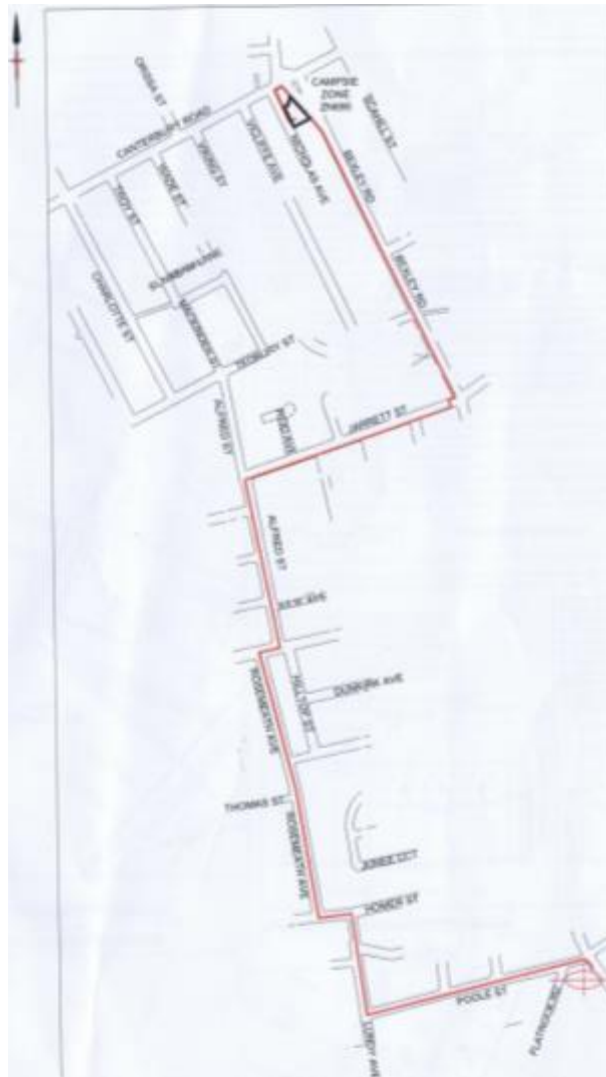
Map 1. Route of Poole Flatrock Kingsgrove HVC.

Site 1: WestConnex Stg 2 Establish HVC “KL” type kiosk S.76819 Poole Flatrock Kingsgrove. Site plans 1 – 14 by UEA Electrical

Trees located within close proximity to the proposed installation line have been included within this document. In some cases, conduit is preexisting and available for use to install cable (cable pulling via access pits). In these locations, disturbance to existing trees will not occur and these trees have not been surveyed.

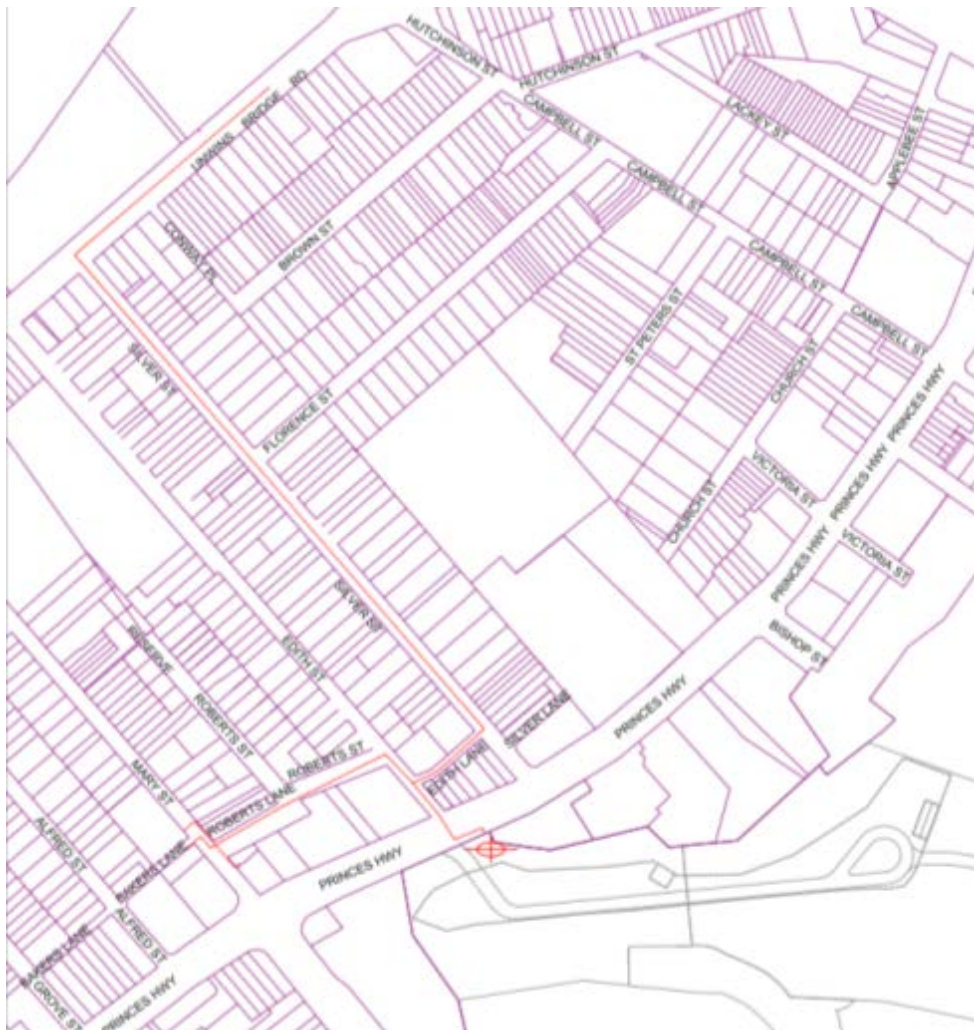
Map 6 Route of St Peters proposed HVC.

Site 2: WestConnex STG 2 Establish two HVC “KL” type kiosks. S. 76844 WestConnex St Peters Temp No 1. S. 76844 WestConnex St Peters Temp No 2 Princes Hwy St Peters. Site plans 1 – 13 by UEA Electrical.

Trees located within close proximity to the proposed installation line have been included within this document. There is no available pre-existing conduit along this route that can be utilised for these works.

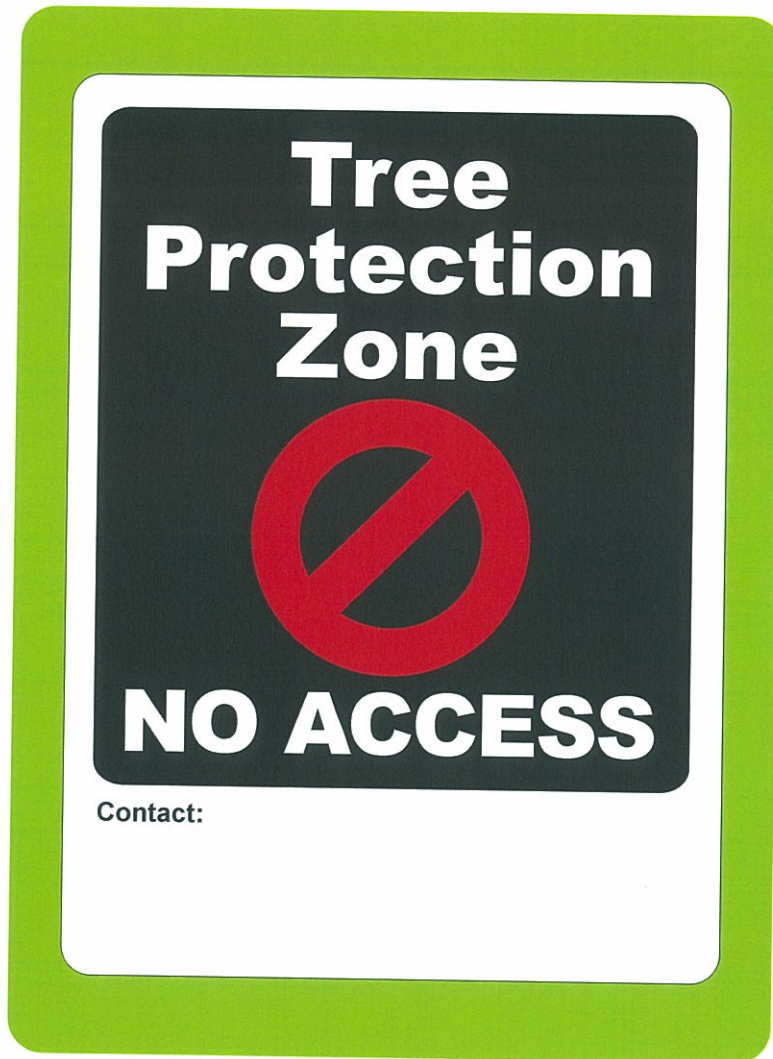
FIGURE C1 TREE PROTECTION ZONE SIGN

A TPZ sign provides clear and readily accessible information to indicate that a TPZ has been established. Figure C1 provides an example of a suitable sign.

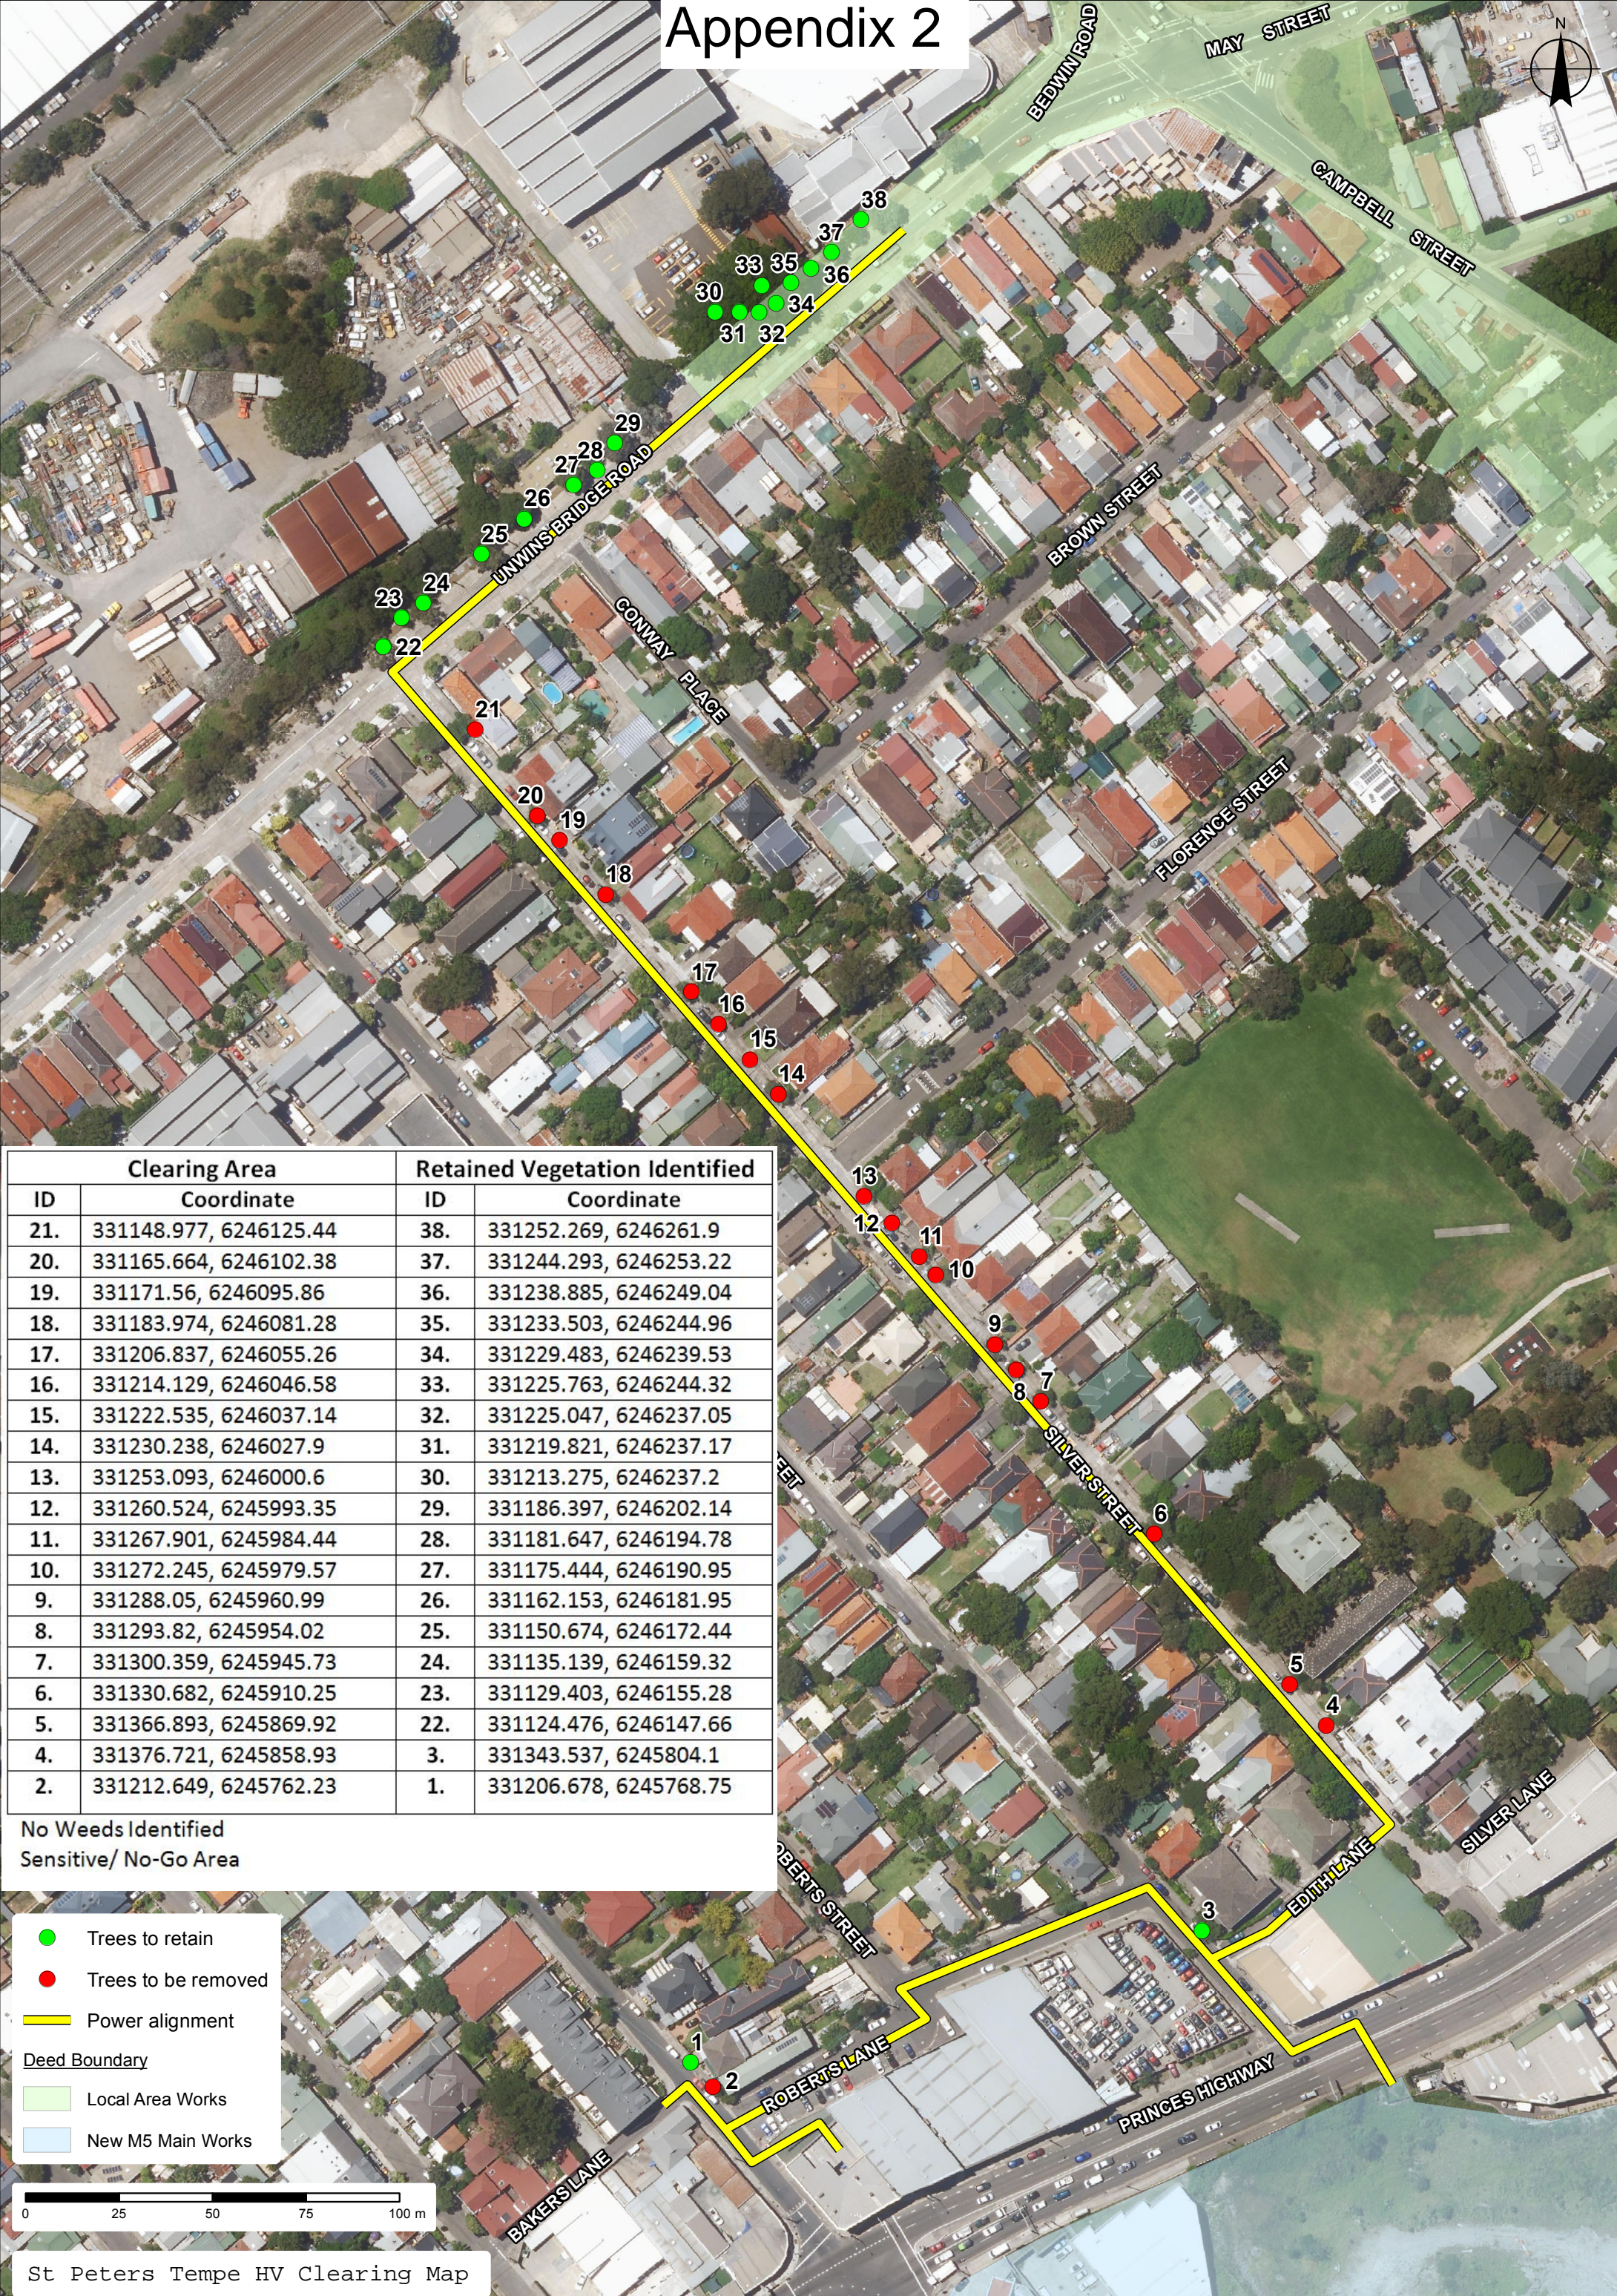
Appendix 2

Clearing Area		Retained Vegetation Identified	
ID	Coordinate	ID	Coordinate
21.	331148.977, 6246125.44	38.	331252.269, 6246261.9
20.	331165.664, 6246102.38	37.	331244.293, 6246253.22

19.	331171.56, 6246095.86	36.	331238.885, 6246249.04
18.	331183.974, 6246081.28	35.	331233.503, 6246244.96
17.	331206.837, 6246055.26	34.	331229.483, 6246239.53
