## 'Rudders Bond Store' - Former Ralph Symonds Factory

53-57 Campbell Road, St Peters

Archival Recording

Prepared for CPB Dragados Samsung Joint Venture

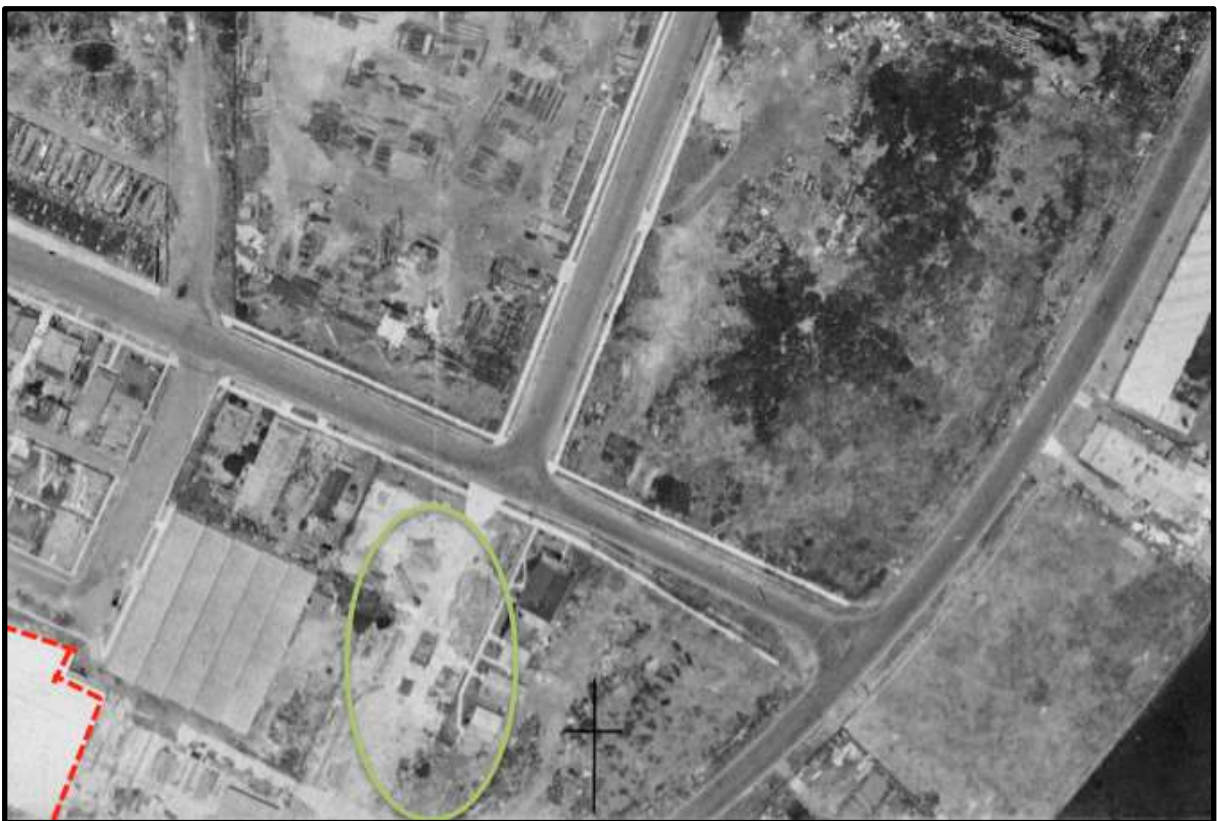
**Figure 7.** 1949 aerial photograph of the subject site. Former Campbell Street building is no longer extant (green oval). New building can be seen on Holland Street (red outline). (Source: Sydney Historical Atlas).

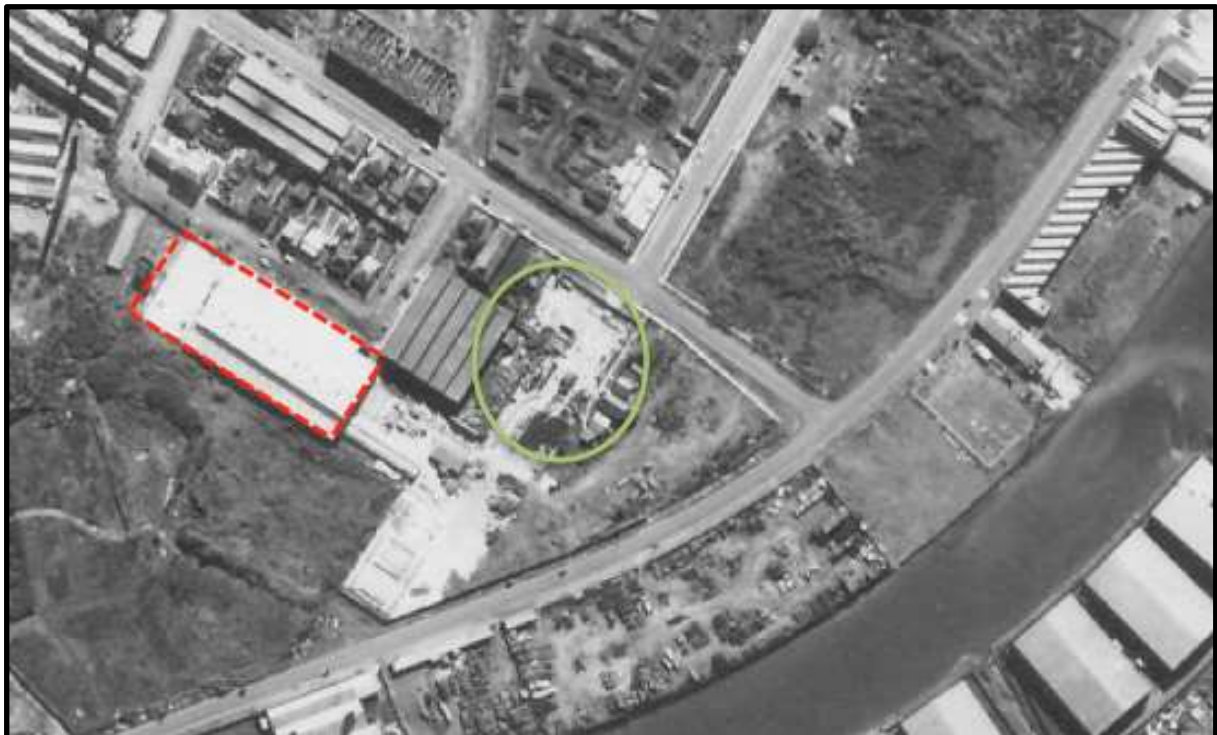
Figure 9. 1951 aerial photograph of the subject site. Holland Street pavilion has reached its extent (red outline) and Campbell Street site is still vacant (green oval).

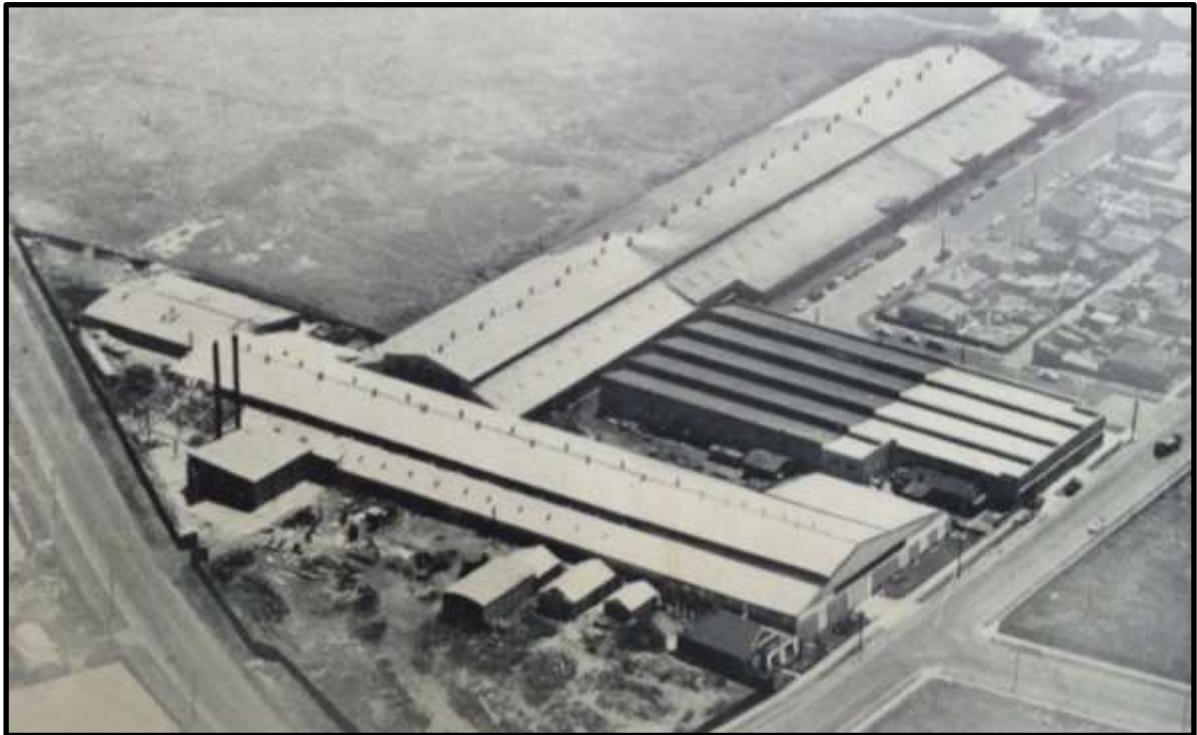
**Figure 12.** *Undated photograph of Symonds St Peters factory (now Rudders Bond Store), showing full structure as per 1950s layout. (Source: Ralph Symonds promotional material, NSW State Library).*

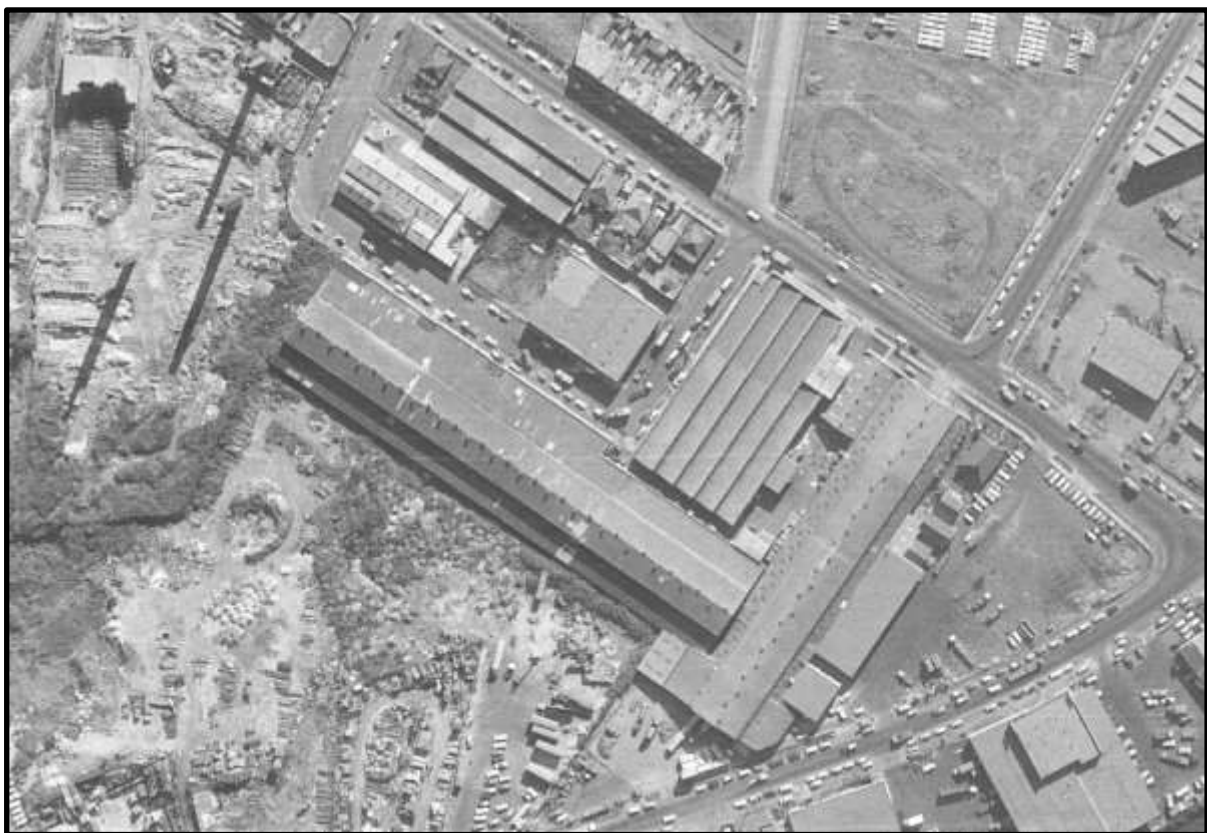
**Figure 13.** *Aerial photograph, 1970. Shows full building as per early 1950s planned layout. (Source: NSW Department of Lands).*

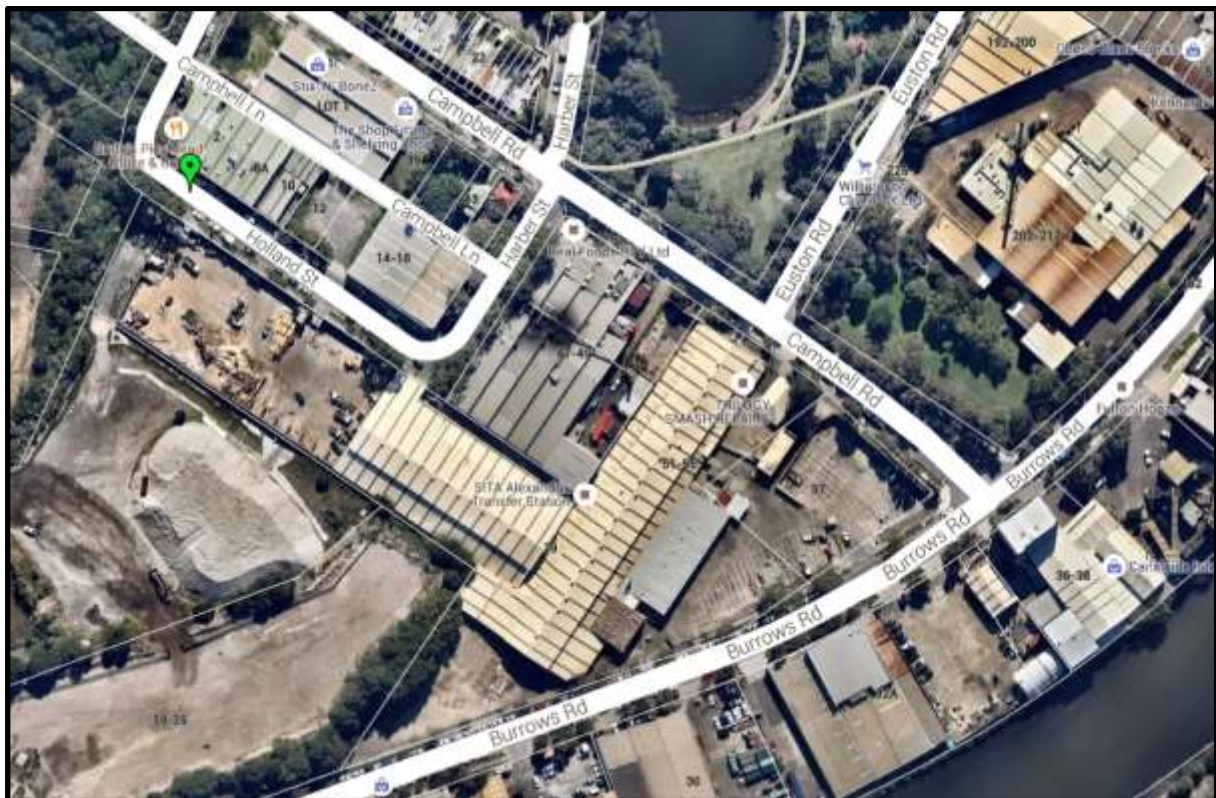
Figure 15. Subject site 2016. Shows current extent of the building. The Holland Street arm has been shortened, reducing it in length by half. (Source: Nearmap, 2016).

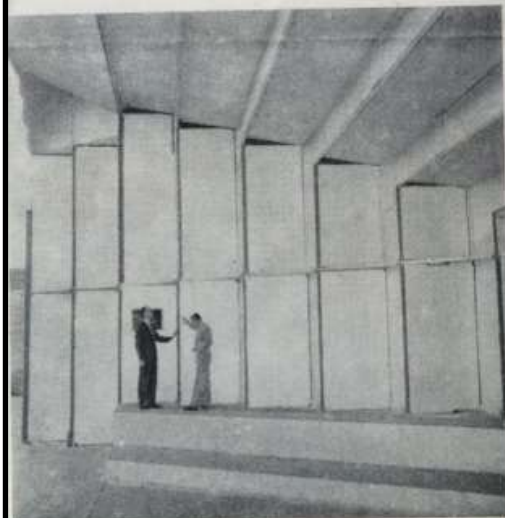
**Top:** The Sydney Symphony Orchestra rehearsing in the plywood music shell. Note amplifier pylons. — **Centre and Left:** Close-up photographs giving some indication of its size, both exterior and interior.

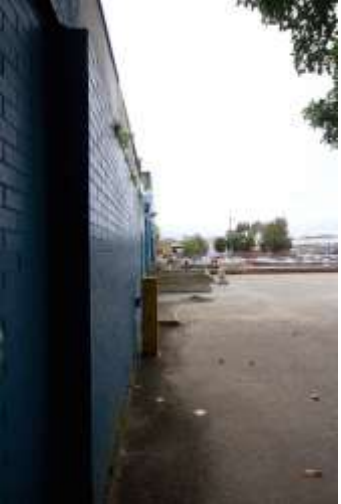
007_RUDDERSBOND_MARCH2016.jpg	NE	Facing north-east, profile of ancillary room, north western elevation.

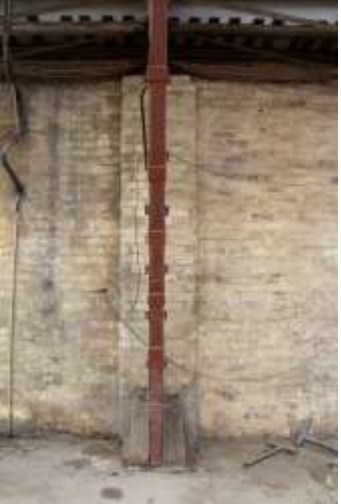
056_RUDDERSBOND_MARCH2016.jpg	E	Facing east in locus 1, view of underside of arch and foundation in profile against east wall.

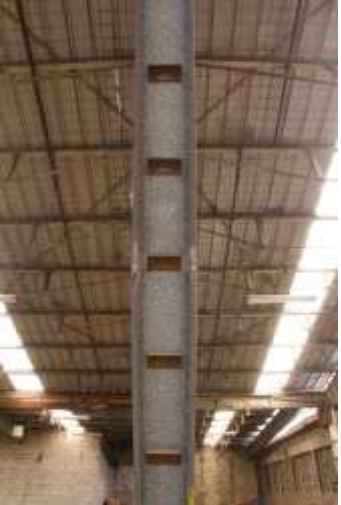
068_RUDDERSBOND_MARCH2016.jpg	NW	Facing north-west in locus 1, detail of inner arch I-Beam and steel clamps.

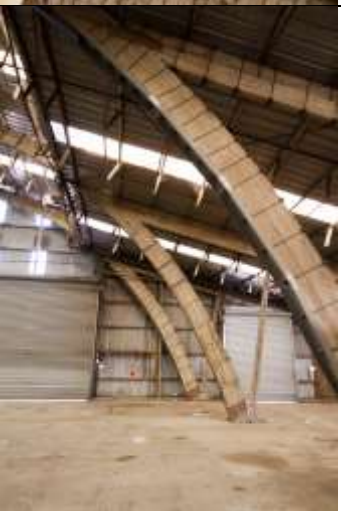
072_RUDDERSBOND_MARCH2016.jpg	SW	Facing south-west in locus 1, view of arches and remnant building.

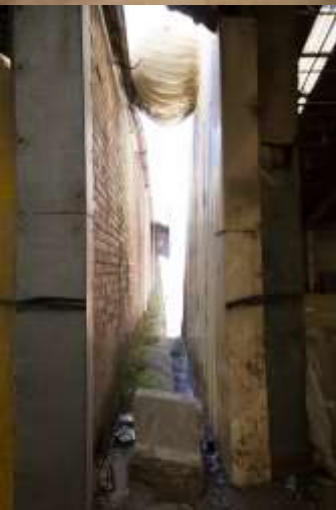
084_RUDDERSBOND_MARCH2016.jpg	NE	Facing north-east in locus 2, detailing gable at south-eastern end.
