ARBORICULTURAL REPORT

Campbell Street and Campbell Road

WestConnex New M5

Prepared for CDS-JV CDS-JV Doc number: M5N-ES-RPT-LRW-0004-04

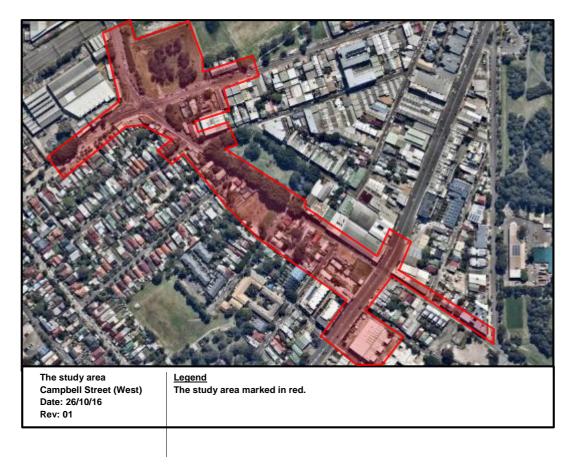
Map 1: The study area

The study area comprises of two sections:

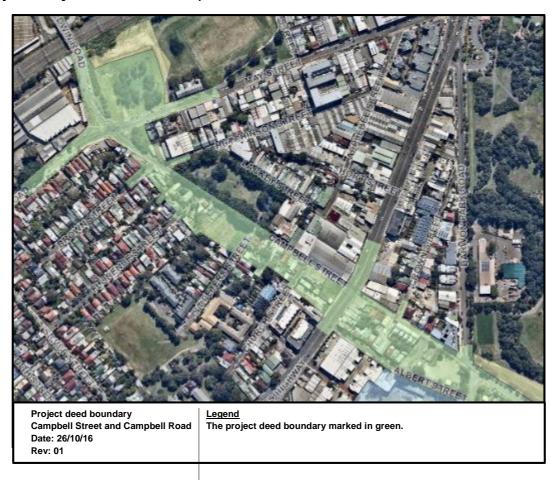
Map 3: Project deed boundary

The southern boundary of the works extend into current residential properties acquired by Roads and Maritime Services and up to boundaries of properties to be retained. The northern boundary of the works will extend to the existing northern extent of the Campbell Street and Campbell Road corridor. The width of the upgrade cannot be lessened without compromising safety design considerations and for this reason the design width cannot be decreased. The location of the road widening is provided in **Map 3** and is represented by the full width of the Project Deed boundary.

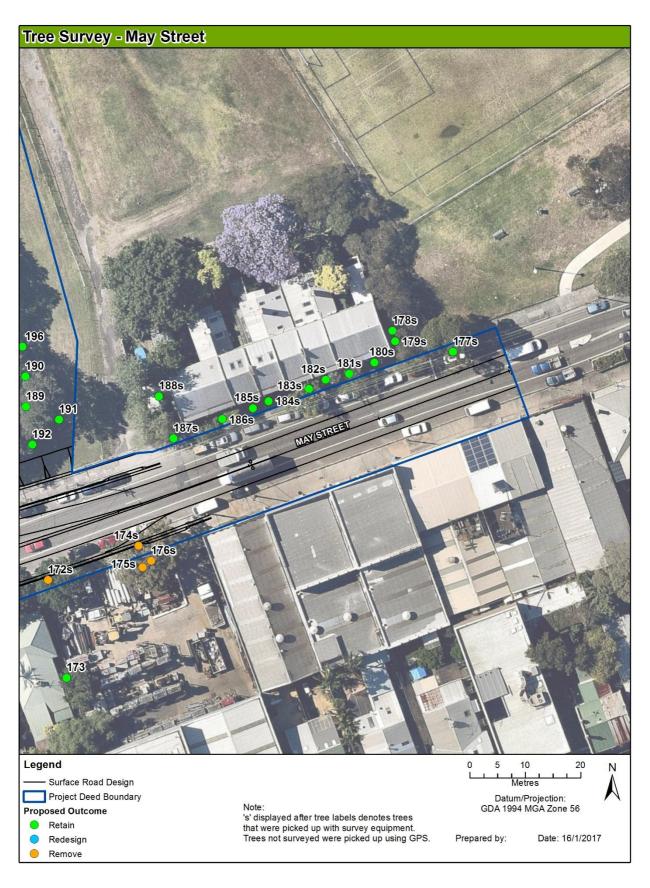
^{*} Trees present in maps that have not been assessed may have been removed prior to the tree survey, or may not qualify. If any additional trees are likely to be impacted, further assessment will be required.

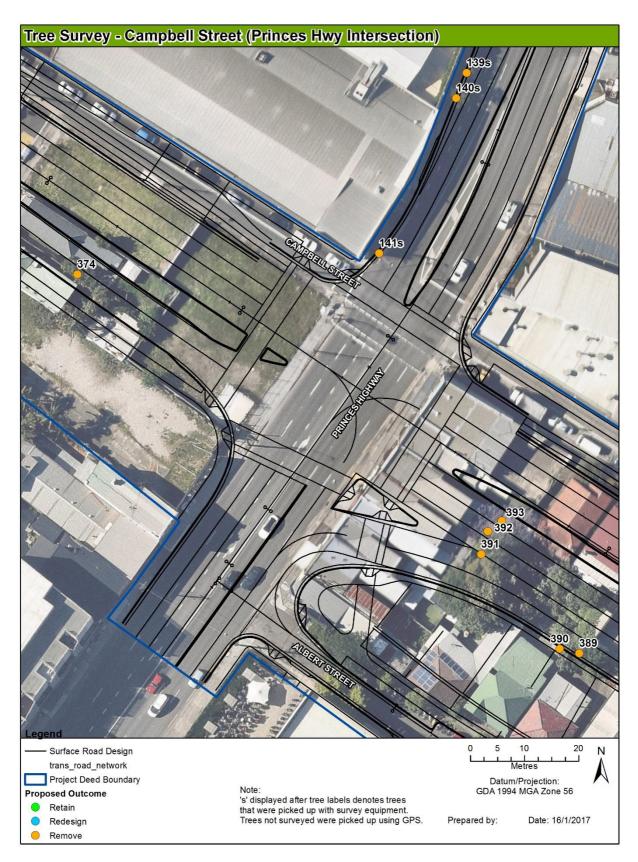
^{*}Map shows trees not surveyed in the previous report M5N-ES-RPT-PWD-0002 revision 03, dated 6 July 2016, section Site 3: St Peters Interchange including Canal Road (C8) Campbell Road Compound (C9) & Burrows Road Compound (C10 & C11). This Tree Report was approved by DPE on 8 July 2016. Trees present in maps that have not been assessed may have been removed prior to the tree survey, or may not qualify.

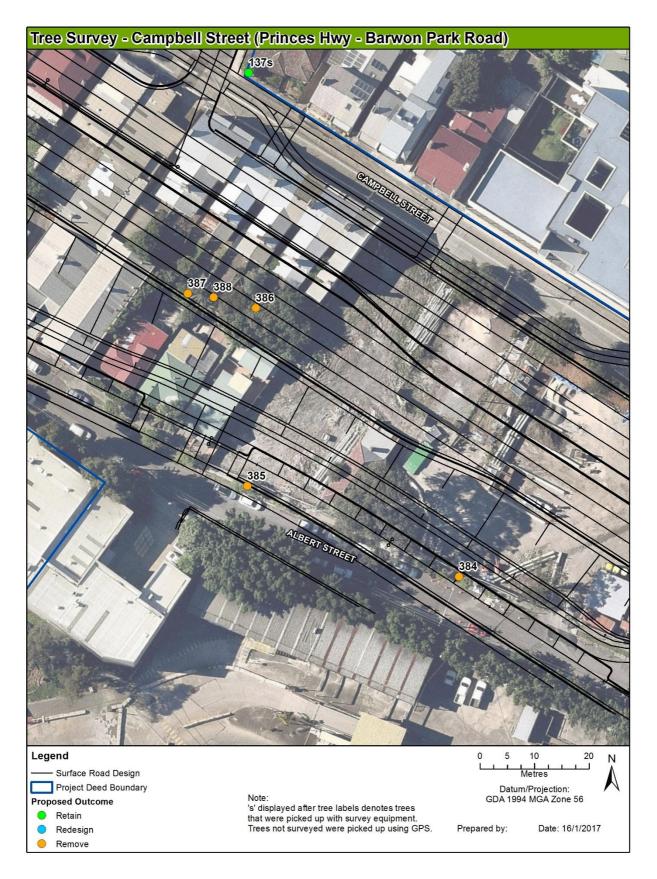
^{*}Map shows trees not surveyed in the previous report M5N-ES-RPT-PWD-0002 revision 03, dated 6 July 2016, section Site 3: St Peters Interchange including Canal Road (C8) Campbell Road Compound (C9) & Burrows Road Compound (C10 & C11). This Tree Report was approved by DPE on 8 July 2016

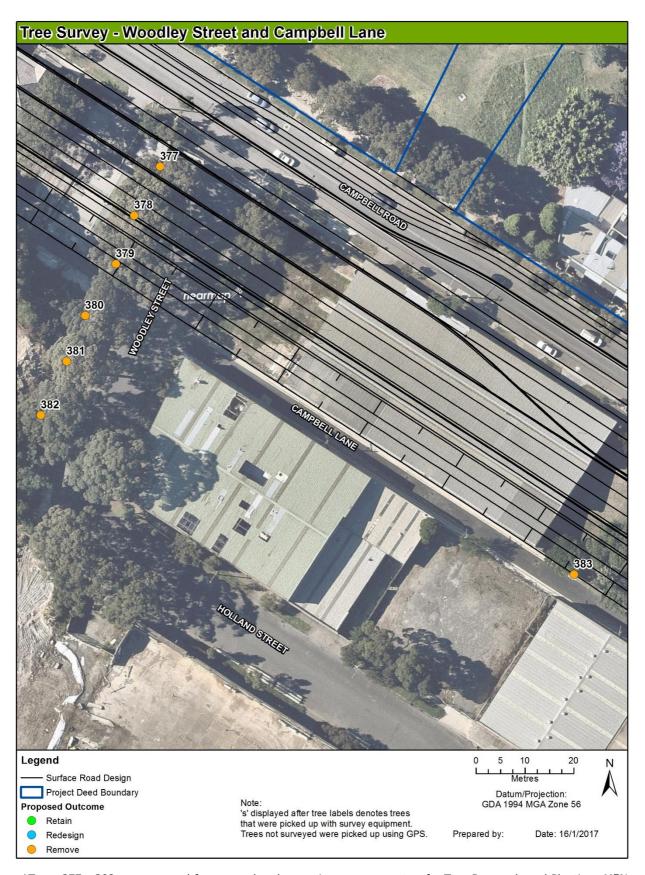
*Trees 377 - 382 are approved for removal under previous assessment, refer Tree Removals and Plantings M5N-ES-RPT-PWD-0002 revision 03, dated 6 July 2016, section Site 3: St Peters Interchange including Canal Road (C8) Campbell Road Compound (C9) & Burrows Road Compound (C10 & C11); Tree number 144. This Tree Report was approved by DPE on 8 July 2016
