ARBORICULTURAL REPORT

**Bourke Road & Burrows
Road
WestConnex New M5
Prepared for CDS-JV
M5N-ES-RPT-LRW-
0007-05
Date 1 March 2017**

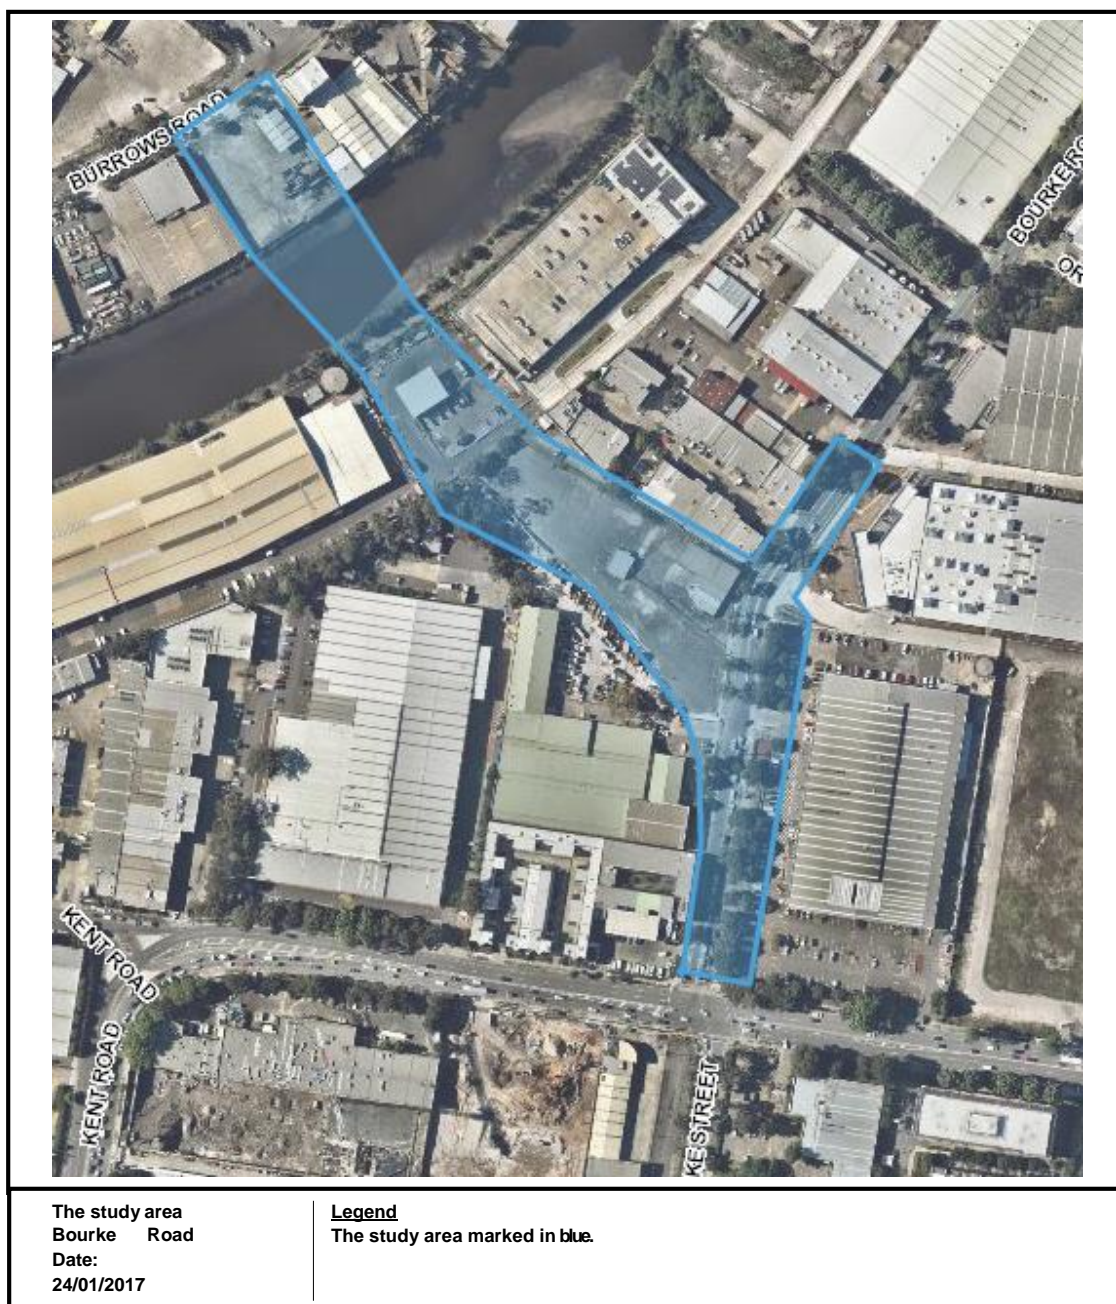
Map 1: The study area

- Approximately 3ha of land situated along and surrounding Bourke Road. The eastern extent of the study area is bound by industrial buildings and offices. The western extent is bound by Alexandra Canal. The southern extent of the study area is bound by Gardeners Road. This is presented in **Map 1**.

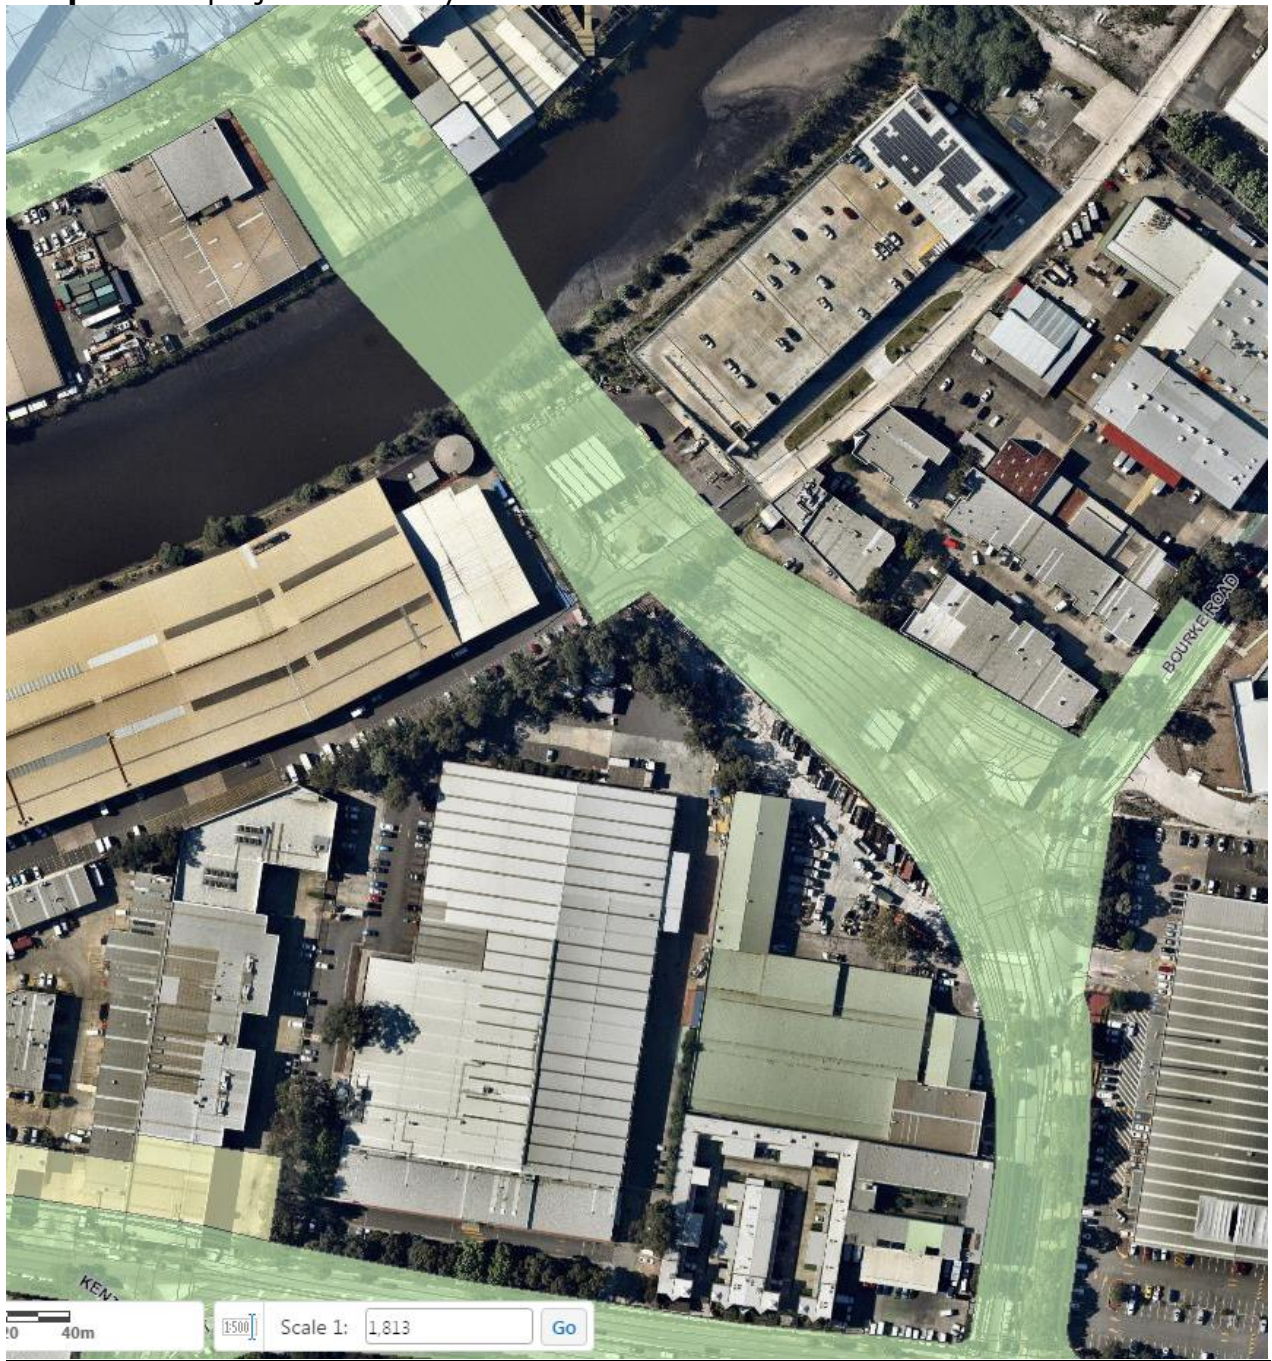
Map 2: The project boundary

Project deed boundary: Bourke Road
Date: 12/01/2017
Rev: 0

Legend: Project deed boundary shaded in green

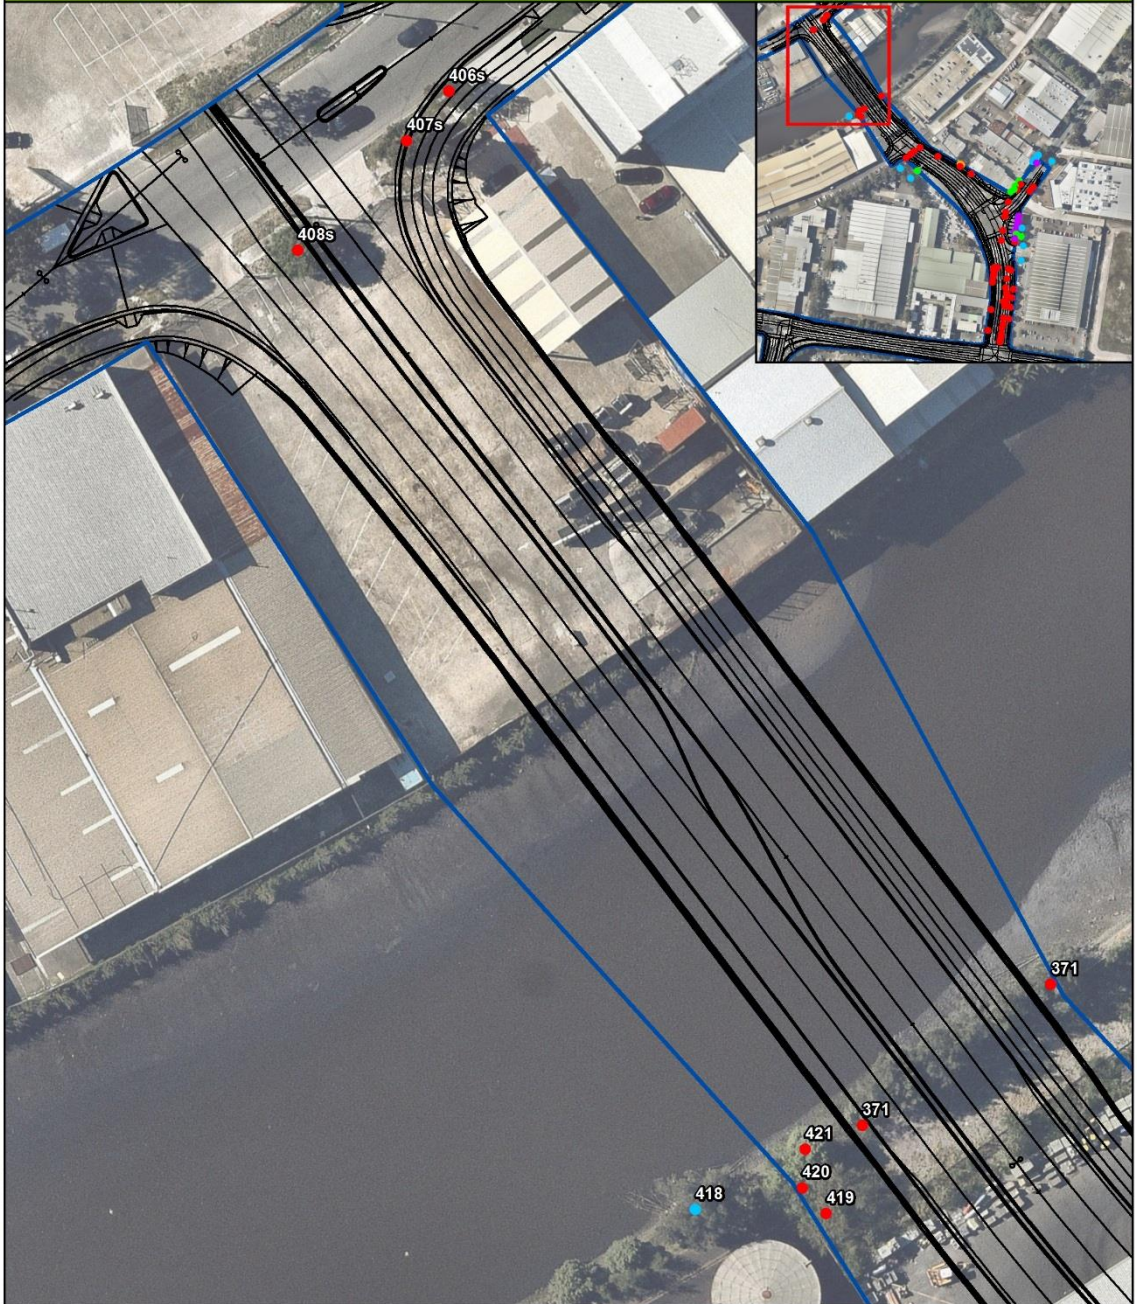
Tree Survey - Proposed Outcome

NW Alexandra Canal

Note:
's' displayed after tree labels denotes trees that were picked up with survey equipment. Trees not surveyed were picked up using GPS.

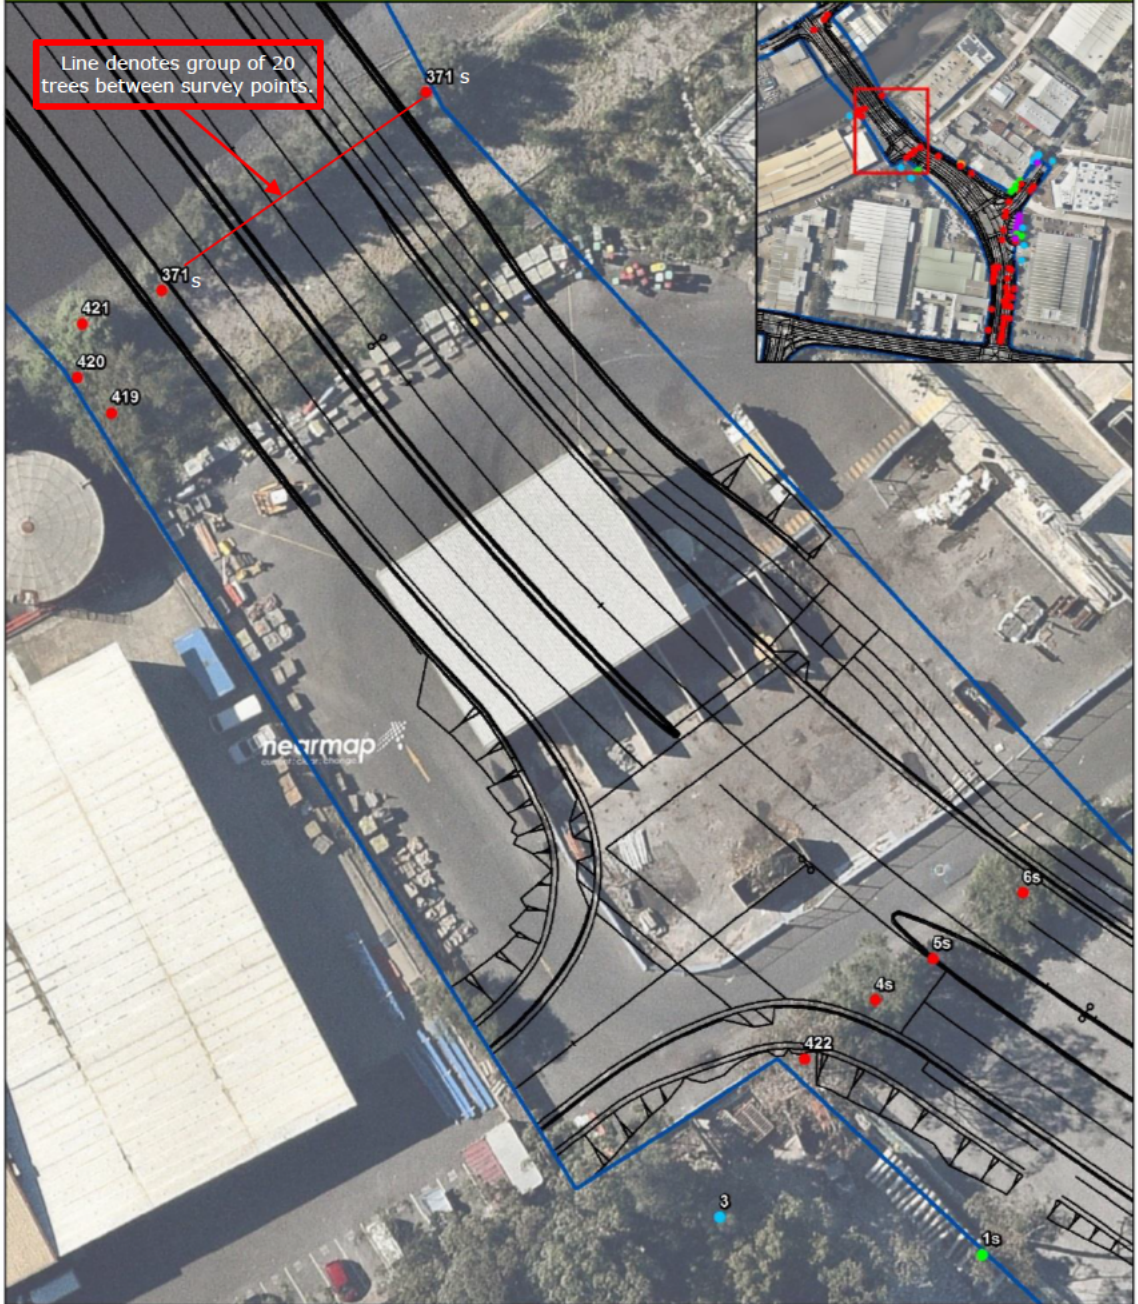
Tree Survey - Proposed Outcome **Alexandra Canal - 81 Bourke Road**

Note:
 's' displayed after tree labels denotes trees that were picked up with survey equipment.
 Trees not surveyed were picked up using GPS.

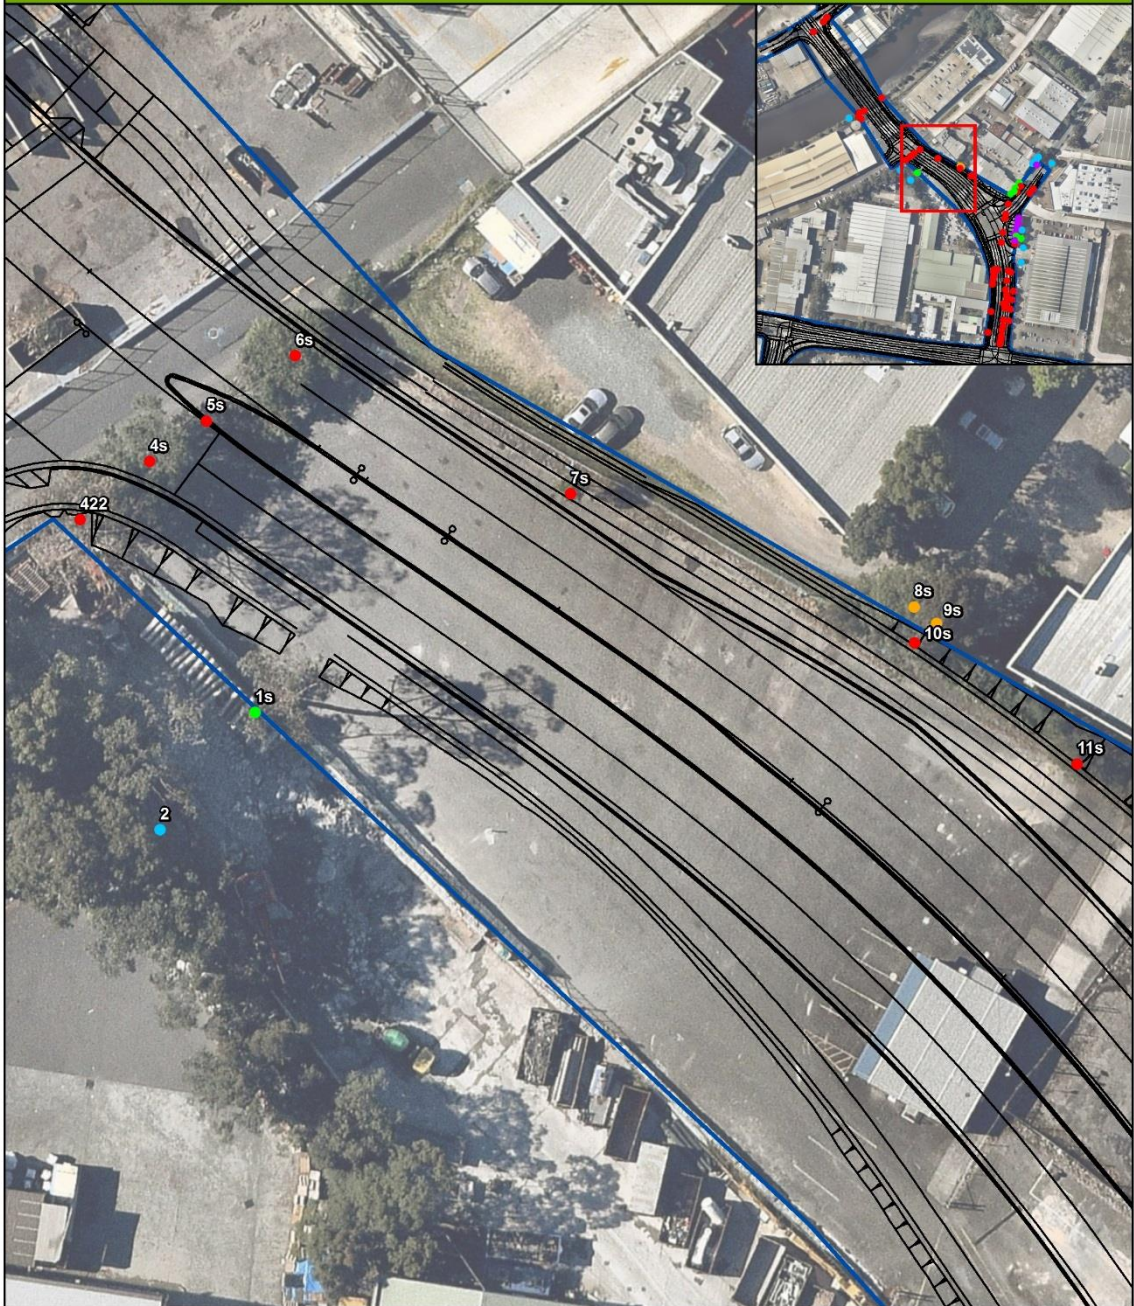
Tree Survey - Proposed Outcome

81 Bourke Road

Note:
 's' displayed after tree labels denotes trees that were picked up with survey equipment. Trees not surveyed were picked up using GPS.

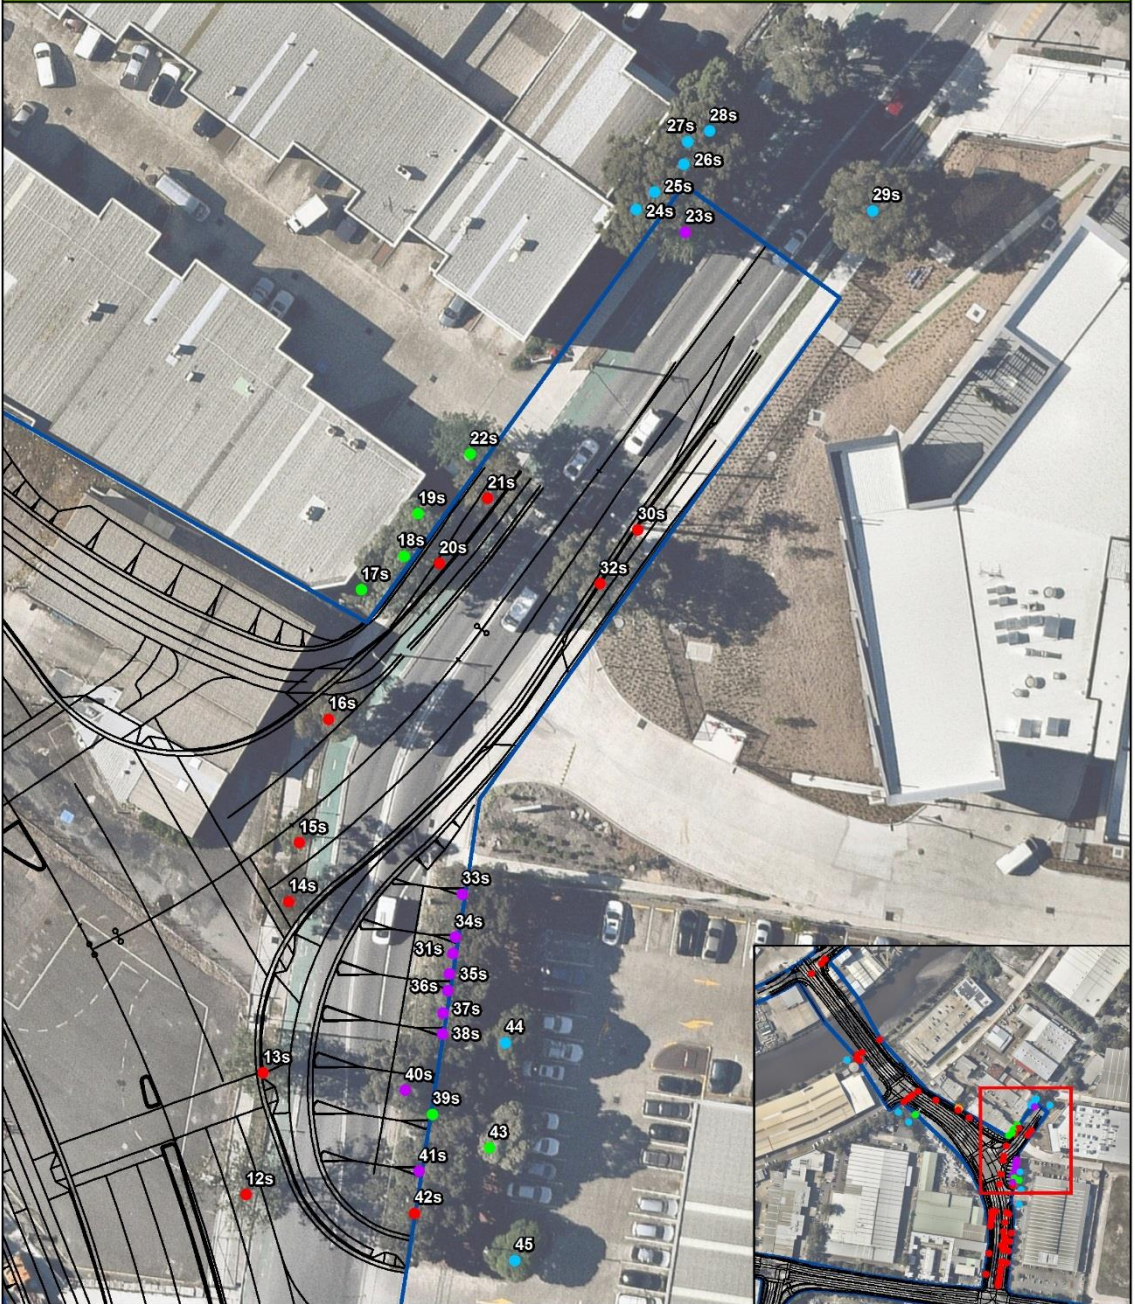
Tree Survey - Proposed Outcome

75A - 81 Bourke Road

Note:
 's' displayed after tree labels denotes trees that were picked up with survey equipment.
 Trees not surveyed were picked up using GPS.

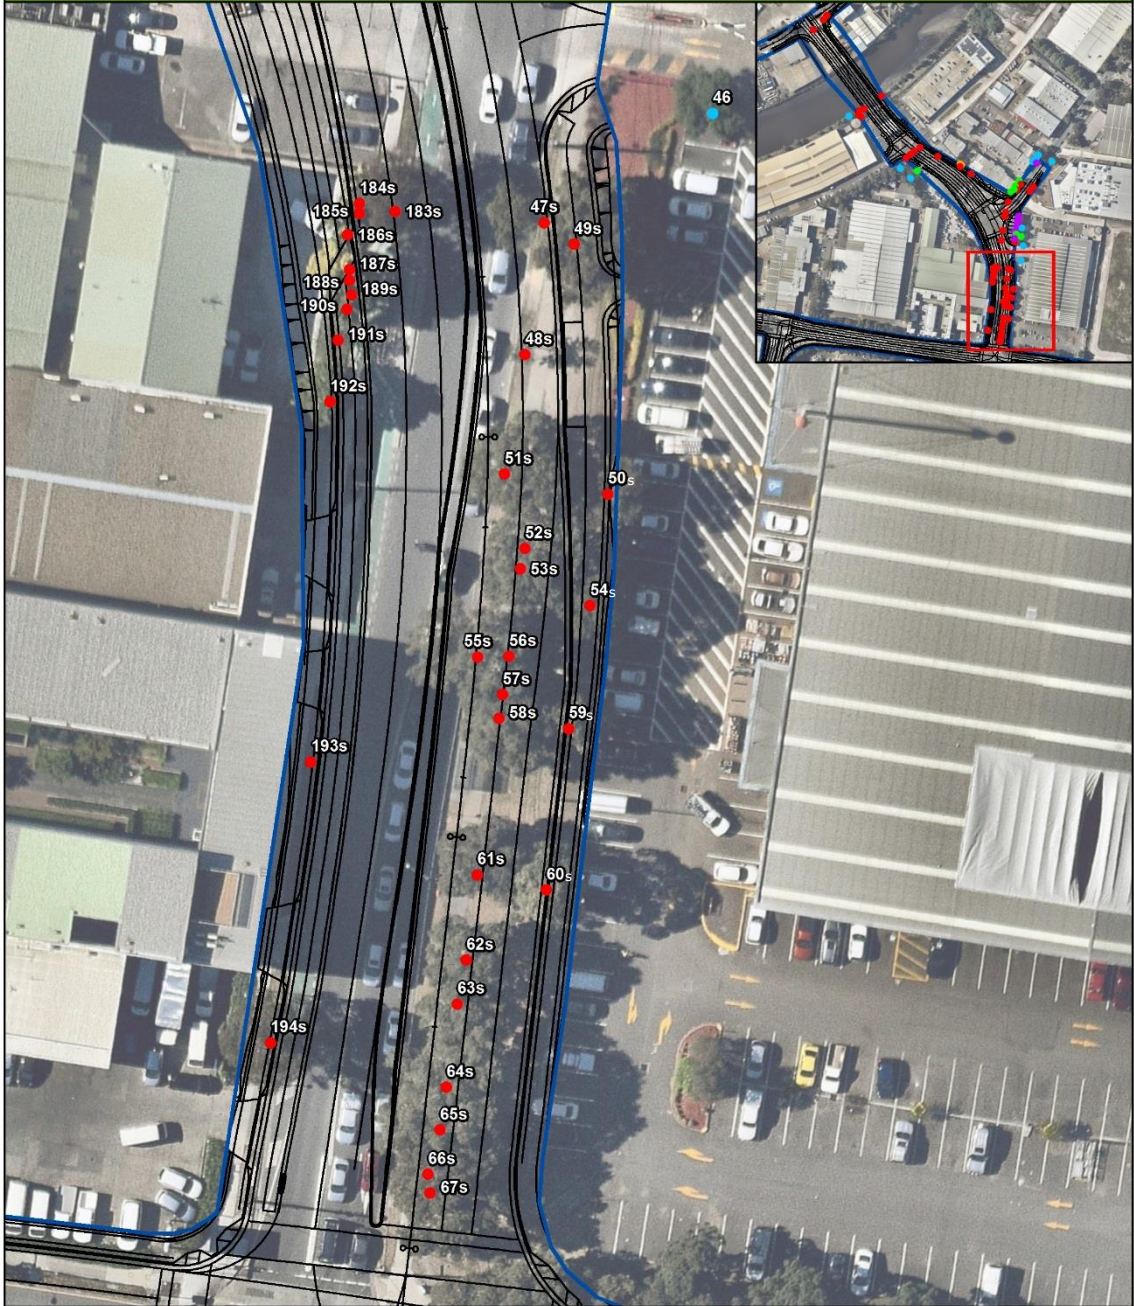
Tree Survey - Proposed Outcome

81 Bourke Road - Gardeners Road

Note:
 's' displayed after tree labels denotes trees that were picked up with survey equipment. Trees not surveyed were picked up using GPS.
