# Site Audit Report 278\_PBR by Dr Ian Swane

WESTCONNEX STAGE 3A PYRMONT BRIDGE ROAD WORKSITE (AREA C9)

ANNANDALE

Final | 25 NOVEMBER 2022

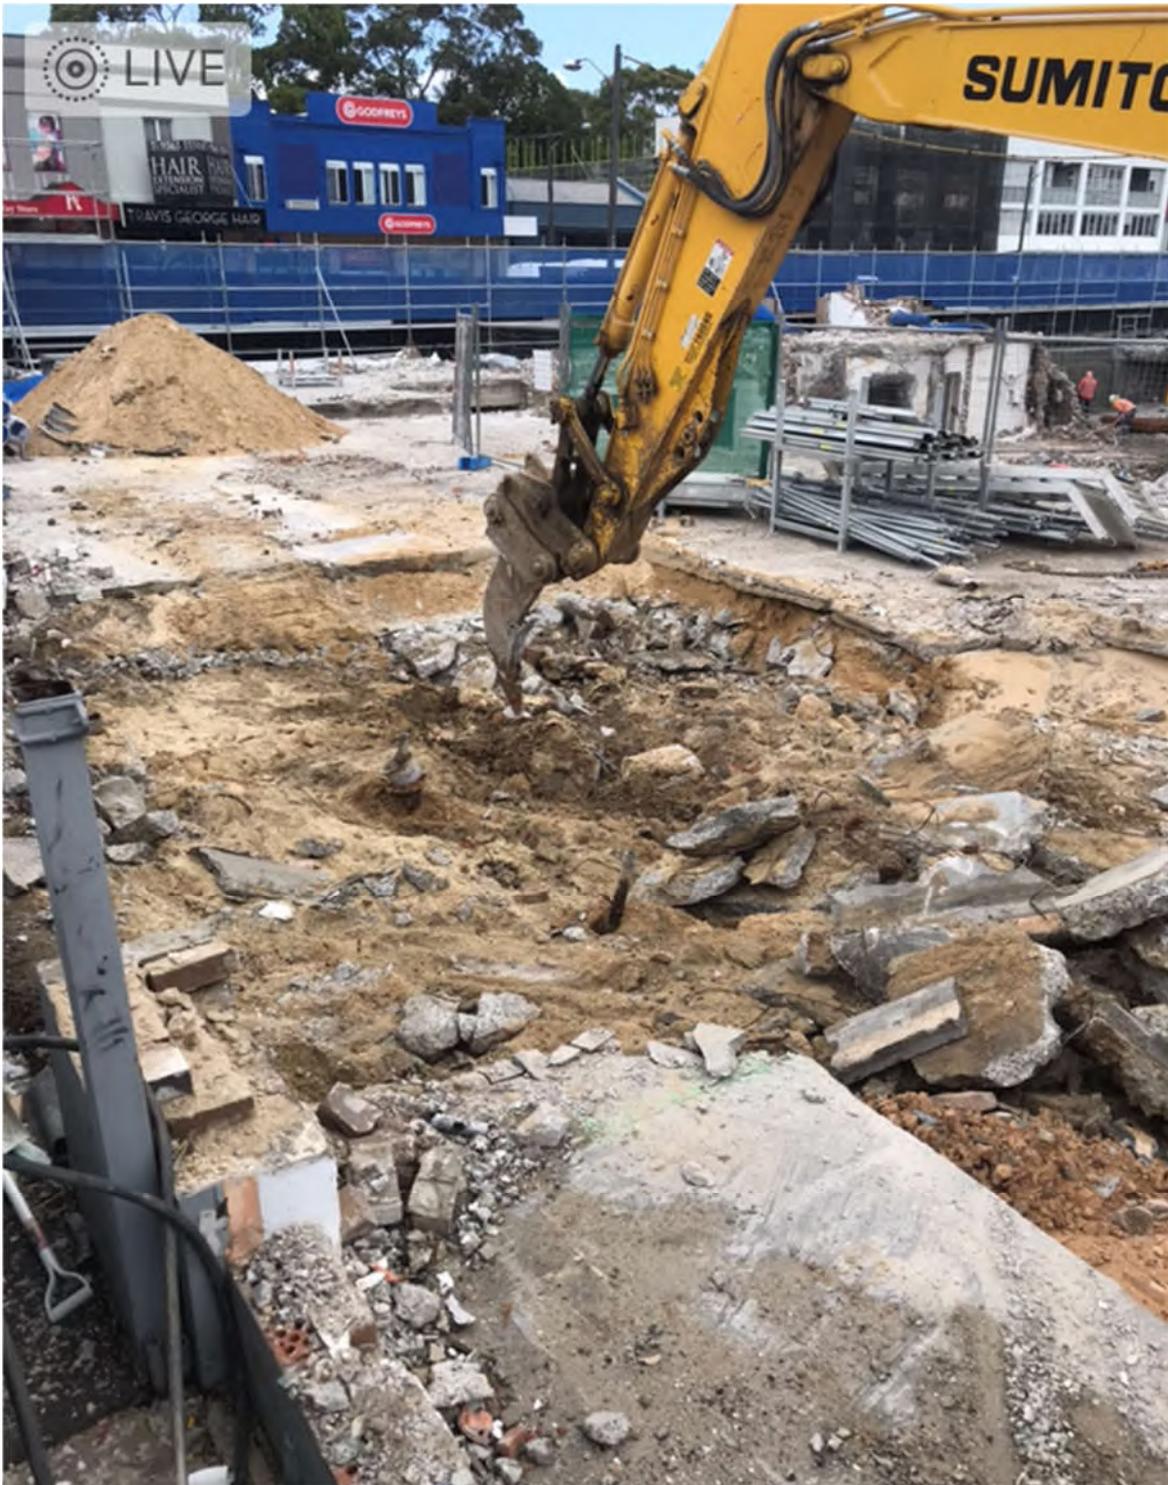
Figure 3-6 Photo of Unexpected UST found at Property 1 on 25/02/19 (Source: Comment 16, Ref [6])

- 15/04/19: Tank destruction certificate issued by Sell & Parker for a UST removed from the PBR site by Metropolitan Demolition on 11/04/19 (weight 0.56 T);
- 11/04/19: Hot work permit and degassing certificate issued by T&V Grainger to Metropolitan Demolition for a UST at the PBR site; and
- A sketch plan prepared by ASBJV showed that six USTs were recorded as having been removed from the PBR site, with their approximate locations shown in **Figure 3-7**.

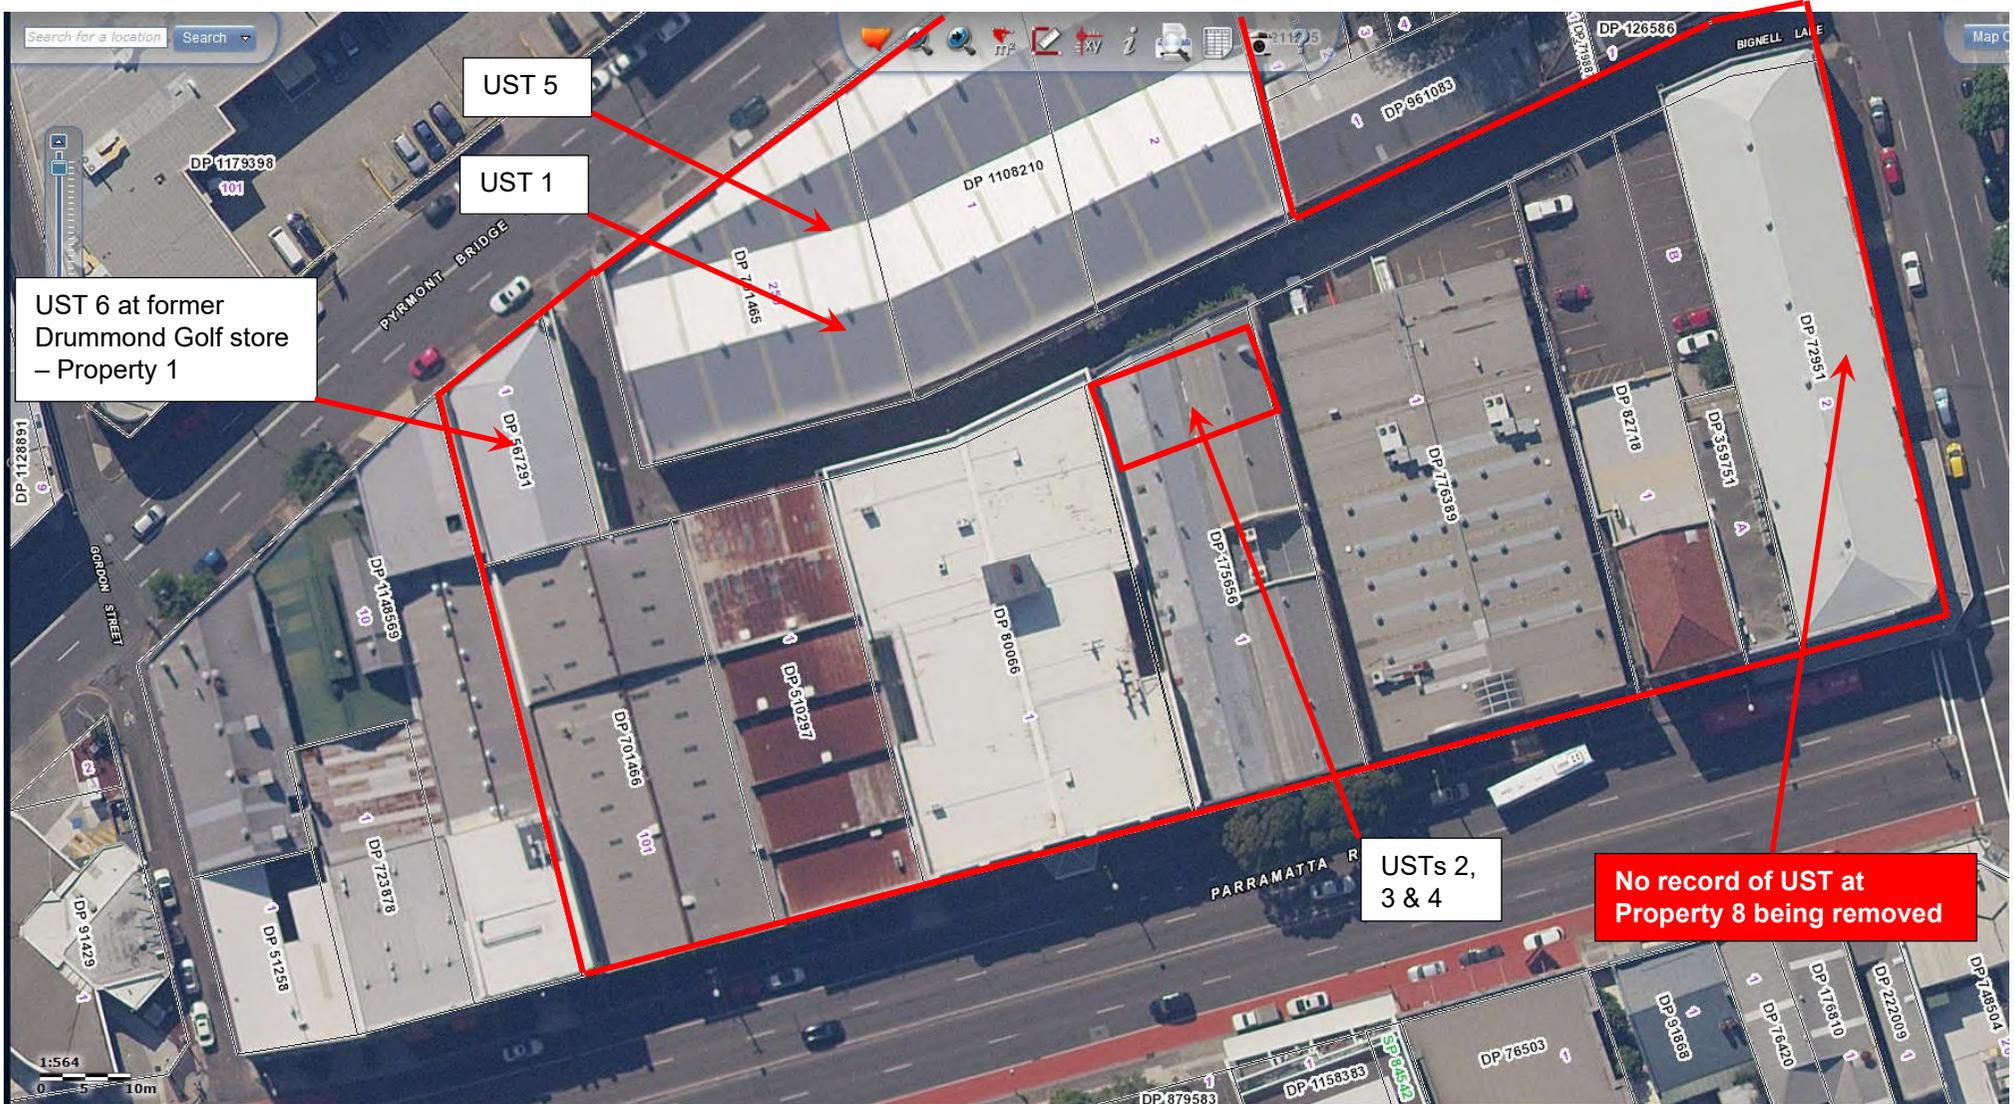
Figure 3-7 Approximate Locations of USTs Removed by ASBJV from PBR site

The Site Auditor identified deficiencies in data provided by ASBJV concerning the removal of USTs at the PBR site. These included:

- No field records were provided showing whether any liquid waste was present in USTs 2, 5 and 6, and if so, a WCR report for the liquid waste and liquid waste tracking and disposal docket;
- No field records were provided showing that hot work permits and degassing certificates were prepared for all USTs removed from the Site;
- No field records were provided showing the size and condition of USTs removed from the Site;
- No field record was provided showing the level of supervision provided by the ASBJV site supervisor / engineer during the decommissioning and removal of the USTs;
- A tank destruction certificate was not provided for one of the six USTs removed from the Site; and
- No documentation was provided on whether the UST at the eastern part of the Site (Property 8) was removed.

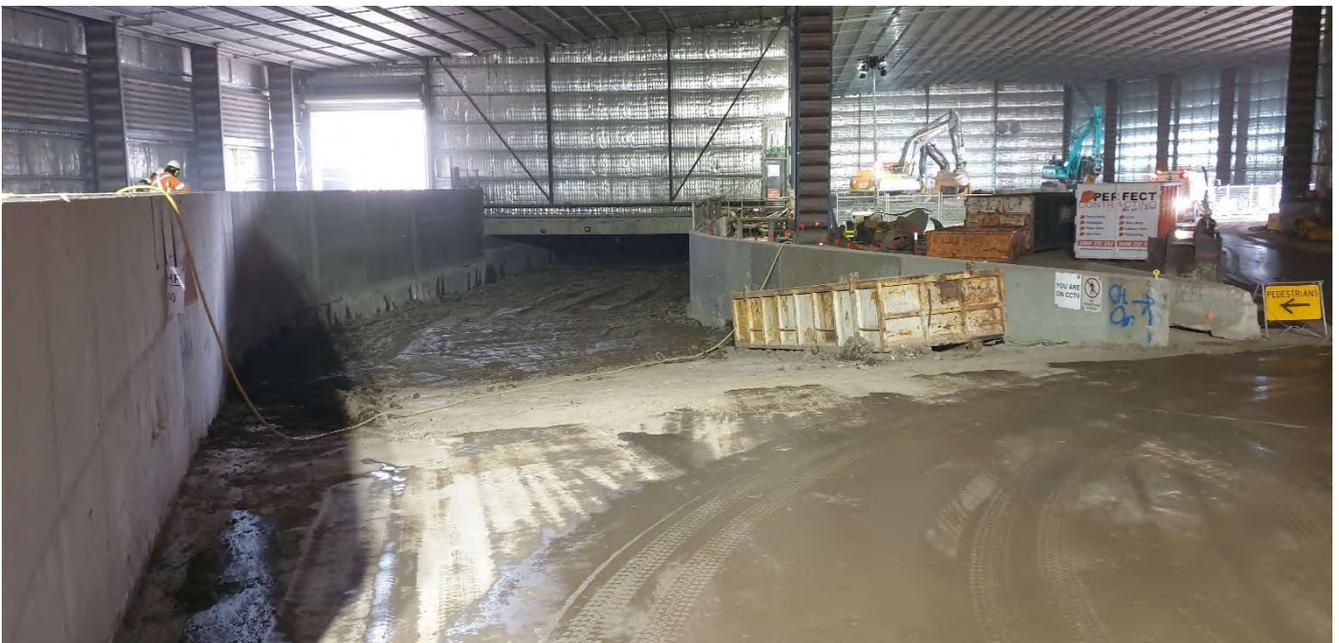
**Figure 3-16 View of Backfill in Tunnel Decline at PBR Site on 4/11/22**

The Site Auditor considered the weight of evidence supported the conclusion that the only soil that was likely to have been imported to the PBR site was not contaminated above commercial / industrial D criteria and suitable for use at a road construction worksite. This is because:

- Only a minimal amount of imported material was required for the construction of the tunnel facilities at the PBR site;
- ASBJV had strict environmental management plans in place that managed the quality of material imported to the PBR site;
- The Site Auditor found no evidence of imported material at the PBR site when inspected; and
- The EPA has issued a Backfill Order / Exemption that provides strict controls on the types of material allowed to be used to backfill the tunnel decline at the PBR site.
