Pre-Construction Road Condition Report for WestConnex M5N

Project No: PSS17131

for WestConnex M5N

date June 2017

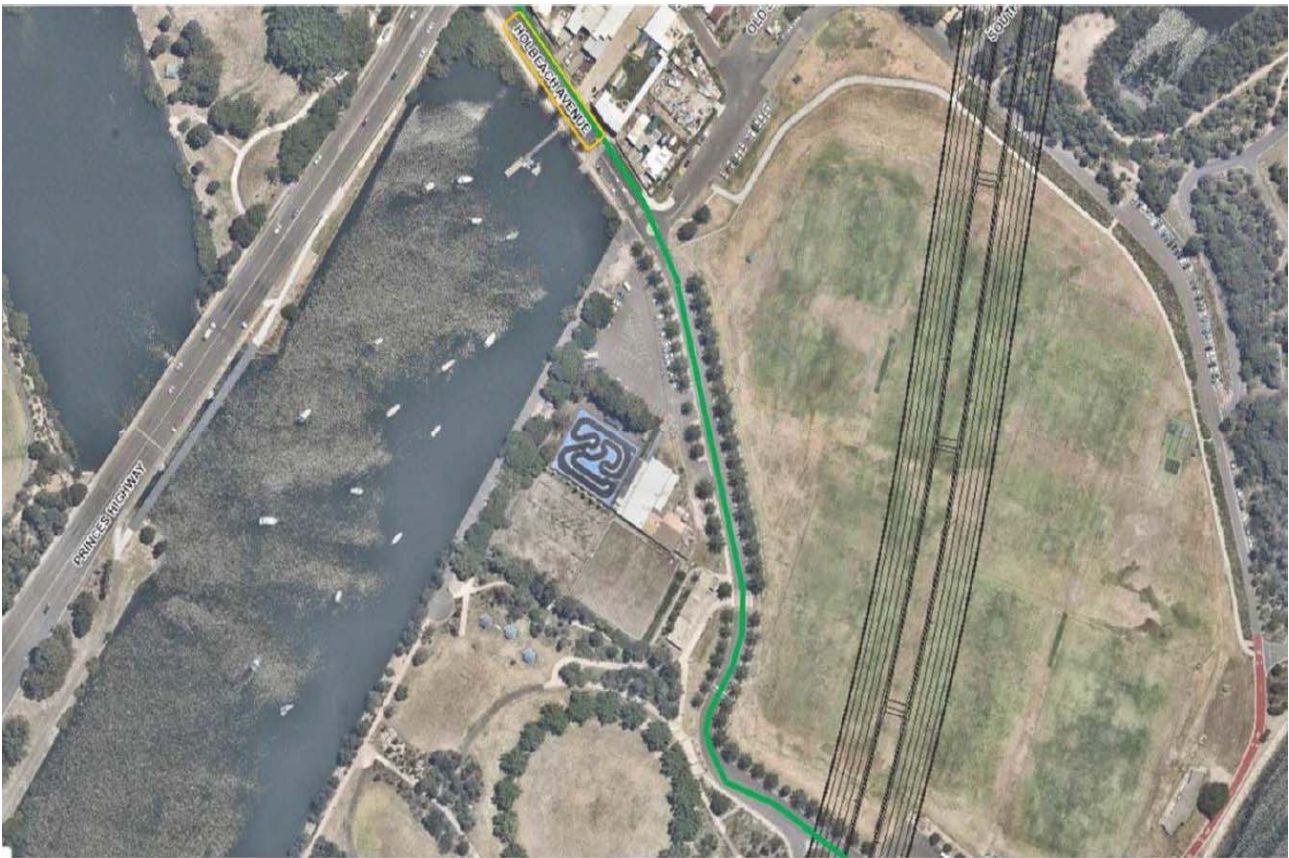
Figure 1.3: Surveyed road section-Inner West Council (Holbeach Avenue, Private Tempe Reserve Road)

Road Section	IRI Group	Rut depth Group	Texture depth Group	Cracking Group
Holbeach Av_C_1	Fair	Fair	Fair	Very good
Holbeach Av_P_1	Very Poor	Good	Fair	Very good
Private Tempe Reserve Rd_C_1	Poor	Good	Good	Very good
Private Tempe Reserve Rd_P_1	Poor	Good	Good	Very good
