Arboricultural Impact Assessment

Westconnex New M5
Conduit Installation
200 Bourke Road
MASCOT NSW 2020

CDS reference: M5N-ES-RPT-LRW-0053-00

April 2019

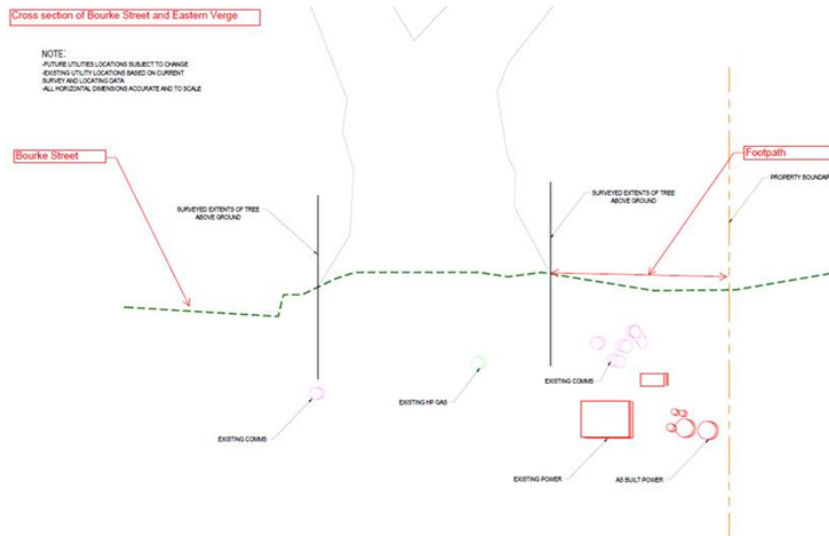
Regarding the paper bark tree in Bourke Street North, CDSJV need to install seven new conduits within the eastern verge of Bourke Street (north of the Equinix SY4 driveway). The data centre Equinix SY4 is the most interconnected data centre in Australia and every asset provider has their lead-in pit within the eastern verge of Bourke Street. Whilst undertaking Non-Destructive Digging (NDD) for service investigation, CDSJV identified numerous existing services and pits within the footpath and root system of the paper bark tree (see image below).
