CONTRACT REPORT

Pre-Construction Road Condition Report for WestConnex M5N

Project No: PSS17131

date June 2017

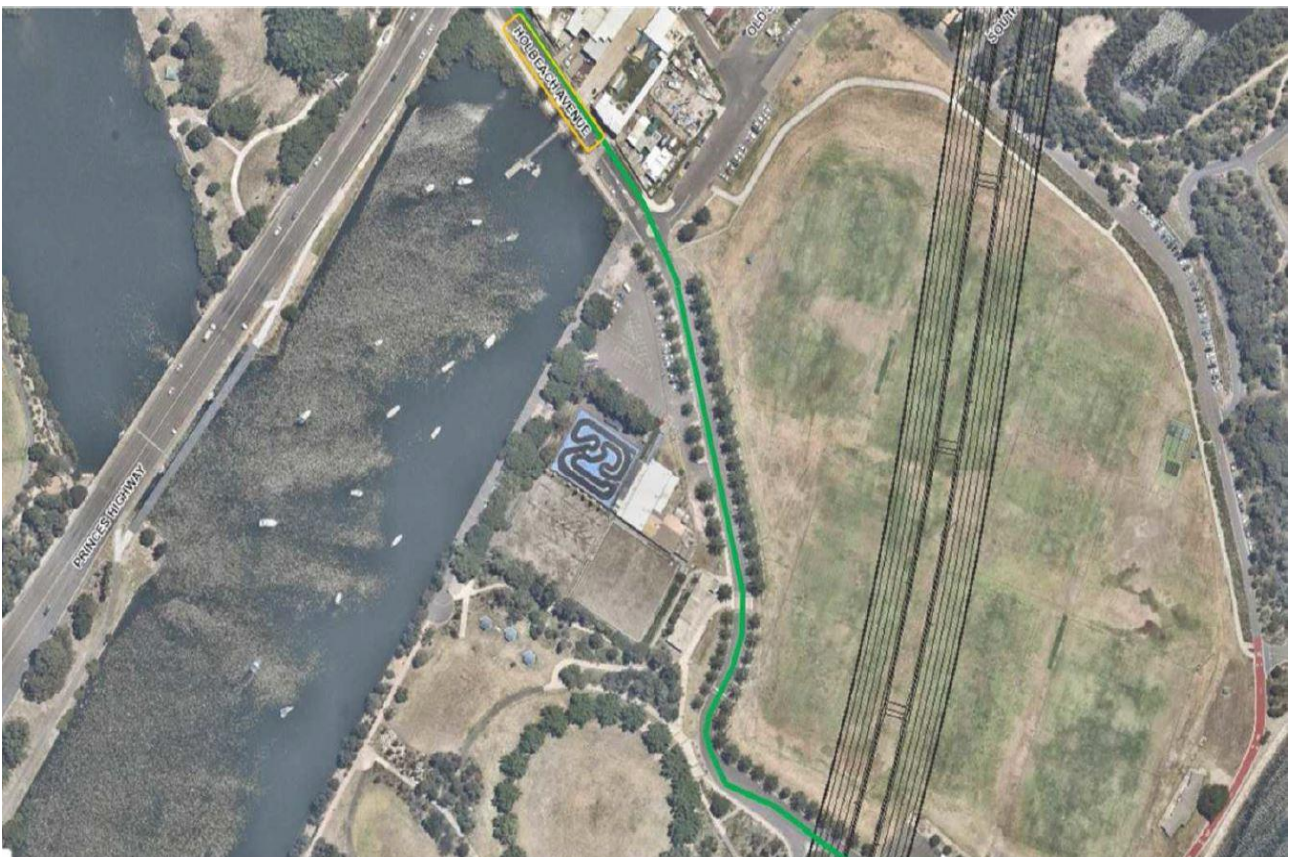
Figure 1.1: Surveyed road section-Inner West Council (Holbeach Avenue, Private Tempe Reserve Road)

Pavement surface condition survey of the selected road sections of Inner West Council's network was undertaken by ARRB in May 2017 to collect surface condition distresses including rut depth, roughness, texture depth and cracking. The surveyed sections have been presented in Figure 1.1
