ARBORICULTURAL REPORT

WestConnex Stage 2 33kV supply 71A Bourke Rd Alexandria

> WestConnex New M5 Prepared for CDS-JV Date 13th October 2017

CDS-JV Document Number: M5N-ES-RPT-MNE-0001_01

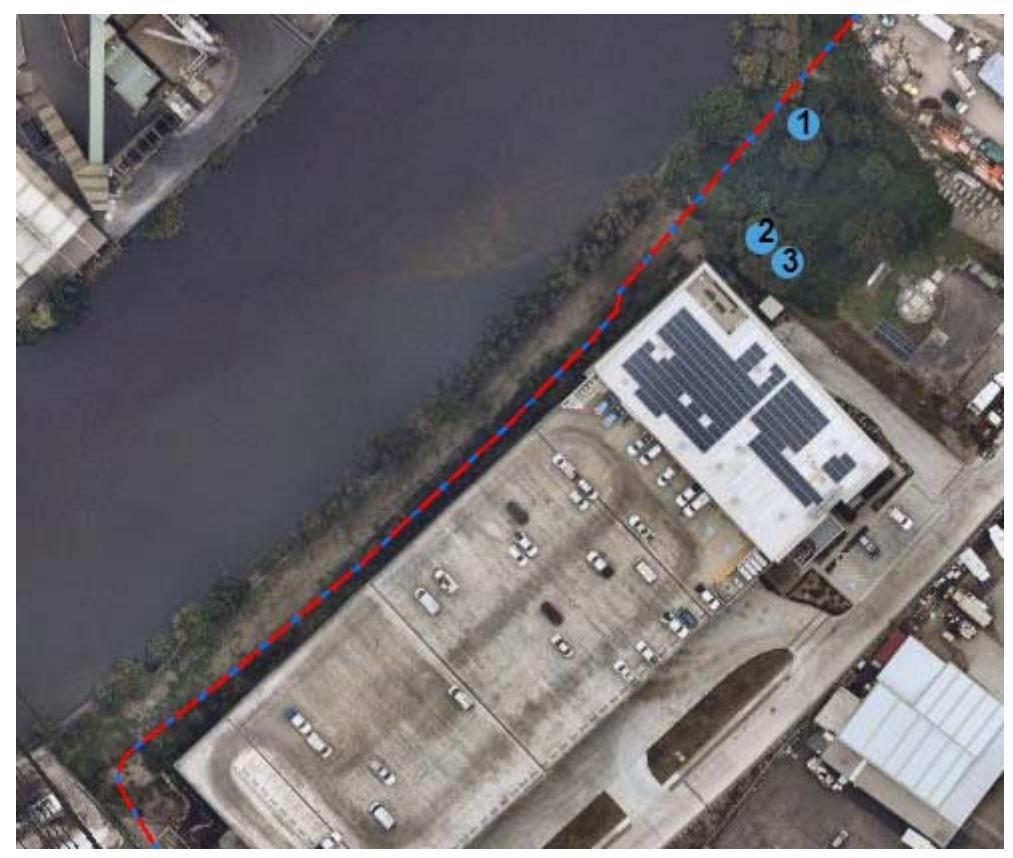
Figure 3 – Trees influenced by construction work — 33 kV Bourke Road

The alignment where the 33kV line is to be installed by trenching is outside any of the *Casuarina glauca* Tree protection Zone the open trenching will not affect any trees or the heritage channel.

No.	Botanical name	Retention value	Tree Location	Encroachment into TPZ		Cause of encroachment	Proposed outcome	Reason for proposed outcome	
1	Acacia <i>longifolia</i>	Low	Outside footprint	Major	60%	Construction	Remove	Major encroachment by construction. Tree is in poor health and at the end of its useful life.	
2	Acacia <i>longifolia</i>	Low	Outside footprint	None	-	-	Retain	Outside work impact area	
3	Acacia longifolia	Low	Outside footprint	None	-	-	Retain	Outside work impact area	
4	Casuarina glauca	Medium	Outside footprint	None	-	-	Retain	Outside work impact area. As trees mature they will continue to damage the heritage listed canal embankment.	
5	Casuarina glauca	Medium	Outside footprint	None	-	-	Retain	Outside work impact area. As trees mature they will continue to damage the heritage listed canal embankment.

Tree protection zone fencing is to be installed along the drip line of the *Casuarina glauca* in accordance with AS 4970-2009: *Protection of Trees on Development Sites.*

- Remove all vegetation in Part 1 2.5m either side of the cable alignment, which consists of: weeds and **1** over-mature Acacia tree.
- Property owner, Sydney Water, is to provide approval prior to any weed and tree clearing.
- At the completion of the works replant with 3 trees that will have a mature canopy that will replace the lost canopy from the Acacia trees. In addition to the trees some understory planting will also help with native birds and restore the area back to a native garden area. Replanting shall be done in consultation with Sydney Water.
