Pre-Construction Road Condition Report for WestConnex M5N

Project No: PSS17265

for WestConnex M5N

date July 2017

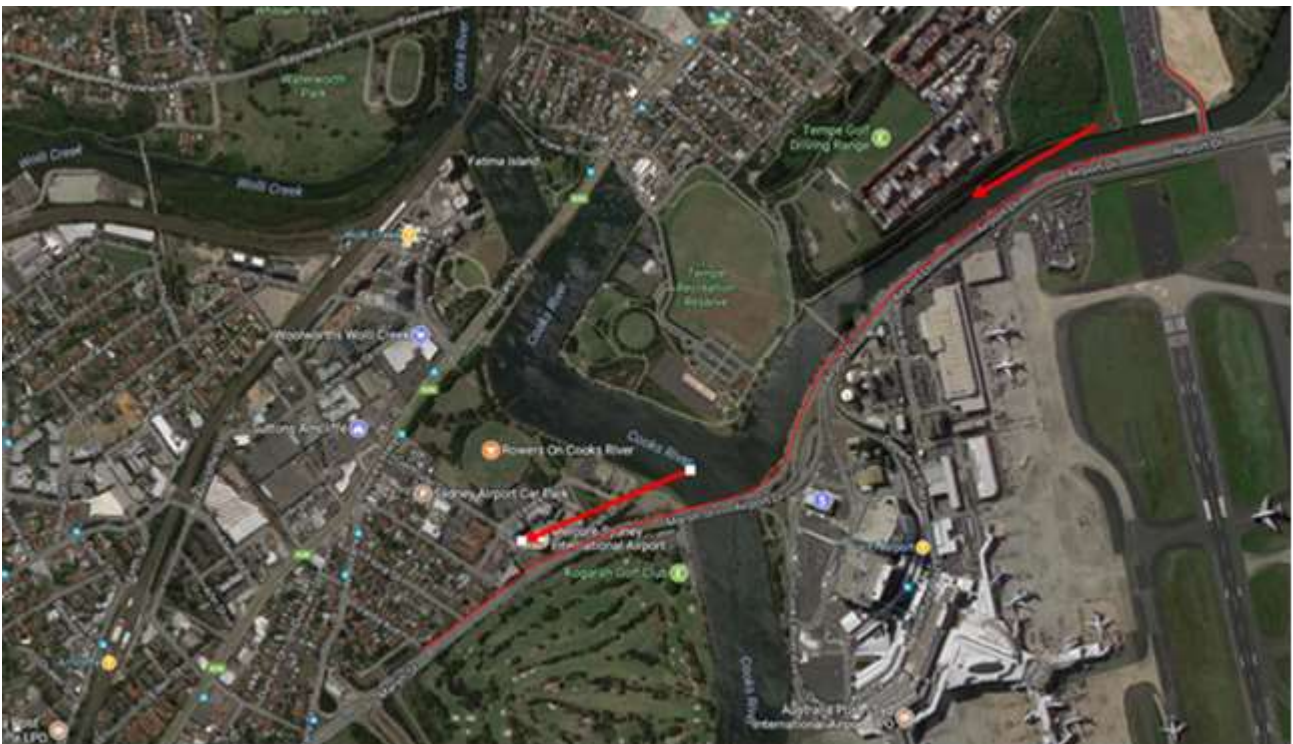
Figure 1.1: Surveyed road section Bayside Council (Airport Drive, Car Park Entry Road)

Pavement surface condition survey of the selected road sections of Bayside Council's network was undertaken by ARRB in July 2017 to collect surface condition distresses including rut depth, roughness, texture depth and cracking. The surveyed sections have been presented in Figure 1.1.
