## **ARBORICULTURAL REPORT**

WestConnex New M5 Prepared for CDS-JV Initial Report Date 14<sup>th</sup> March 2018

VMS Signage Installation at Tempe and St Peters

CDS-JV Document Number: M5N-ES-RPT-LRW-0032 Rev 4. Date 3 May 2018

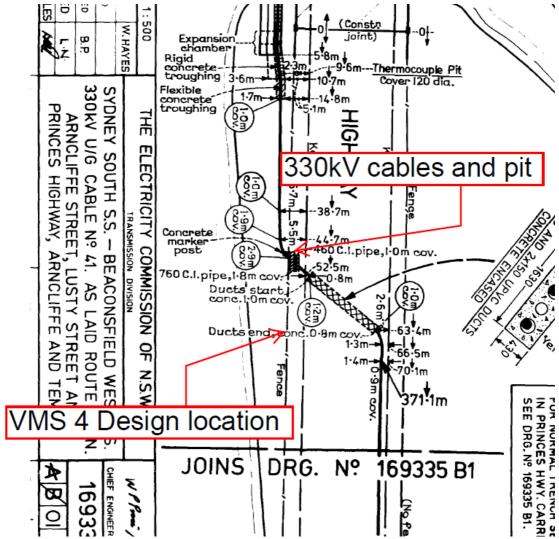
Figure 1. VMS 4 Location and surrounding transmission power.

The area to the north of the proposed location, where there is a gap is trees, is sterilised by a TransGrid 330kV electricity transmission cables (see Figure 1.) and telecommunications lines. Whilst it may be feasible to relocate the telecommunication lines, similar to the overhead power that will be relocated, it is not feasible to relocate the transmission power cables without significant impact to Sydney's power supply, traffic on Princess Hwy and increased tree removal. For these reasons the location identified in Map 2 has been assessed as the lowest impact location.

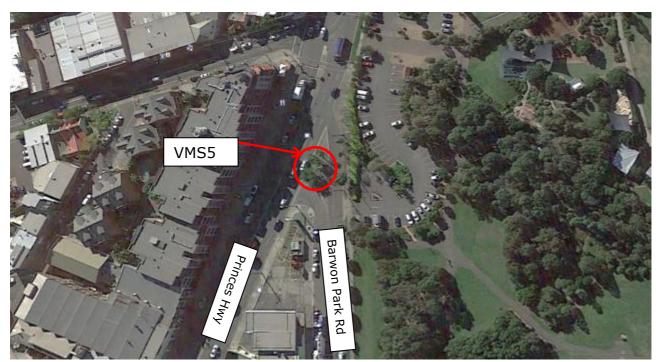
Map 4. Googlearth map of site VMS5 - Princes Highway, St Peters.

The three (3) Fig trees that are required to be removed will be in the way of the sign, supporting infrastructure and the drilling rig to install the sign. Trees are in fair to poor condition due to the site constraints at the location of the trees.

- Remove three (3) Ficus trees TN#16, TN#17 and TN#18
- Additional Ficus tree in photo 7 may need to have underground services located close to the tree, TN#20. This can be installed with vacuum truck with the supervision of a Consulting Arborist.
- If required undertake lateral branch pruning works.
- Replacement planting of the Ficus to be undertaken at alternative site.
