## Site Audit Statement

Site audit statement no. 2023/SY036

Title: WestConnex Stage 3B Rozelle, Pigtail Bridge – Site Audit Report – 2023/ SY036, City West Link. SY180068.01, 1 December 2023.

Title: WSP 2023b, 'WestConnex Stage 3B – Rozelle Interchange – Sub Site Area – Pigtail Bridge – Long Term Environmental Management Plan'(Ref: PS117368-CLM-REP-Pigtail EMP RevC

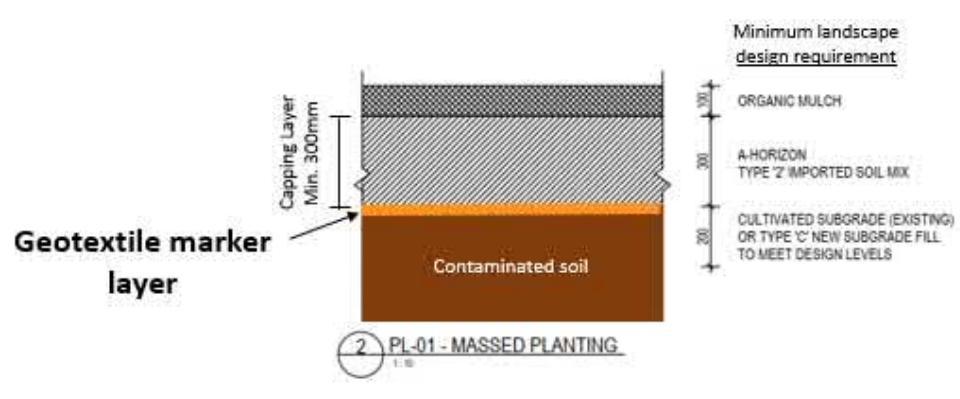
Figure 5.1 Soil cap construction (excluding the Northern Batter)

- basal layer of permeable coloured synthetic geotextile material (overlying existing soils); overlain by
- capping layer comprising validated soil and surficial layer (generally minimum 300 mm thickness, refer below) of mulch.

The soil capping layer thickness at the site (excluding the Northern Batter area) is minimum 300 mm, with the exception of two minor areas in the western portion of the site where capping thickness was measured at 266 and 285 mm<sup>3</sup> (refer to Appendix E for surveyed capping thickness).

<sup>&</sup>lt;sup>3</sup> Section 2, 0.000 m offset, capping thickness 266 mm; Section 7, 0.000 m offset, capping thickness 285 mm (refer Appendix E).

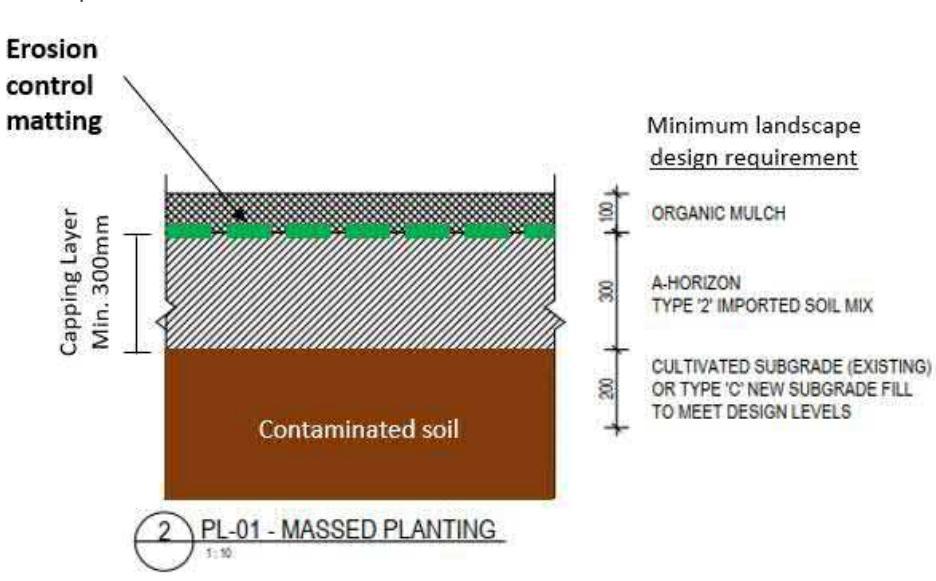
Figure 5.3 Soil cap construction at the Northern Batter

- basal capping layer comprising validated soil (overlying existing soils); overlain by
- erosion matting layer; overlain by
- surficial layer (approximately 100 mm thickness) of mulch.
