WestConnex M4-M5 Link Project

Ambient Air Quality and Weather Monitoring Validated Report

1st May 2022 – 31st May 2022

Report No.: DAT18443 - Revision 1

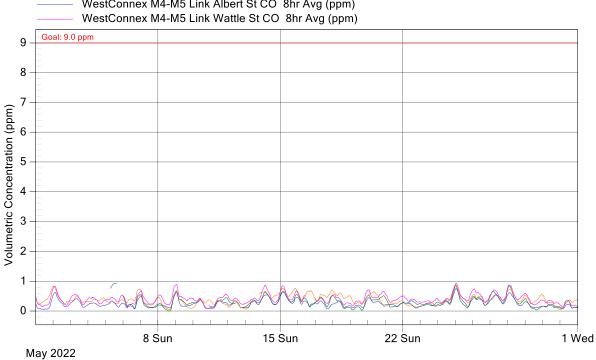
Figure 2: WCX M4-M5 Link Project Air Monitoring Stations - CO 8-Hour Rolling Graph for May 2022

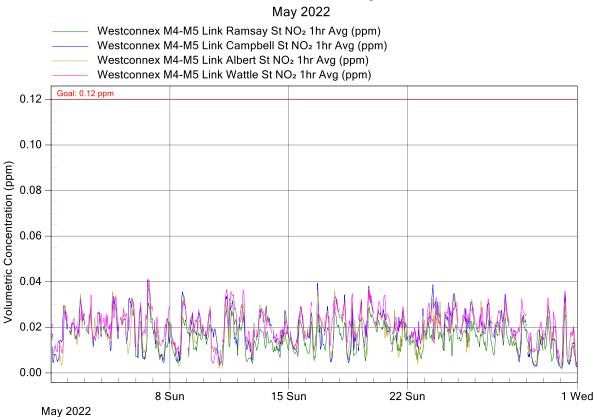
Figure 3: WCX M4-M5 Link Project Air Monitoring Stations - NO₂ 1-Hour Averages Graph for May 2022

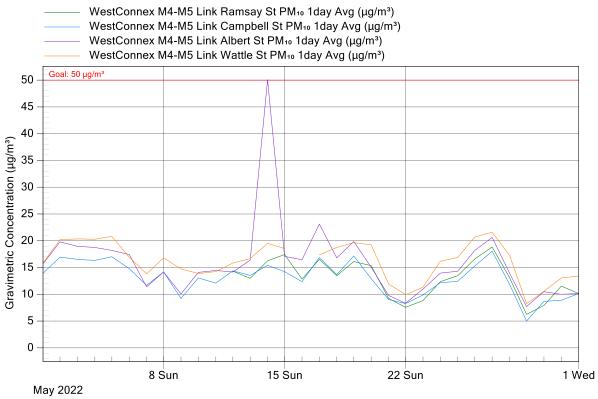
Figure 4: WCX M4-M5 Link Project Air Monitoring Stations - PM₁₀ 24-Hour Averages Graph for May 2022

There was a PM_{10} 24-hourly exceedance of the air quality goals at the WCX Albert Street for the reporting month. Please refer to Tables 14-17 in Section 5.2 – Air Quality Monthly Summary for further information.

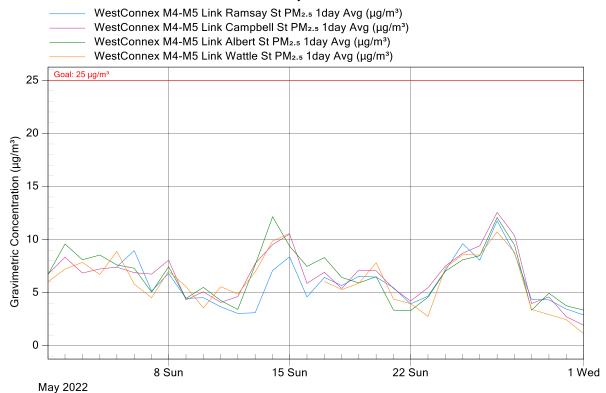
Figure 5: WCX M4-M5 Link Project Air Monitoring Stations - PM_{2.5} 24-Hour Averages Graph for May 2022

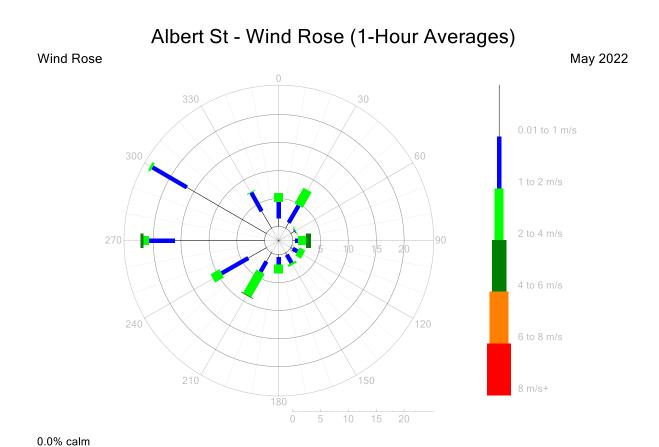
95.7% valid data present

Figure 6: WCX Albert Street – Wind Rose for May 2022

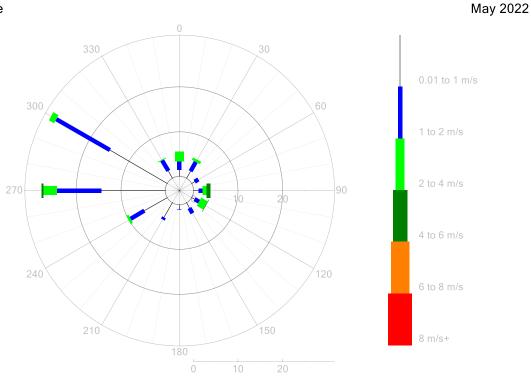
0.0% calm 99.5% valid data present

Figure 7: WCX Campbell Street – Wind Rose for May 2022

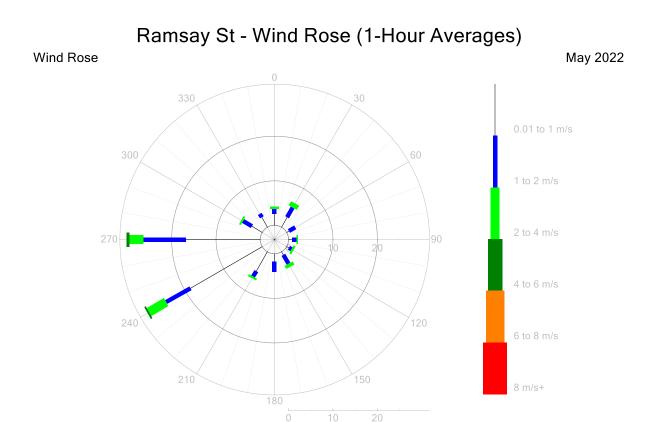
Figure 8: WCX Ramsay Street – Wind Rose for May 2022

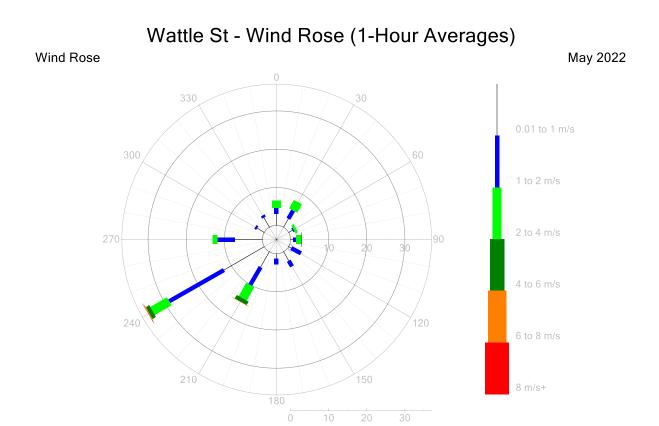
Figure 9: WCX Wattle Street – Wind Rose for May 2022
