TfNSW - Rozelle Interchange WestConnex 3B Project

Ambient Air Quality and Weather Monitoring Validated Report

1st September 2023 – 30th September 2023

Report No.: DAT20404

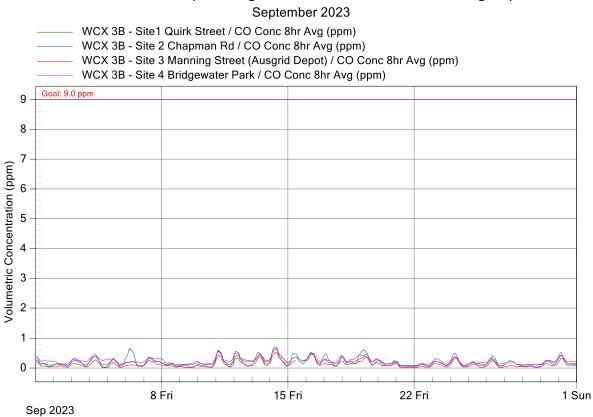
CO 8-Hour (Rolling, based on 1-Hour Averages)

Figure 2: WCX 3B Project Air Monitoring Stations - CO 8-Hour Rolling Graph for September 2023

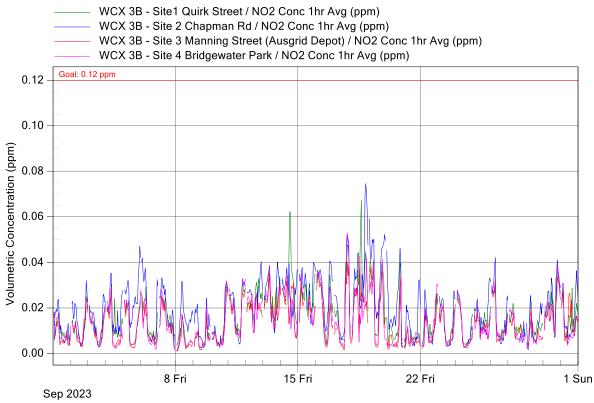
NO₂ 1-Hour Averages

Figure 3: WCX 3B Project Air Monitoring Stations - NO₂ 1-Hour Averages Graph for September 2023

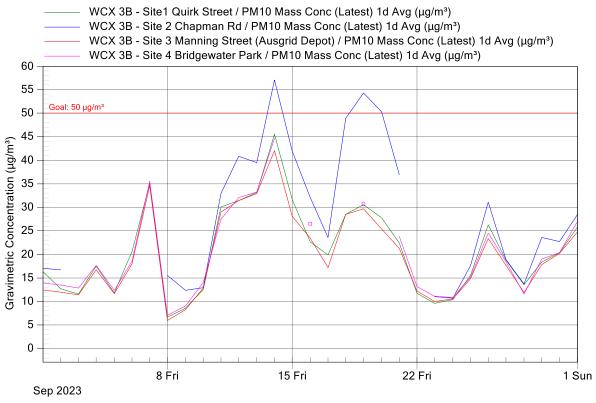
PM₁₀ 24-Hour Averages

Figure 4: WCX 3B Project Air Monitoring Stations - PM₁₀ 24-Hour Averages Graph for September 2023

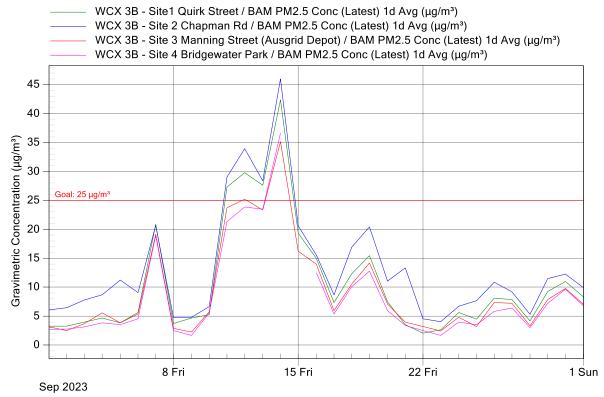
PM_{2.5} 24-Hour Averages

Figure 5: WCX 3B Project Air Monitoring Stations - PM_{2.5} 24-Hour Averages Graph for September 2023

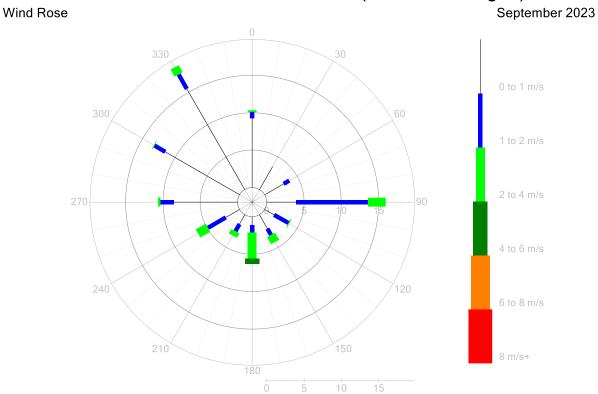
Site 1 Quirk Street - Wind Rose (1-Hour Averages)

99.6% valid data present

Figure 6: WCX Quirk Street - Wind Rose of September 2023

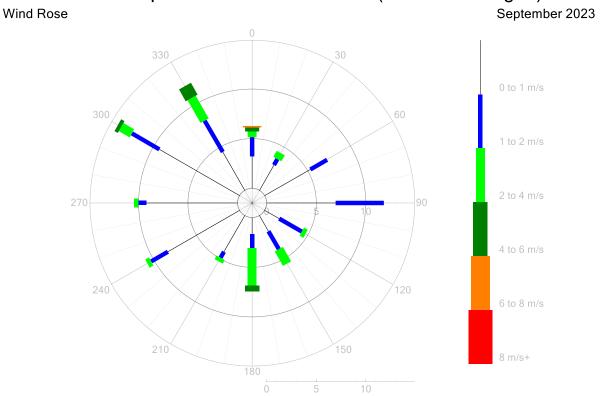
Site 2 Chapman Road - Wind Rose (1-Hour Averages)

99.9% valid data present

Figure 7:WCX Chapman Road - Wind Rose of September 2023

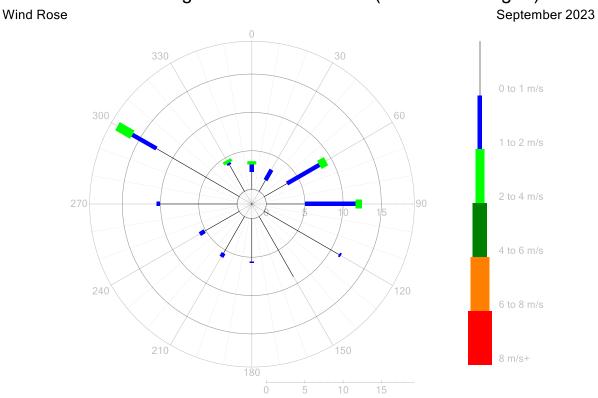
Site 3 Manning Street - Wind Rose (1-Hour Averages)

99.3% valid data present

Figure 8:WCX Manning Street - Wind Rose of September 2023

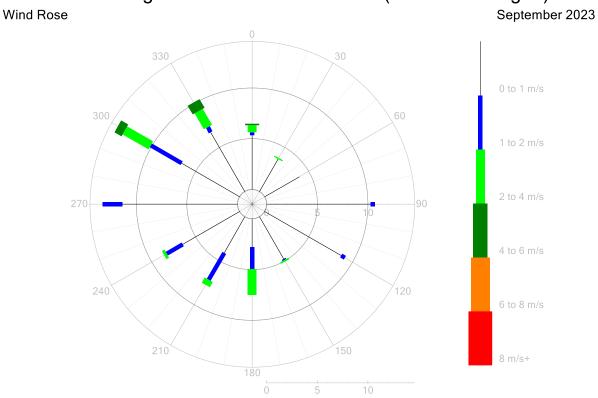
Site 4 Bridgewater Park - Wind Rose (1-Hour Averages)

99.0% valid data present

Figure 9:WCX Bridgewater Park - Wind Rose of September 2023
