WestConnex

M4 East Project

Ambient Air Quality and Weather Monitoring Validated Report

1st November 2018 – 30th November 2018

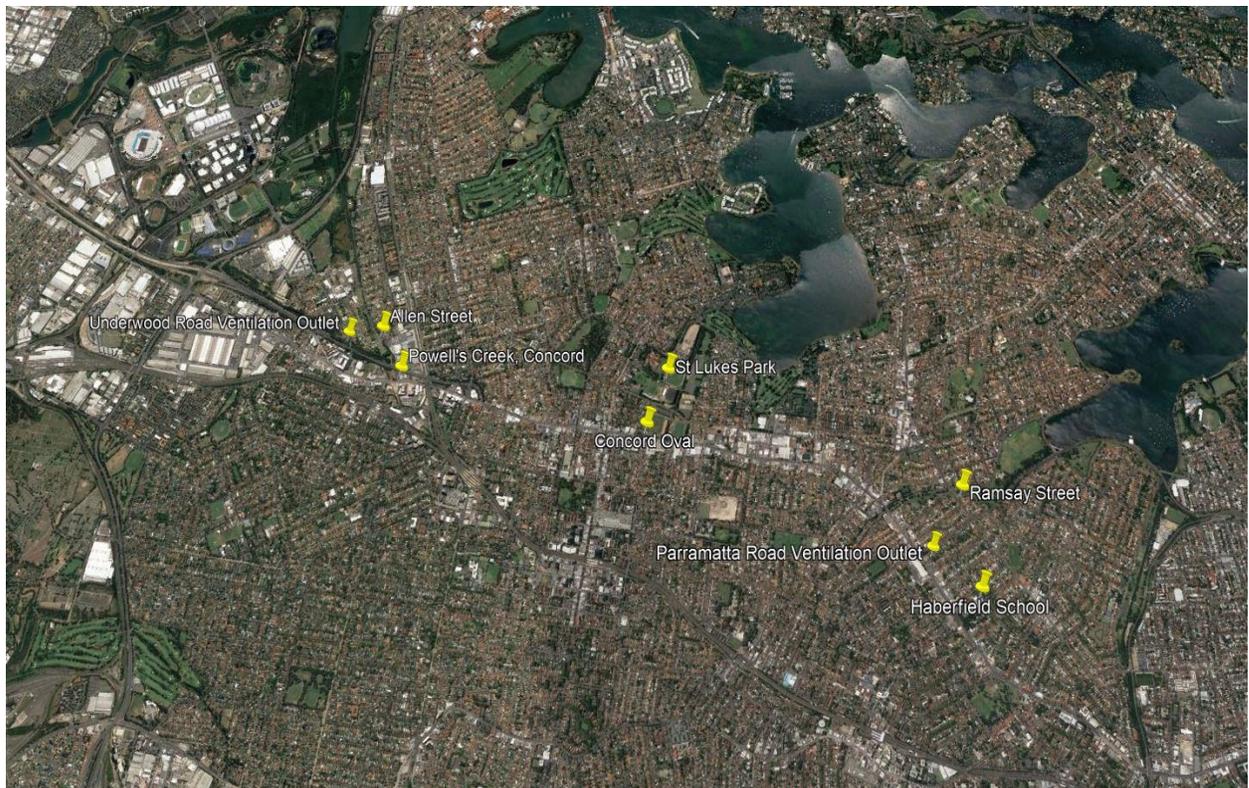
Figure 1: M4 East Project Monitoring Station Locations

The WestConnex M4 East Project monitoring network consists of six ambient air quality and weather monitoring stations. The stations location and siting details are described below.

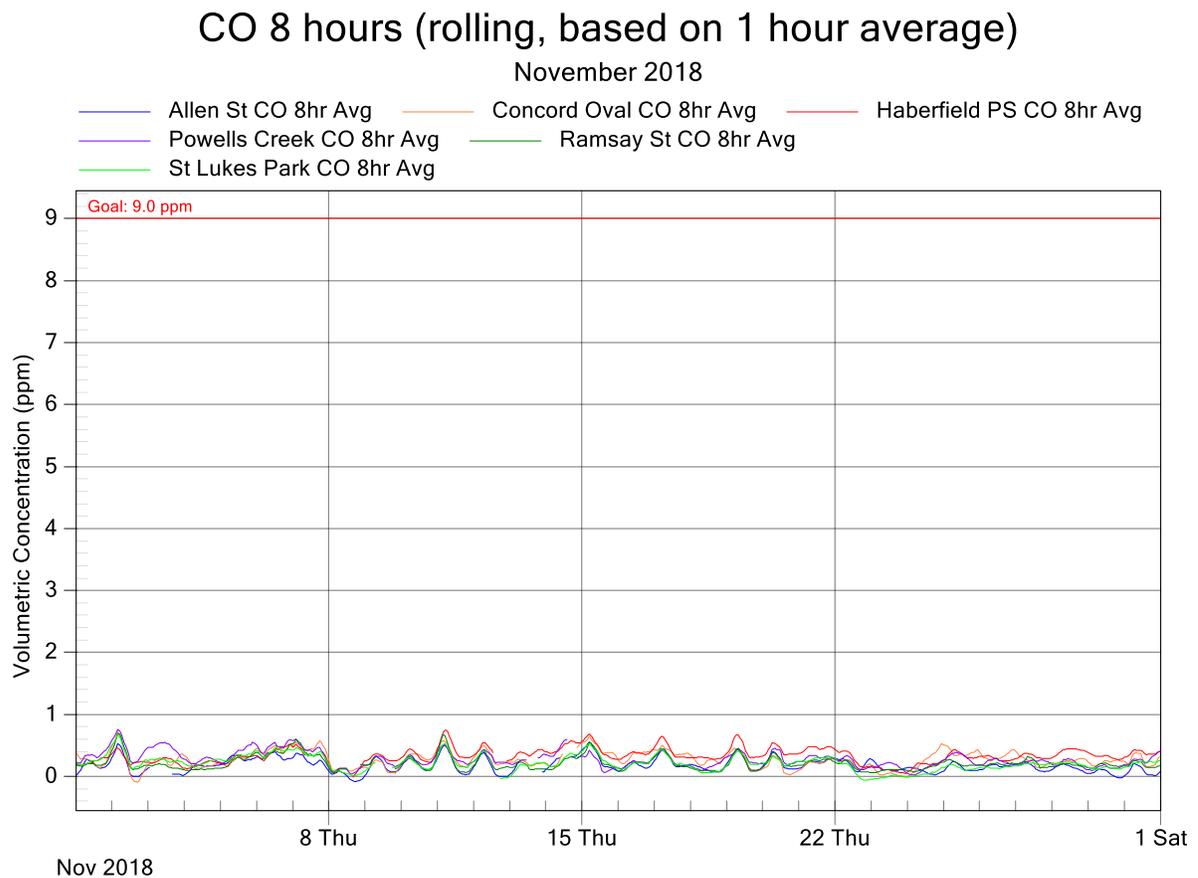
Figure 2: M4 East Project Air Monitoring Stations - CO 8 hours Rolling graph for November 2018

This section displays graphs of the pollutants and meteorological parameters monitored at the M4 East sites for November 2018. The graphs are based on validated 5 minutes or 1-hour data as appropriate.

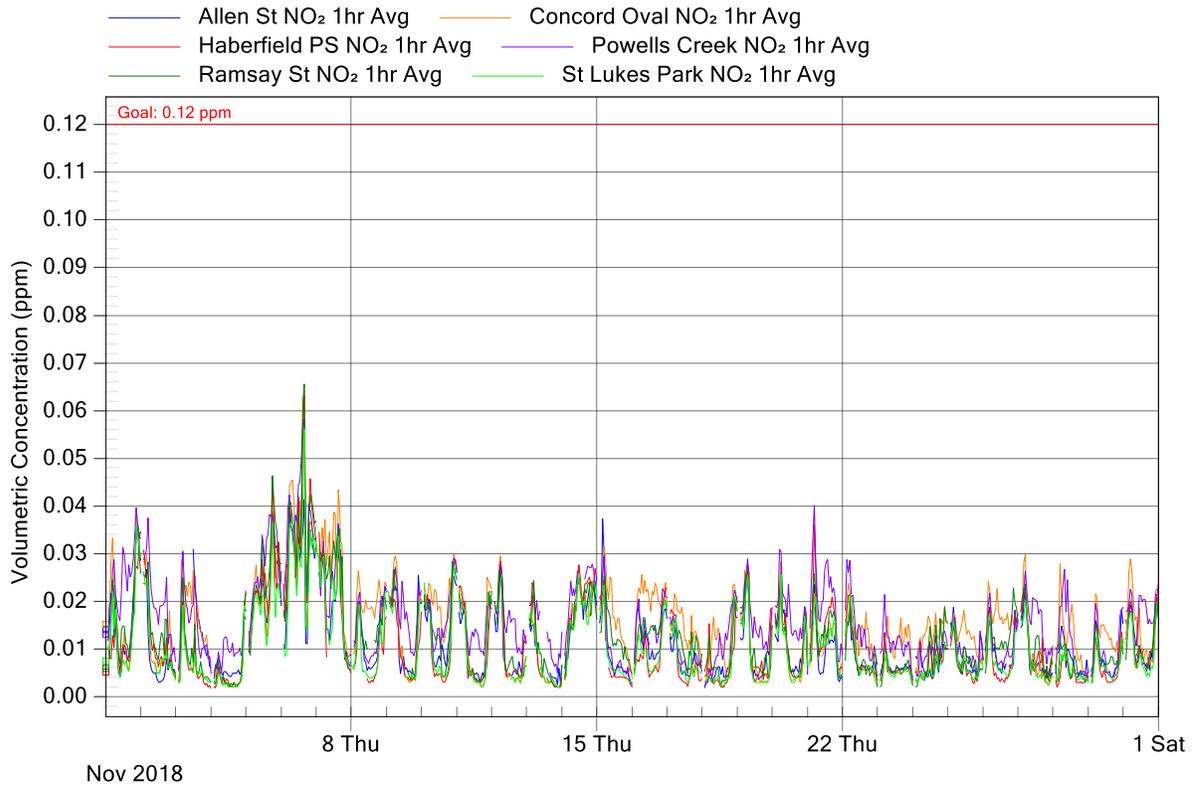
Figure 3: M4 East Project Air Monitoring Stations - NO₂ graph for November 2018

NO₂ 1 hour average

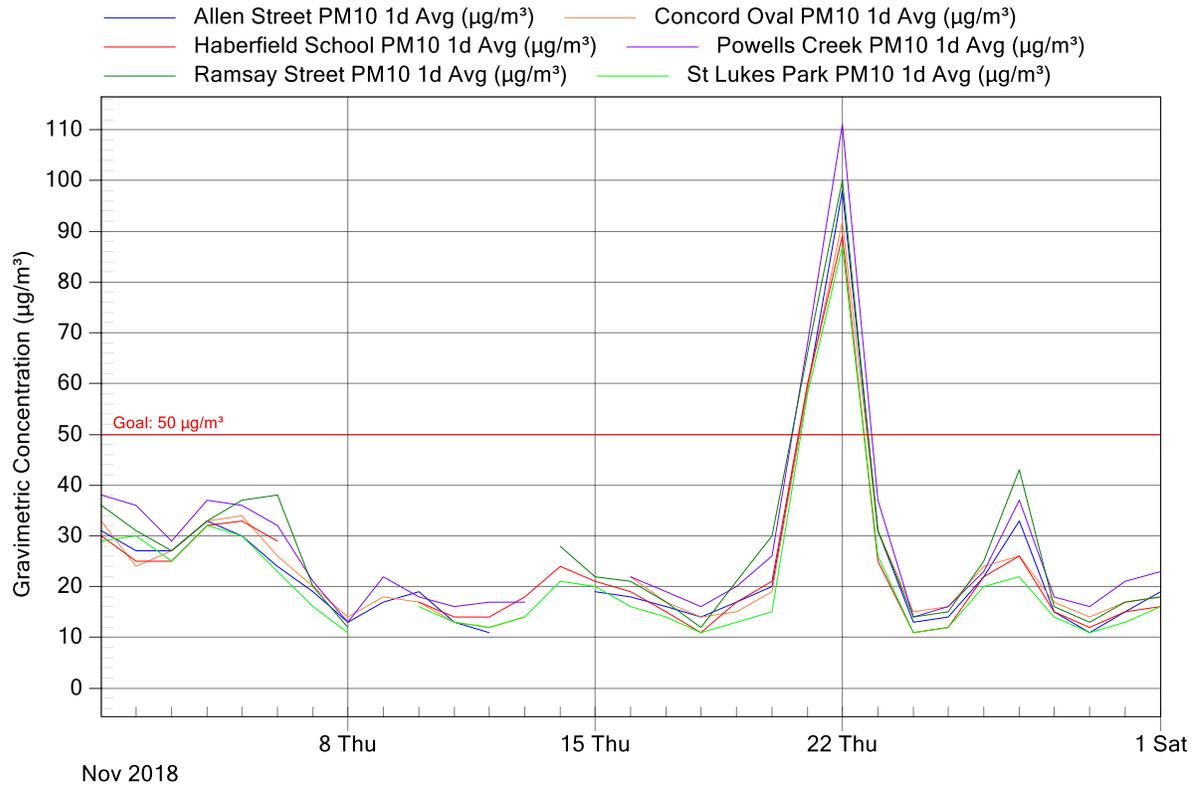
Figure 4: M4 East Project Air Monitoring Stations - PM₁₀ 24 Hour graph for November 2018

PM₁₀ 24 hour average

Monthly Summary for further information. Ecotech have been advised that Sydney had experienced elevated particulate levels due to dust storms which may have had significant impact on reported particulate concentrations during 21st to 22nd November 2018.

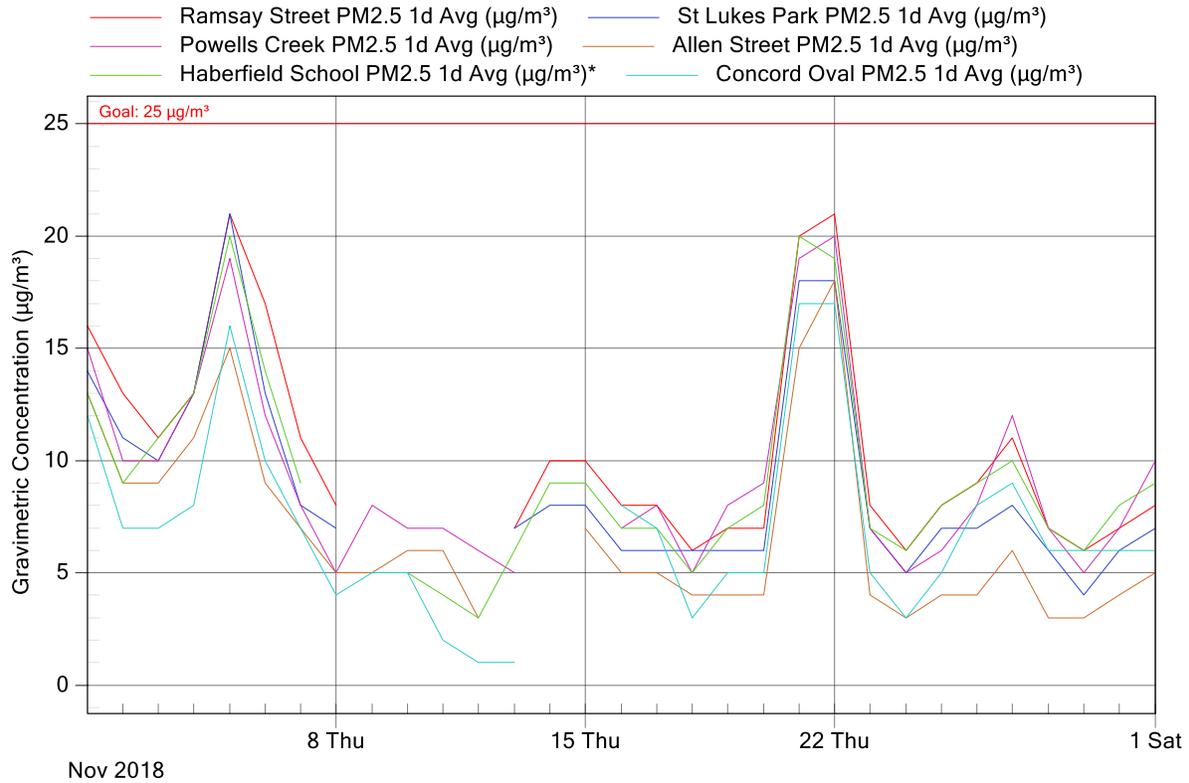
Figure 5: M4 East Project Air Monitoring Stations - PM_{2.5} 24 Hour graph November 2018

*Data for Haberfield School station has been included in this figure for reference purposes only. Refer to Appendix 3 for details.

- Following an investigation into elevated PM_{2.5} readings at Haberfield School station, data shown in figure 5 has had a correction applied based on the internal background setting observed in a visit in March 2019.

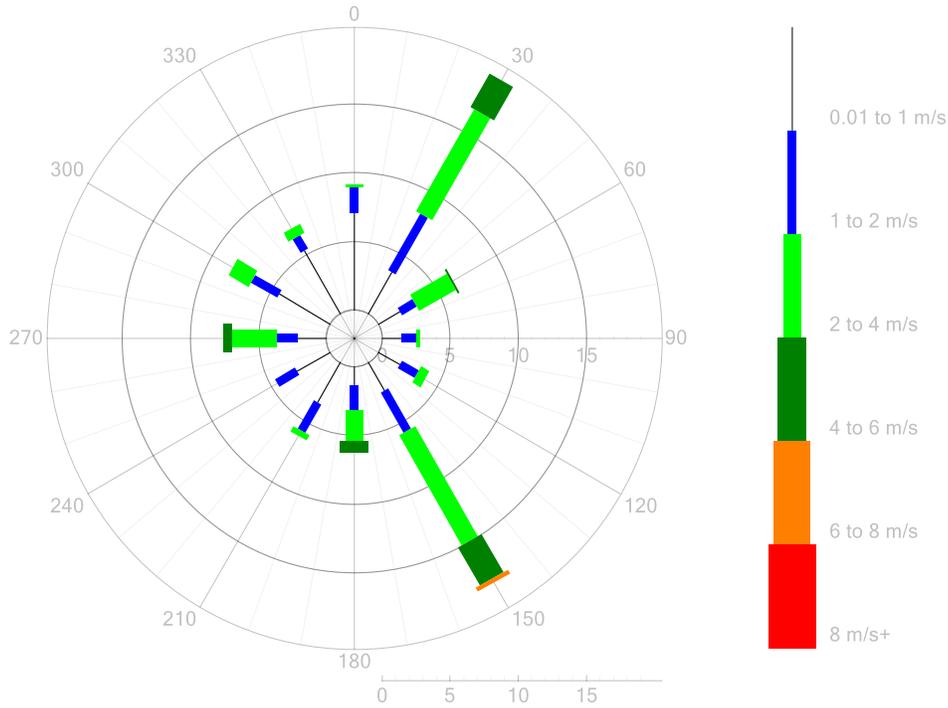
Figure 7: Concord Oval – Wind Rose for November 2018

0.1% calm
99.4% valid data present

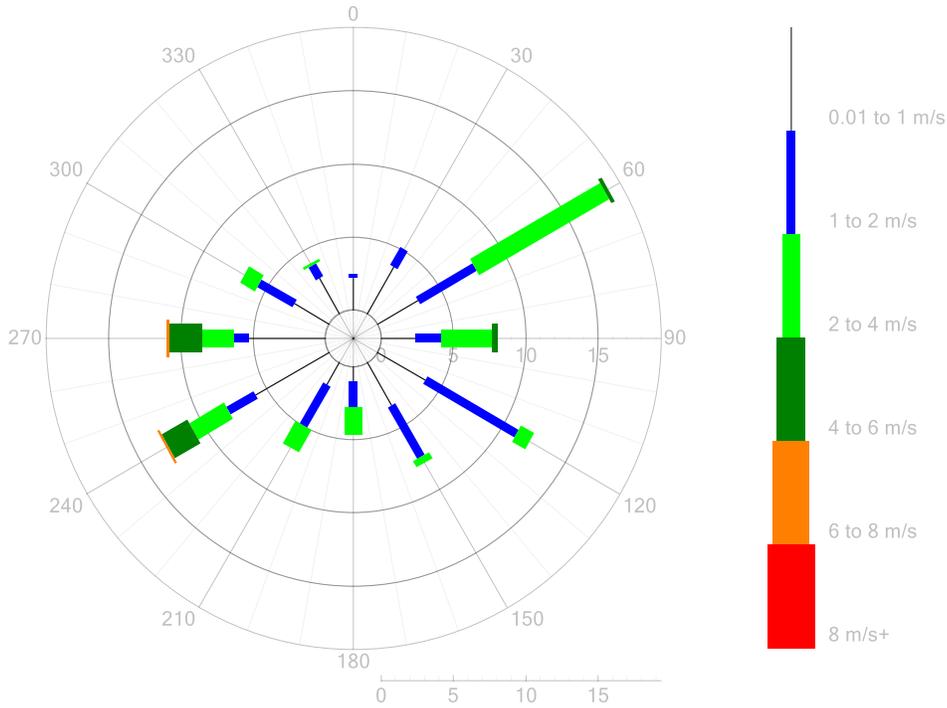
Figure 8: Haberfield Public School – Wind Rose for November 2018

0.0% calm
95.1% valid data present

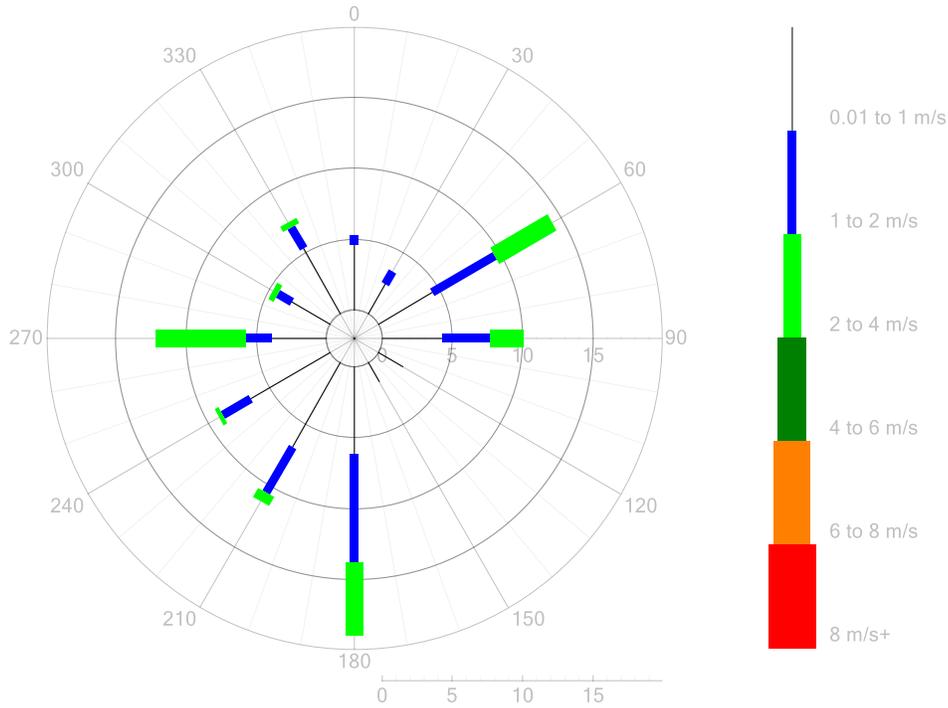
Figure 9: Powells Creek – Wind Rose for November 2018

0.0% calm
97.6% valid data present

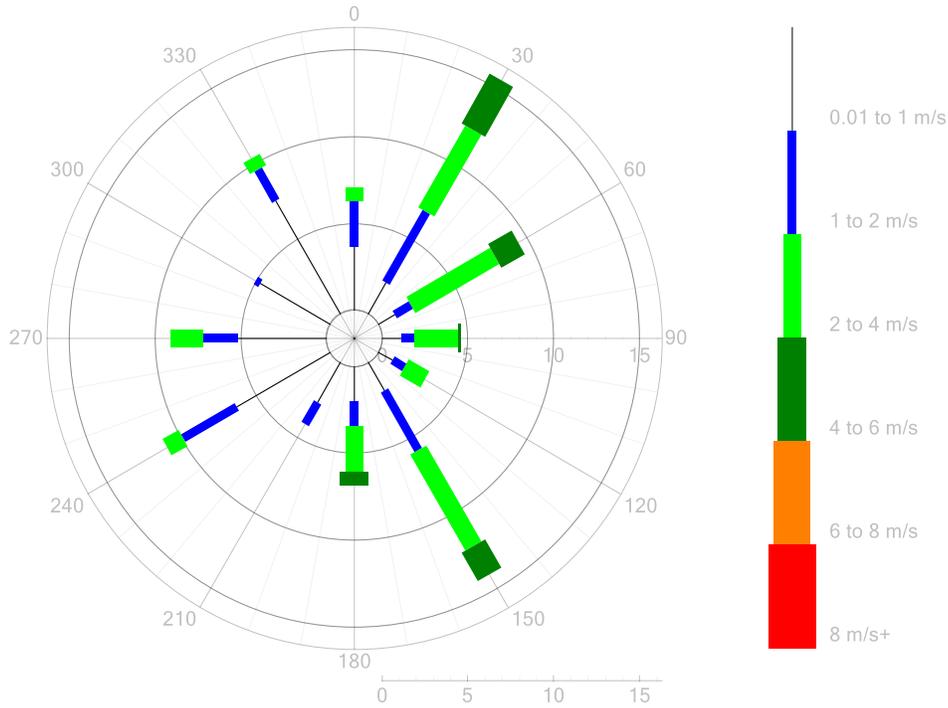
Figure 11: Saint Lukes Park – Wind Rose for November 2018

0.0% calm
88.8% valid data present

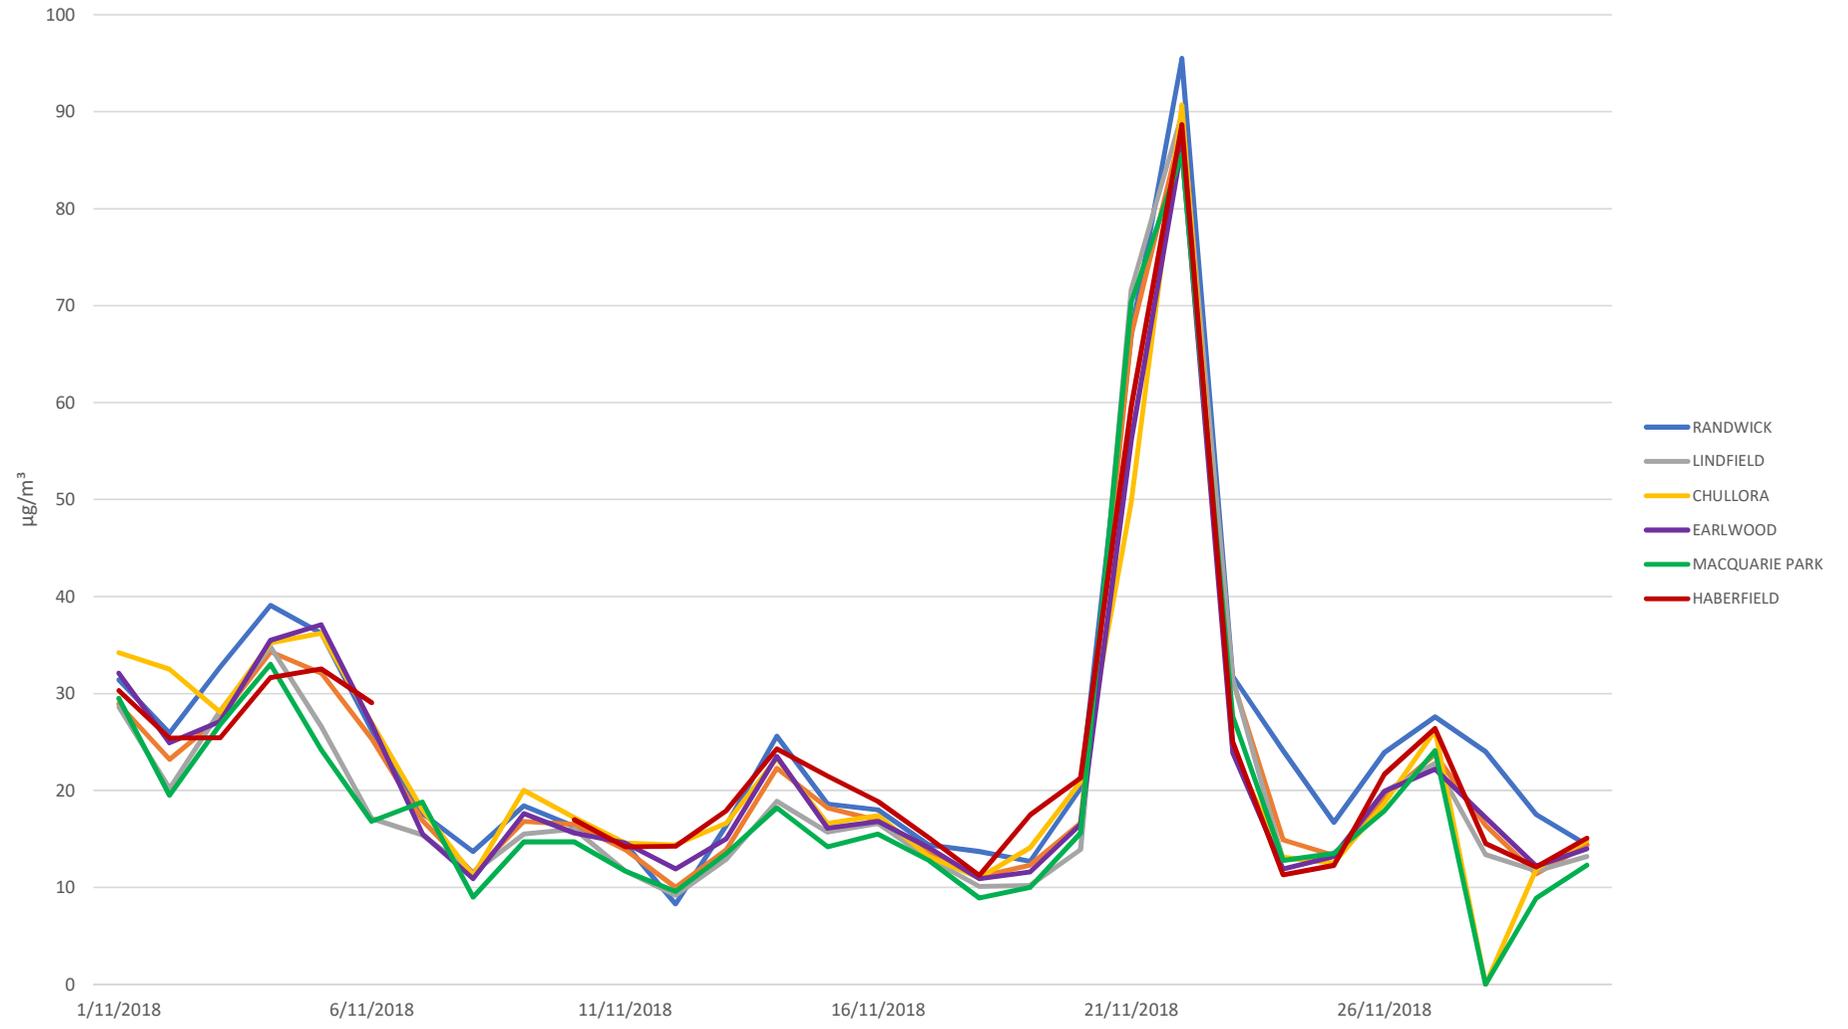
PM10 - November

This data has not been used to compile station statistics.
