WestConnex

M4 East Project

Ambient Air Quality and Weather Monitoring Validated Report

1st February 2019 – 28th February 2019

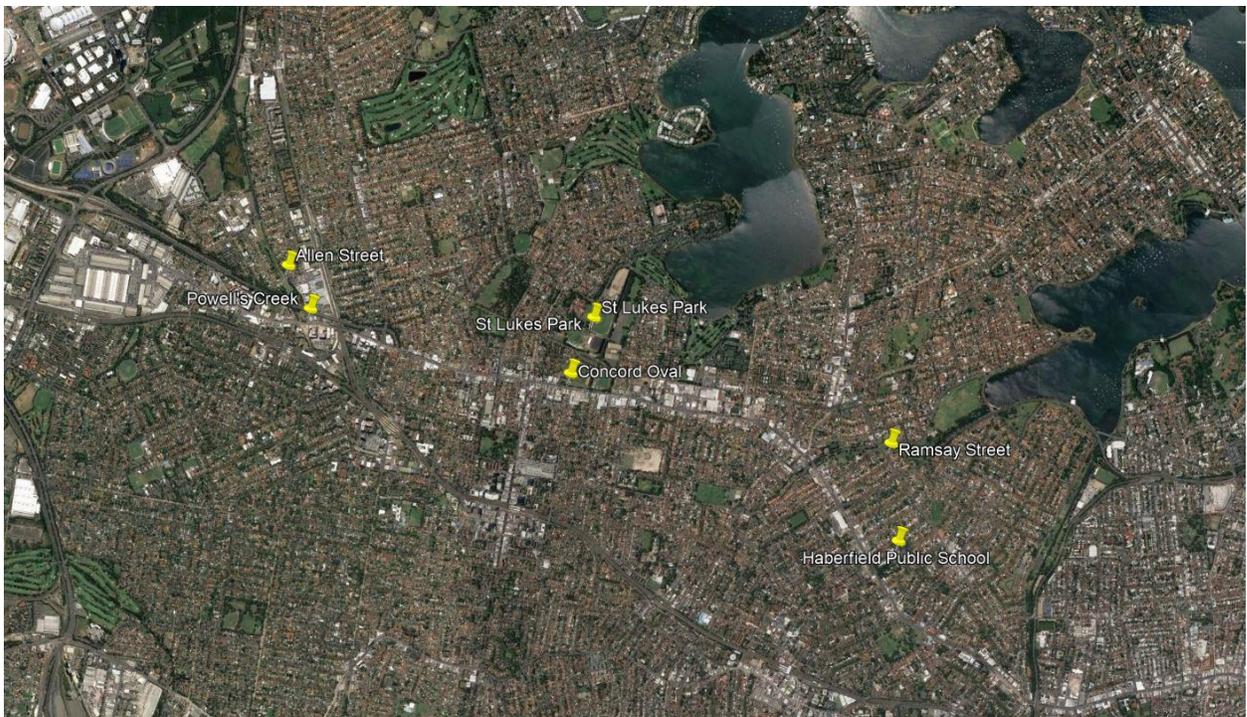
Figure 1: M4 East Project Monitoring Station Locations

The WestConnex M4 East Project monitoring network consists of six ambient air quality and weather monitoring stations. The stations location and siting details are described below.

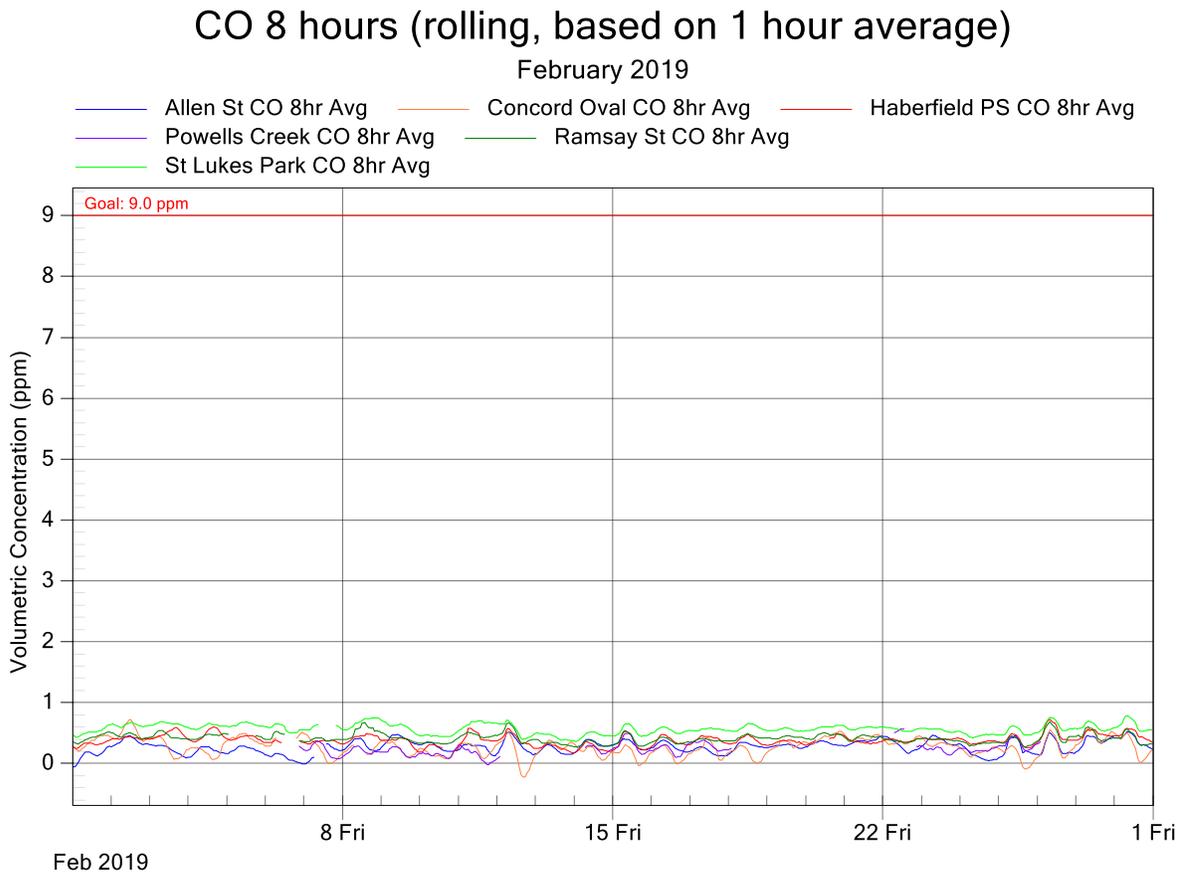
Figure 2: M4 East Project Air Monitoring Stations - CO 8 hours Rolling graph for February 2019

This section displays graphs of the pollutants and meteorological parameters monitored at the M4 East sites for February 2019. The graphs are based on validated 5 minutes or 1-hour data as appropriate.

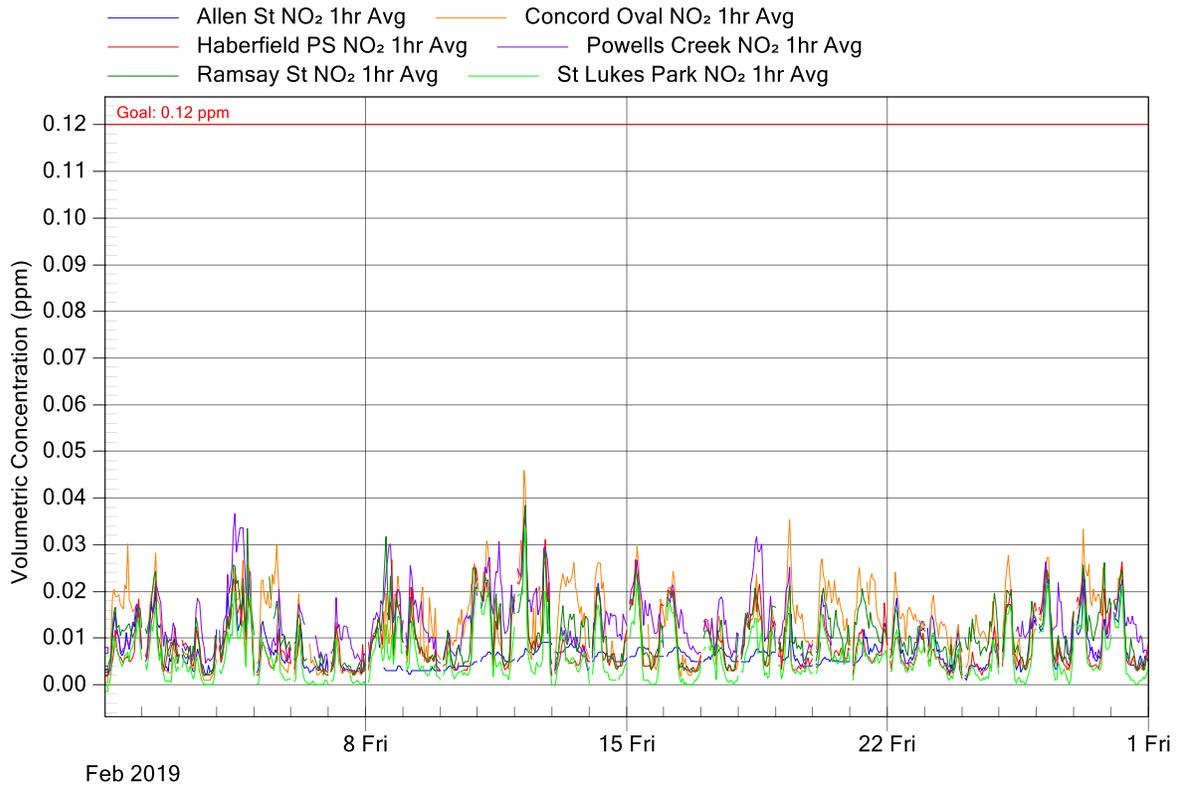
Figure 3: M4 East Project Air Monitoring Stations - NO₂ graph for February 2019

NO₂ 1 hour average

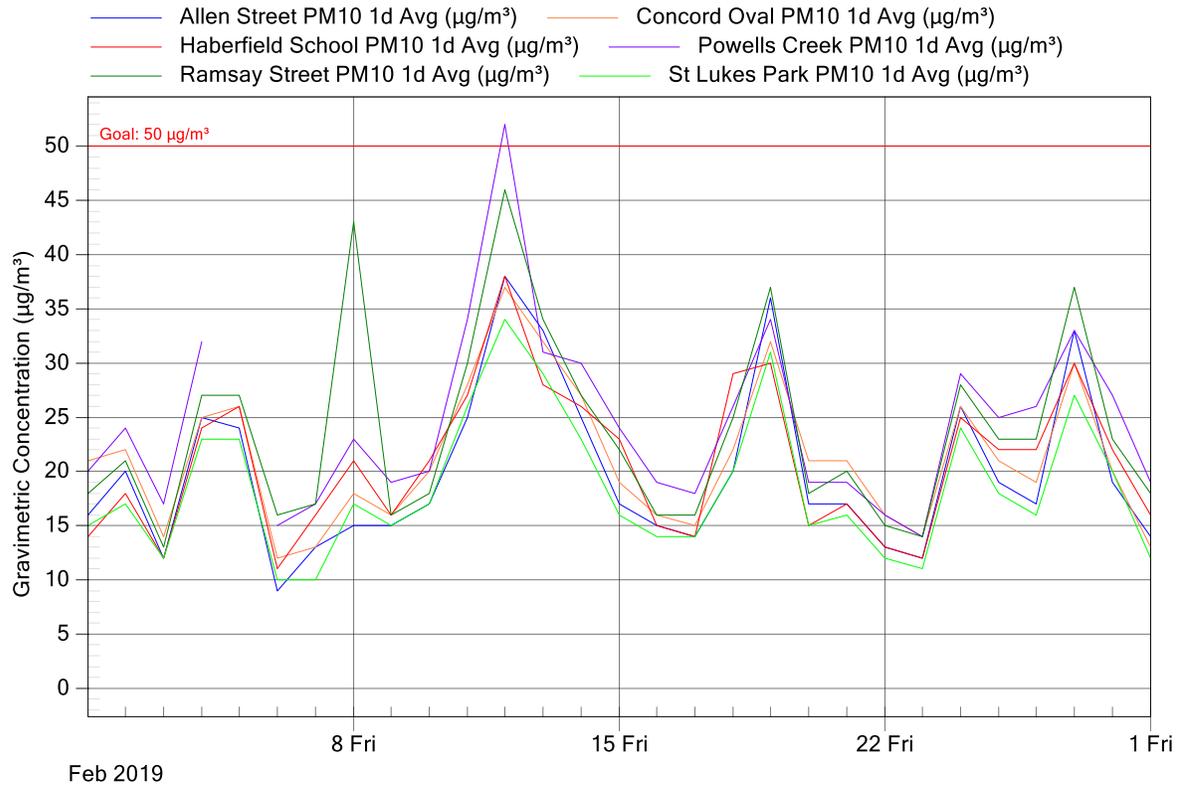
Figure 4: M4 East Project Air Monitoring Stations - PM₁₀ 24 Hour graph for February 2019

PM₁₀ 24 hour average

Parameter	Time Period	Value of Exceedence	Date of Exceedence
NO ₂ (ppm)	1 hour	-	-
CO (ppm)	8-hour rolling	-	-
PM ₁₀ (µg/m ³)	24-hour	52.4	12/02/2019
	Annual	-	-
PM _{2.5} (µg/m ³)	24-hour	-	-
	Annual ¹⁶	-	-

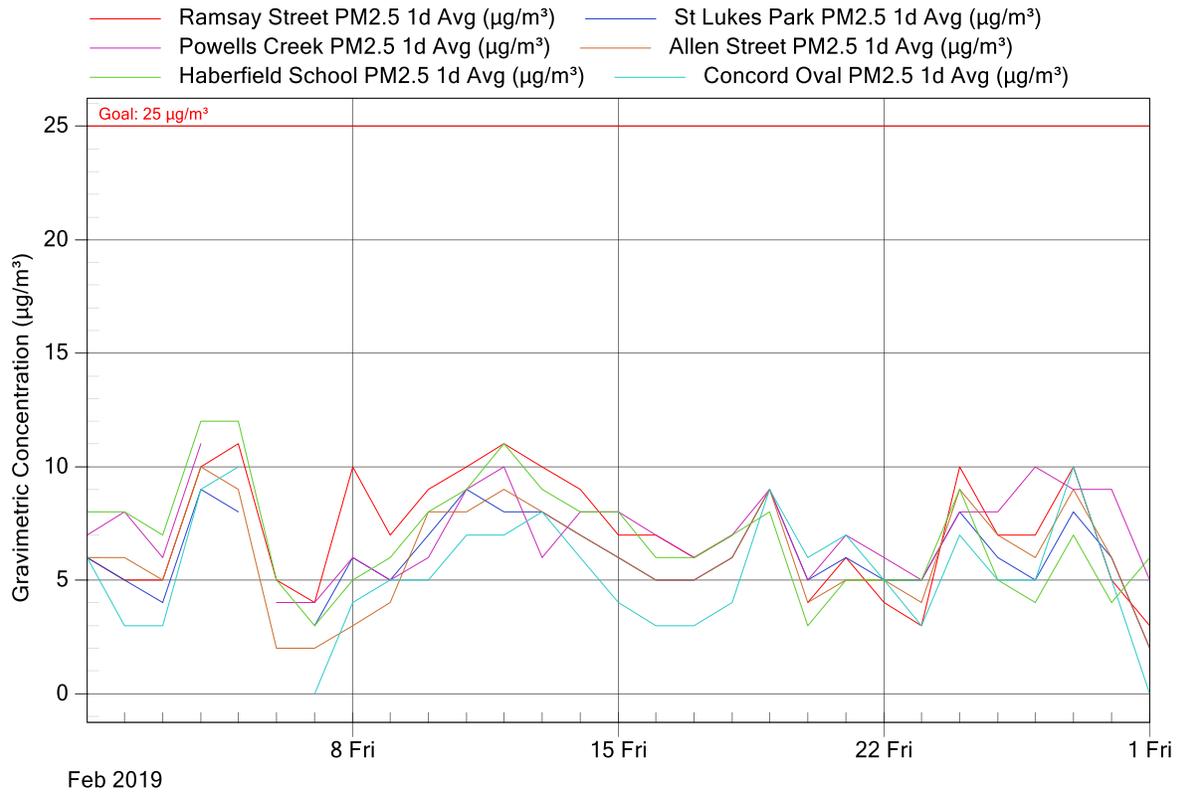
Figure 5: M4 East Project Air Monitoring Stations - PM_{2.5} 24 Hour graph February 2019

PM_{2.5} 24 hour average

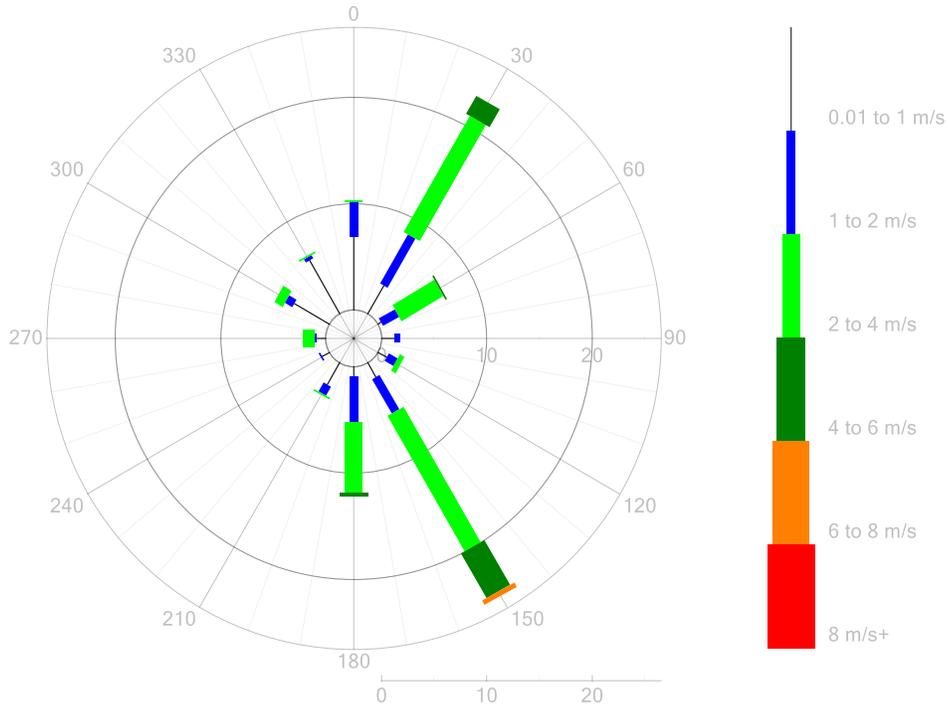
Figure 7: Concord Oval – Wind Rose for February 2019

Concord Oval - Wind Rose (1-hour average)

0.0% calm
93.2% valid data present

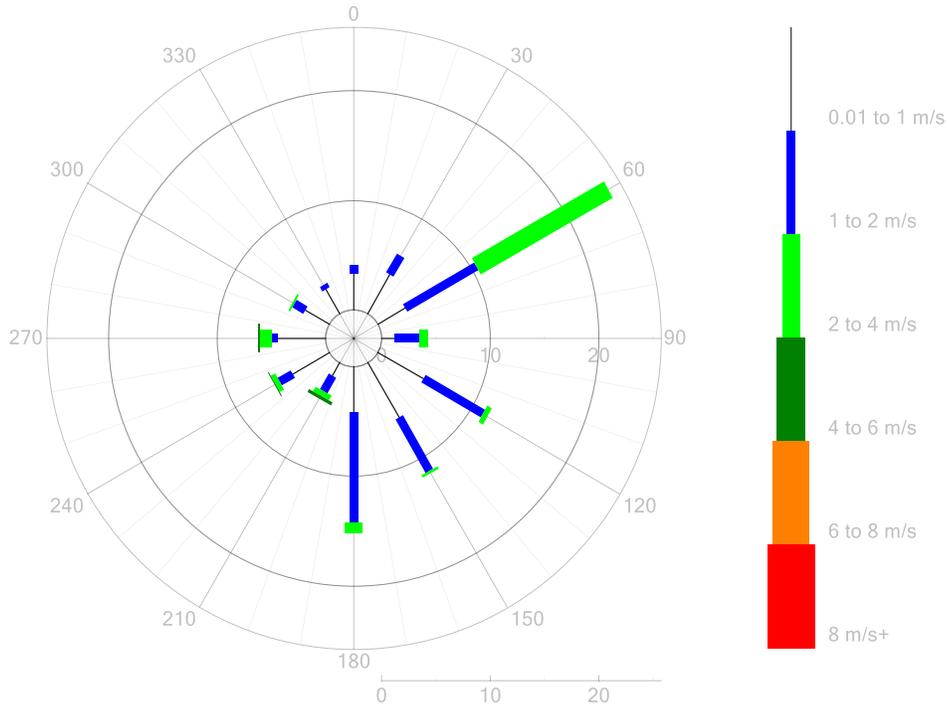
Figure 8: Haberfield Public School – Wind Rose for February 2019

Haberfield Public School - Wind Rose (1-hour average)

0.0% calm
98.5% valid data present

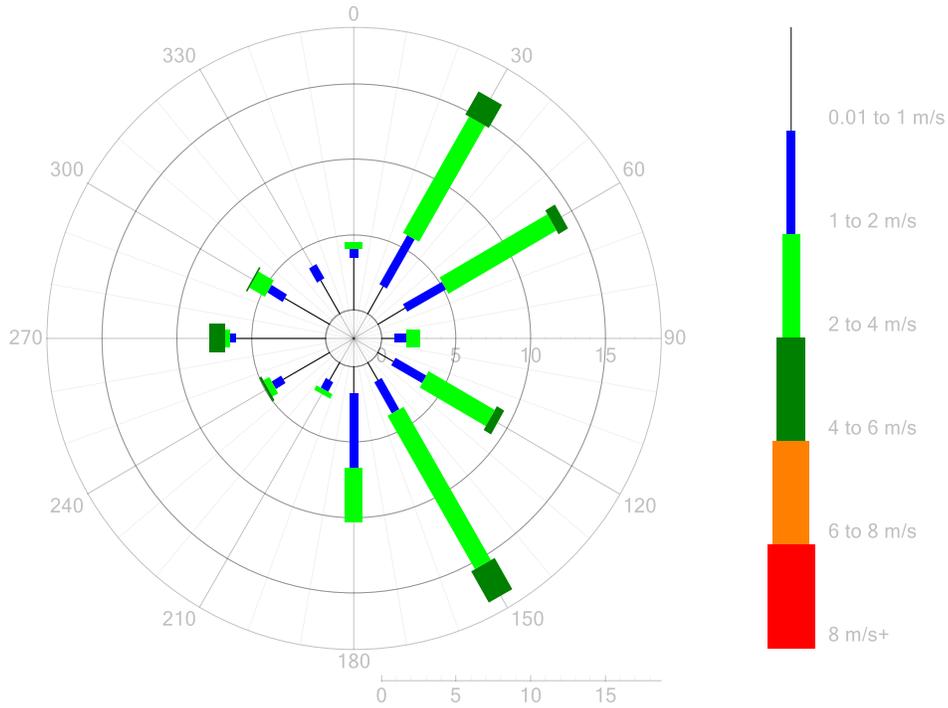
Figure 10: Ramsay Street – Wind Rose for February 2019

Ramsay St - Wind Rose (1-hour average)

0.1% calm
99.4% valid data present

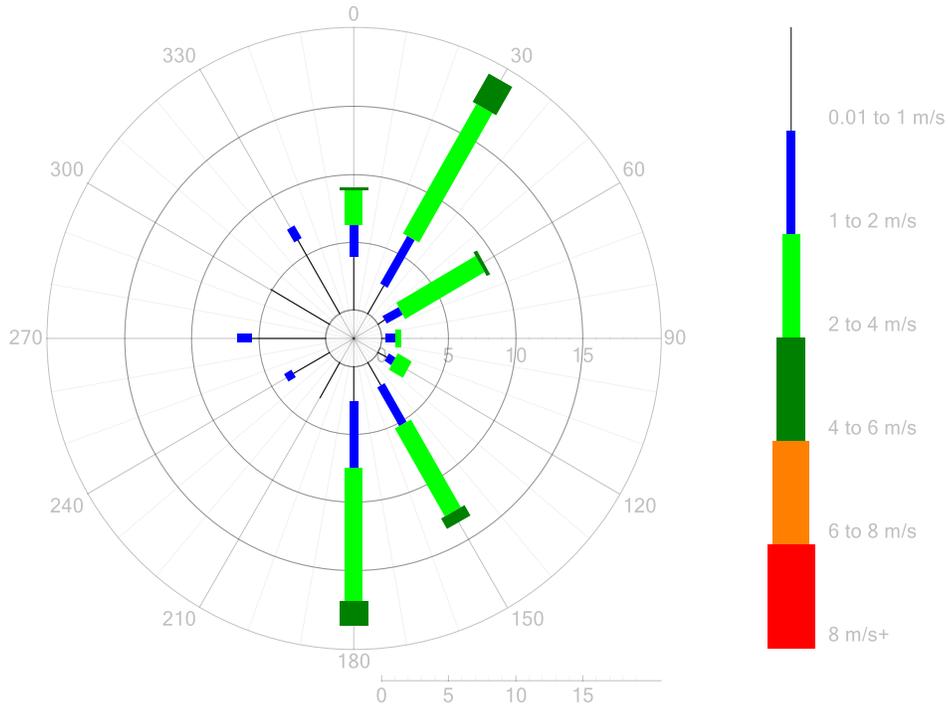
Figure 11: Saint Lukes Park – Wind Rose for February 2019

St Lukes Park - Wind Rose (1-hour average)

0.0% calm
100.0% valid data present

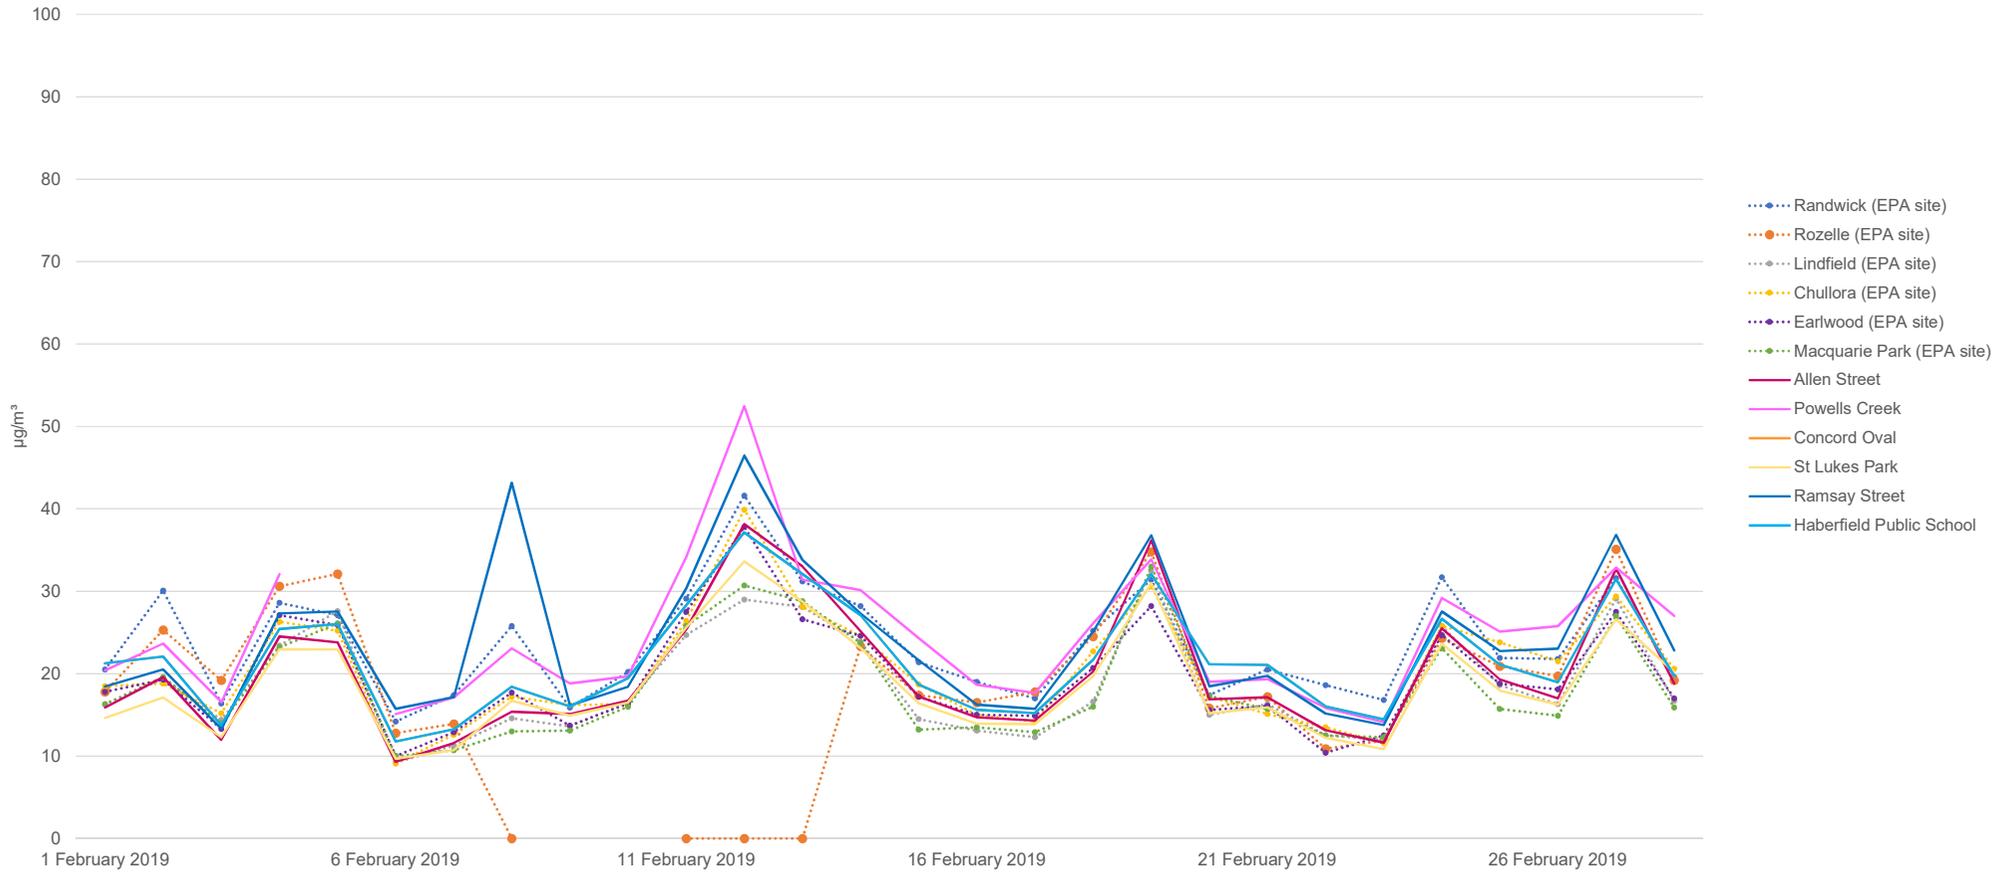
Comparison of WestConnex M4 East sites with EPA sites

PM10
24 hour average
February 2019
