28, 32 and 42-44 Campbell Street St Peters

Catalogue of Historic Building Fabric

Prepared for CPB Dragados Samsung Joint Venture

December 2016

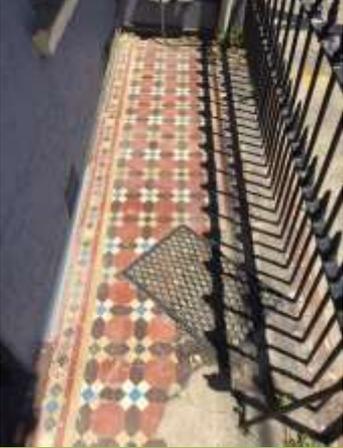
5	Tessellated tiles	1	Poor condition

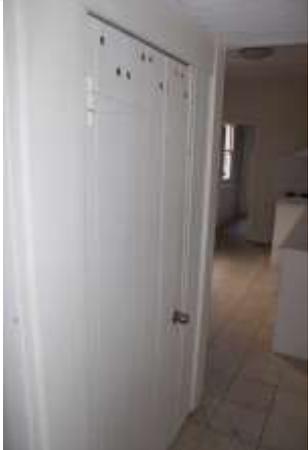
19	Door joinery – timber board & brace <i>Note: this concerns the door only. The timber louvre vent above the bathroom door is of poor quality and low significance.</i>	2		Asbestos cement sheeting to infill panel above the door to upboard under stairs.

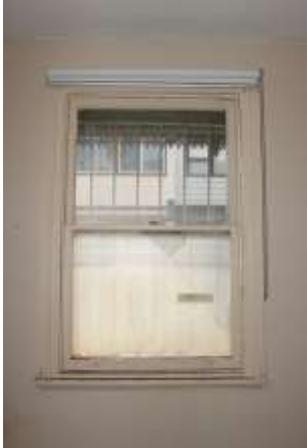
10	Window joinery – Large timber double-hung sash	7		Lead (pb) paint

- Any salvage material found to contain hazardous material, i.e. lead paint, should be managed in accordance with current hazardous materials legislation.

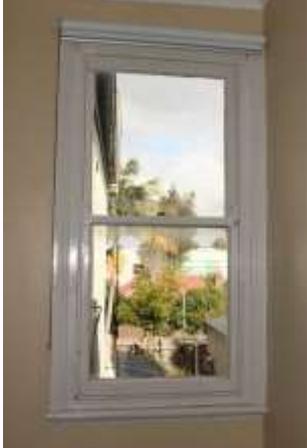
11	Window joinery – Small timber double-hung sash	1		Lead (pb) paint

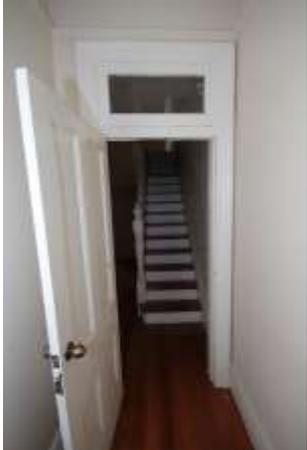
16	Door joinery – timber frame	9		Lead (pb) paint

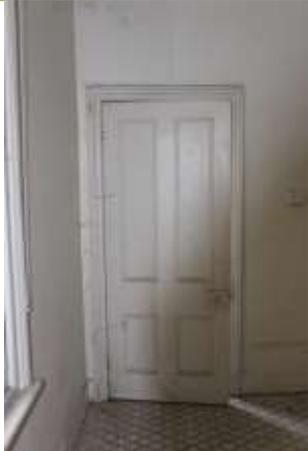
Ref. #	Feature	Qty	Notes	Hazardous Materials Present	Thumbnail
17	Door joinery – panel timber door	2		Lead (pb) paint

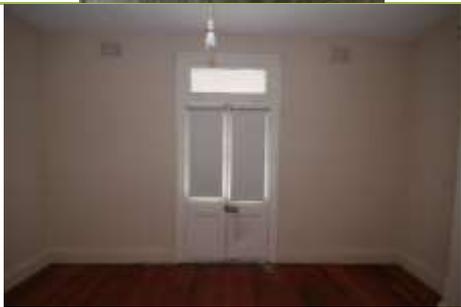
18	Door joinery – timber French door	1		Lead (pb) paint

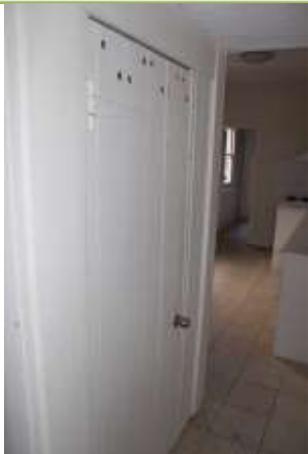
19	Door joinery – timber board & brace <i>Note: this concerns the door only. The timber louvre vent above the bathroom door is of poor quality and low significance.</i>	2		Lead (pb) paint

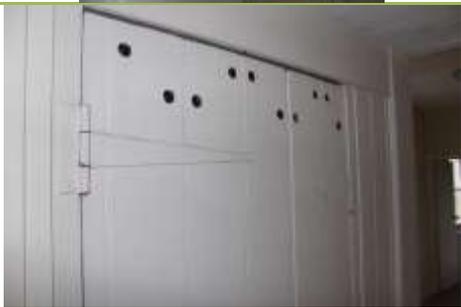
20	Door joinery - hardware	1		Lead (pb) paint

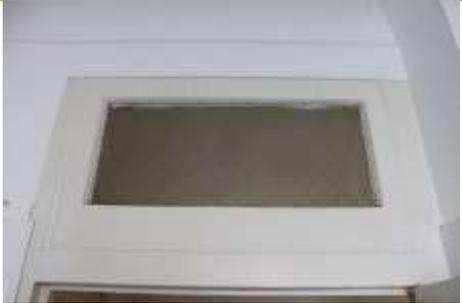
Ref. #	Feature	Qty	Notes	Hazardous Materials Present	Thumbnail
22	Door light – sealed frame	8		Lead (pb) paint

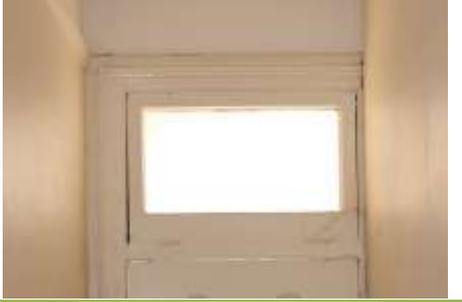
23	Door light - louvered	3		Lead (pb) paint

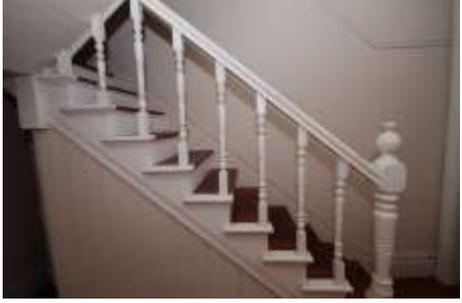
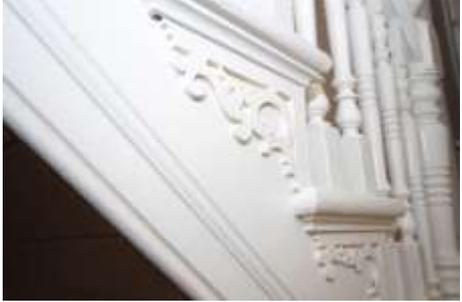
25	Stair – balustrade	1		Lead (pb) paint

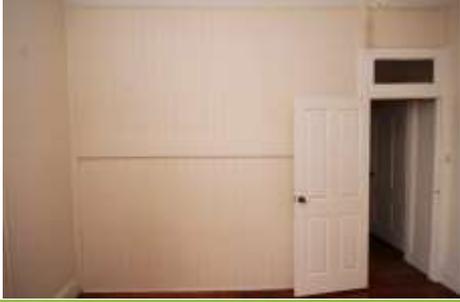
27	Wall – beaded cladding	3		Lead (pb) paint to hallway

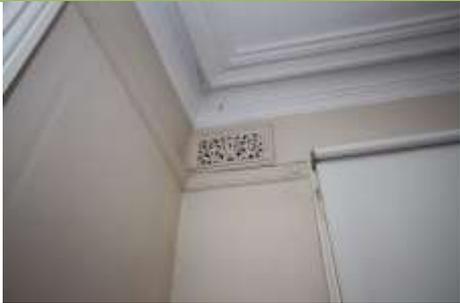
29	Chimney surrounds	0			
30	Tessellated tiles	0			
31	Vents – ceiling	0			
32	Vents – floor	0			
33	Vents – wall	6		Lead (pb) paint

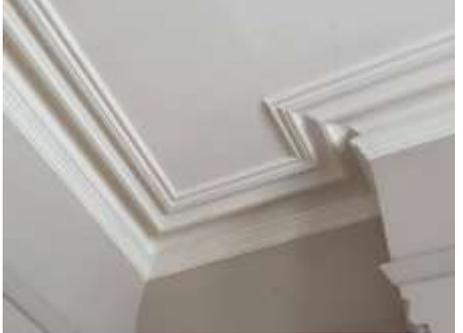
Ref. #	Feature	Qty	Notes	Hazardous Materials Present	Thumbnail
34	Cornicing	2		Lead (pb) paint

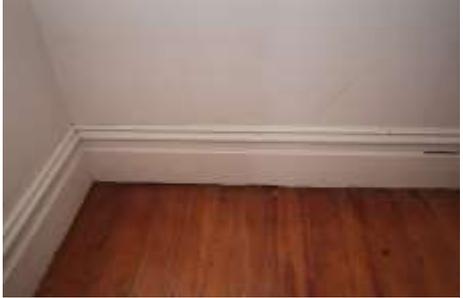
35	Skirting boards	6		Lead (pb) paint

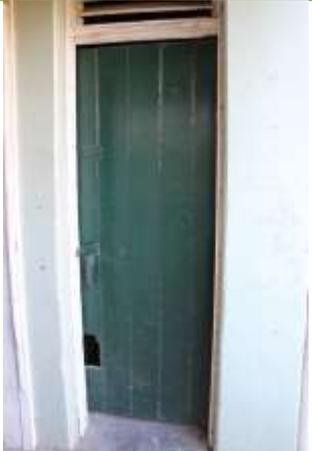
Ref. #	Feature	Qty	Notes	Hazardous Materials Present	Thumbnail
19	Door joinery – timber board & brace <i>Note: this concerns the door only. The timber louvre vent above the bathroom door is of poor quality and low significance.</i>	1

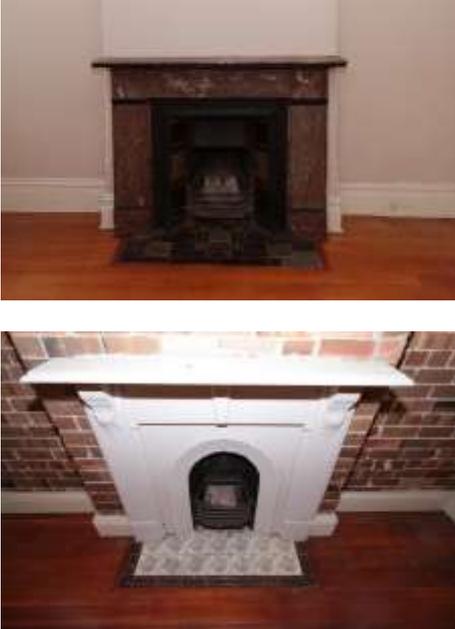
29	Chimney surrounds / fireplace	3	Extreme care must be taken for the removal of these items
